**Docket No. 272 – Development and Management Plan Inspection**

**Segment 3 Underground Line**

**Date:** October 30, 2008

**Location:** East Devon Substation to the Housatonic River Crossing

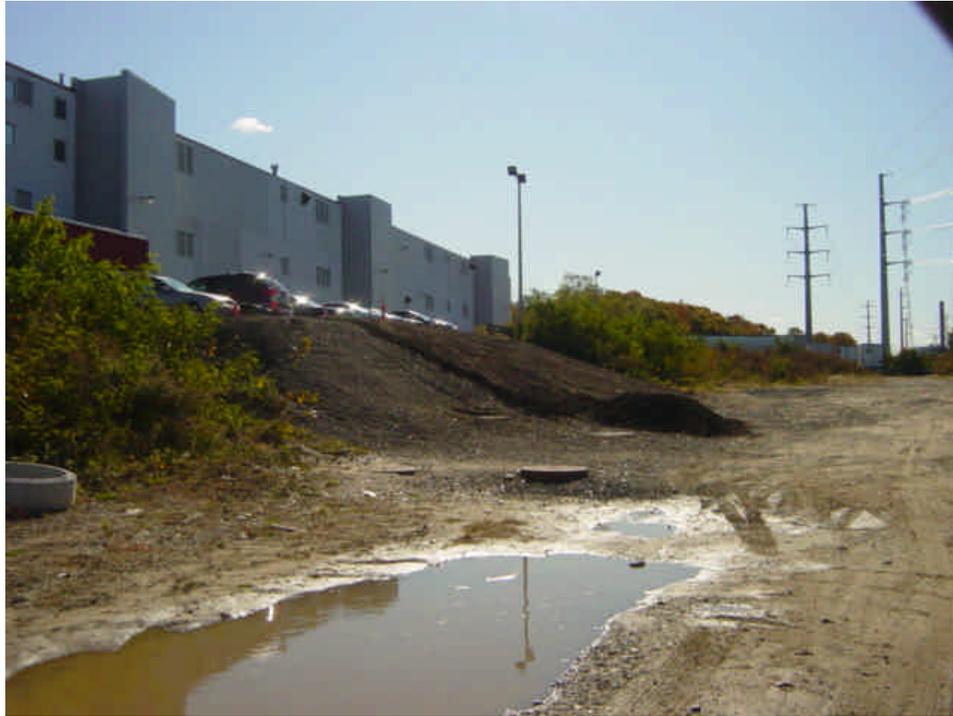
**Topsoil had been applied to a portion of the slope near sta. #1080 two weeks ago. Complete the application and ensure that soil is stabilized with mulch as soon as feasible.**

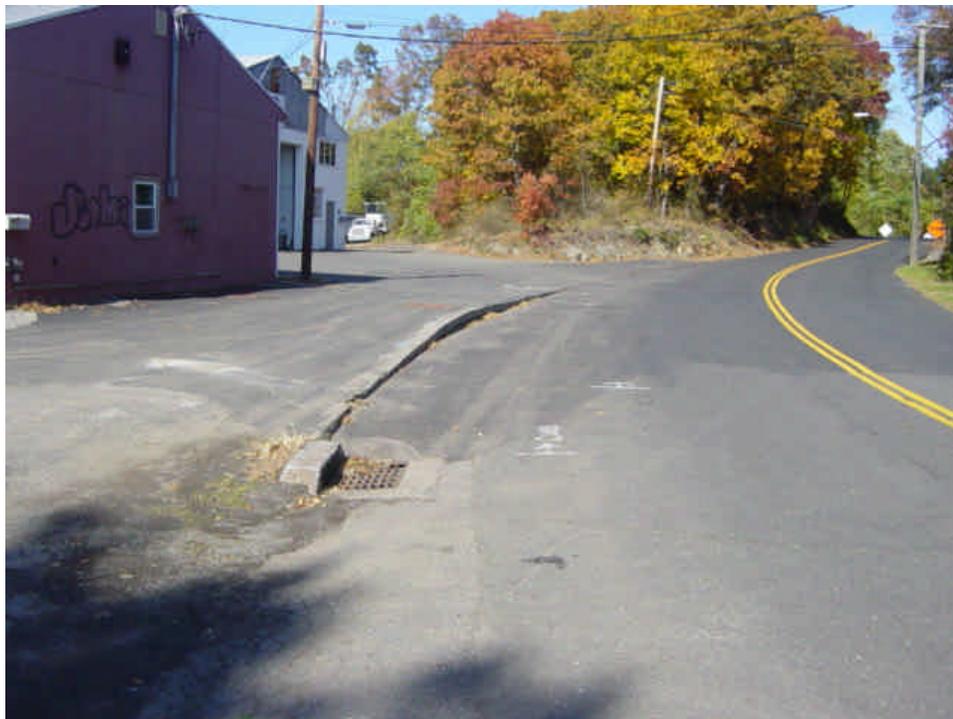
**Catch basin near sta. #1030 has been cleaned and sediment/debris along the roadway has been swept.**
