Docket No. 272 – Development and Management Plan Inspection

Segment 4a Underground Line

Date: March 20, 2008

Location: Singer Substation to Fairfield/Westport Town Line

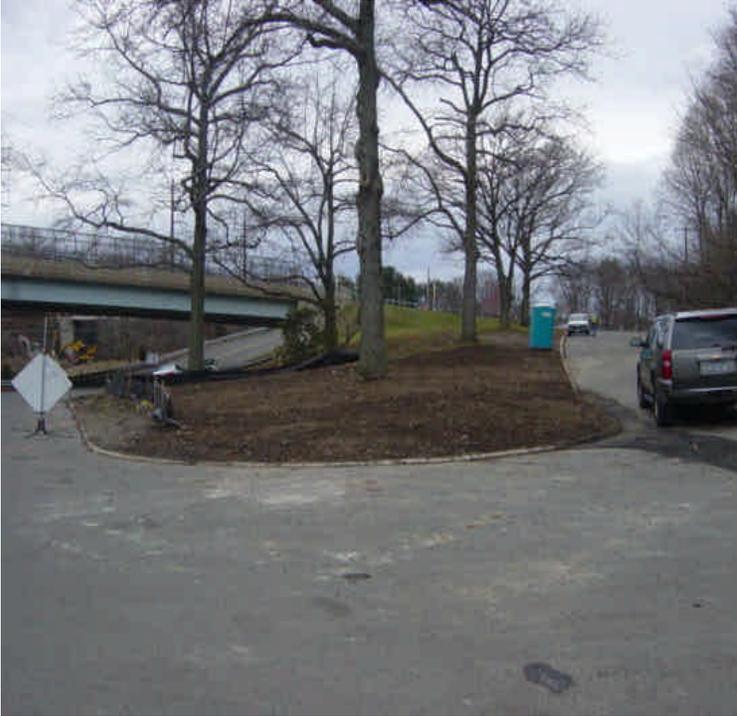
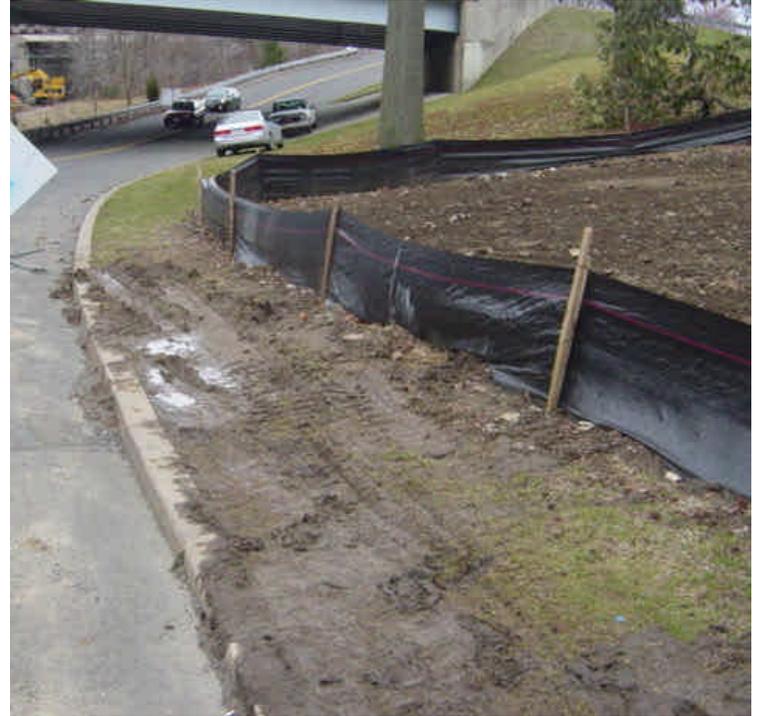
The median near sta #494 has been largely restored and silt fence remains in place along the curb line. However, minor ruts and some exposed soil were observed adjacent to the fence. Some sediment has also accumulated along the curb. 3/20/08	Regrade rutted area and stabilize the exposed soils. Sweep the curb area if needed. 3/20/08	Needs attention.
Bridgeport	The stone wall was being reconstructed at sta. #503-504. Soils remain exposed but stable and temporary pavement and bituminous curbing remain in place. A minor amount of sediment has accumulated along the shoulder of the roadway. 3/20/08	Ensure soils are contained to the work area. Sweep roadways before the end of a work day as necessary to minimize tracking. 3/20/08	NA
	Some ruts were observed along the shoulder of Railroad Ave between Hancock Ave. and	Refresh/add gravel or hard-pack along the shoulders of the roadway in this area to reduce the	Needs attention. Continue to monitor.

The median area near sta. #493-494 has been restored. The concrete washout material has been removed. Silt fence remains along the curb line. Minor ruts and exposed soil were observed adjacent to the silt fence, and some sediment has accumulated along the curb line.

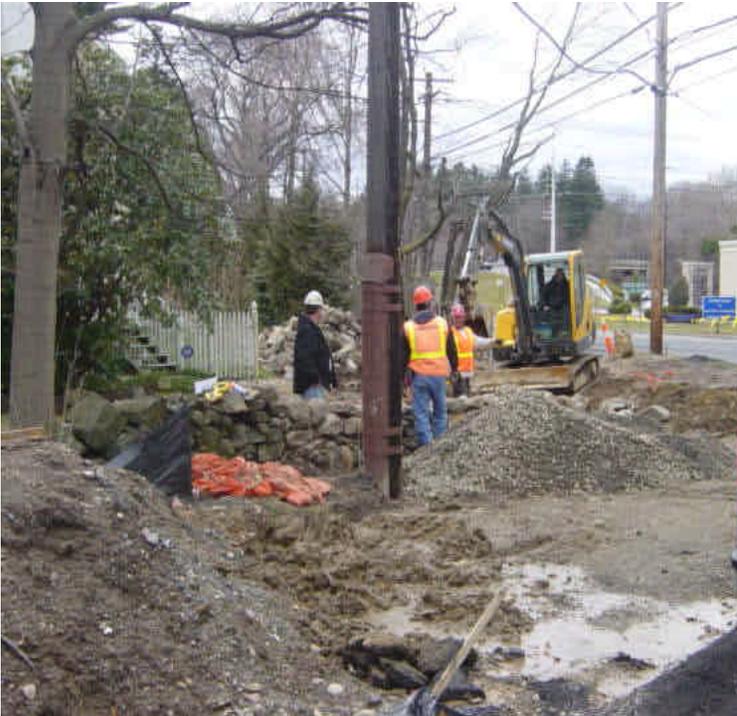
Areas of Inspection	Observation	Recommended Action	Corrected Action
	area at sta #503 per the D&M plan. The stone wall is being rebuilt at this time. 3/20/08		
Dewatering	Dewatering was not observed this week. 3/20/08	Continue to properly contain and/or filter discharge water when dewatering is required. 3/20/08	NA
Spills and Material Storage	Spill cleanup materials/kits were observed in the storage yards. 3/20/08 Multiple concrete washout areas were previously observed along the median area near sta. #494. The area has been restored and washouts properly removed. 3/20/08	Ensure that spill kits are also present with each vehicle during active construction 3/20/08 Perform future concrete washouts in a single contained location to minimize the total impact area. 3/20/08	NA Concrete washouts were properly removed.
Additional Observations	None. 3/20/08	None. 3/20/08	NA

The stone wall was being reconstructed near sta. #502-503.

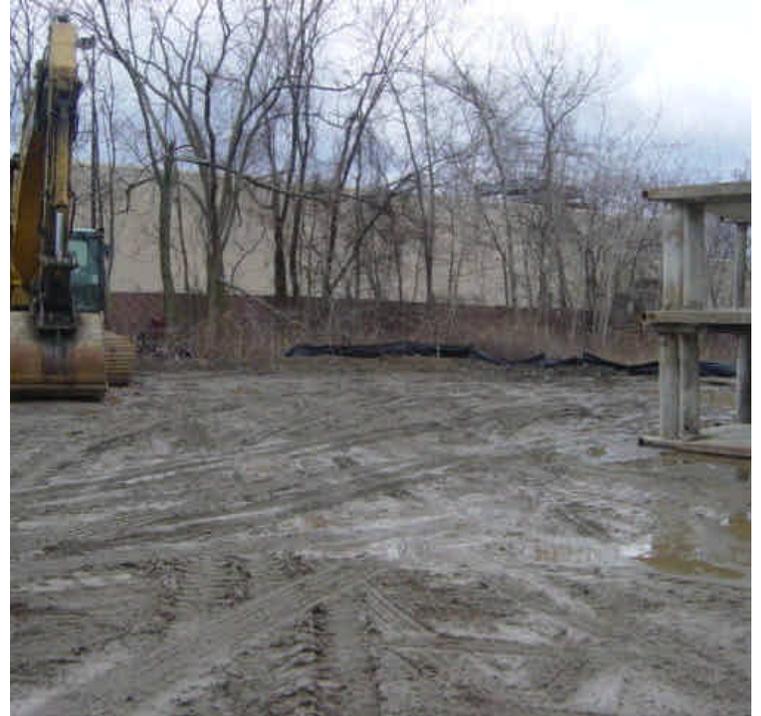
The King's Highway lay-down yard was very muddy. Some sections of silt fence are in need of repair. Monitor for sediment tracking at the yard entrance.
