**Docket No. 272 – Development and Management Plan Inspection**

**The Connecticut Light and Power Company Certificate of Environmental Compatibility and Public Need for the construction of a new 345-kV electric transmission line and associated facilities between Scovill Rock Switching Station in Middletown and Norwalk Substation in Norwalk, Connecticut, including reconstruction of portions of existing 115-kV and 345-kV electric transmission line, the construction of Beseck Switching Station in Wallingford, East Devon Substation in Milford, (and Singer Substation in Bridgeport), modifications at Scovill Rock Switching Station and Norwalk Substation, and the reconfiguration of certain interconnections.**

**Segment 4a Underground Line**

**Date:** April 10, 2008

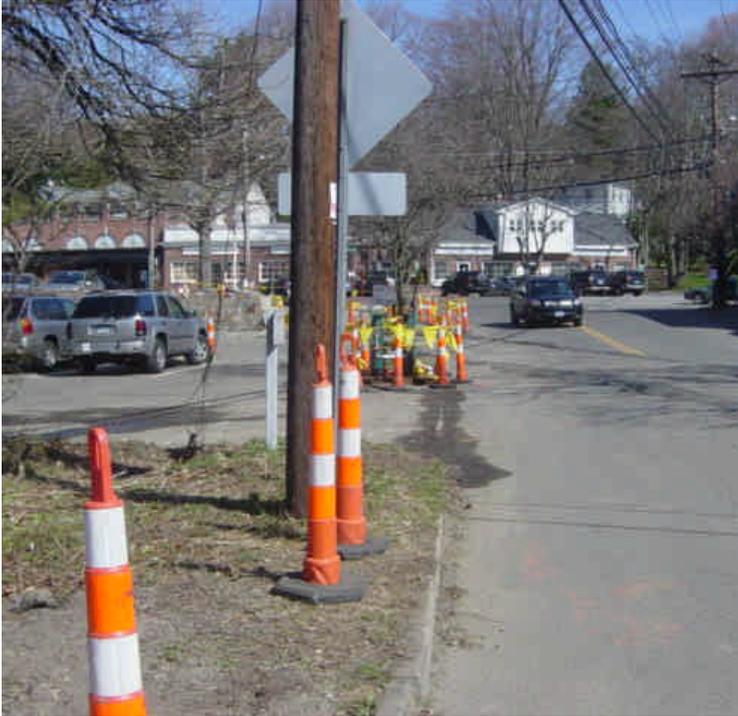
**Trenching work continues near sta. #480-482.**

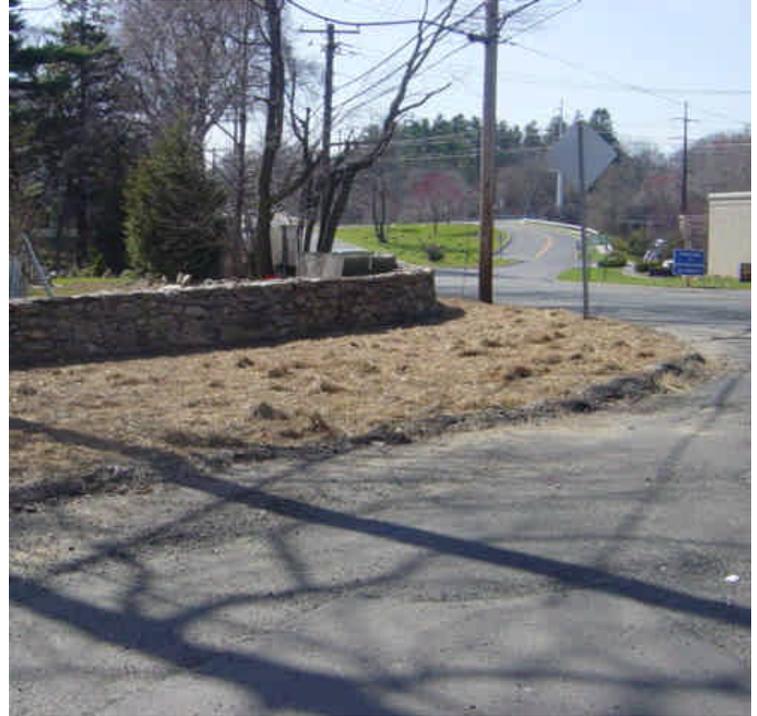
**The stone wall has been reconstructed near sta. #503. Hay mulch has been applied to stabilize the areas of exposed soil.**

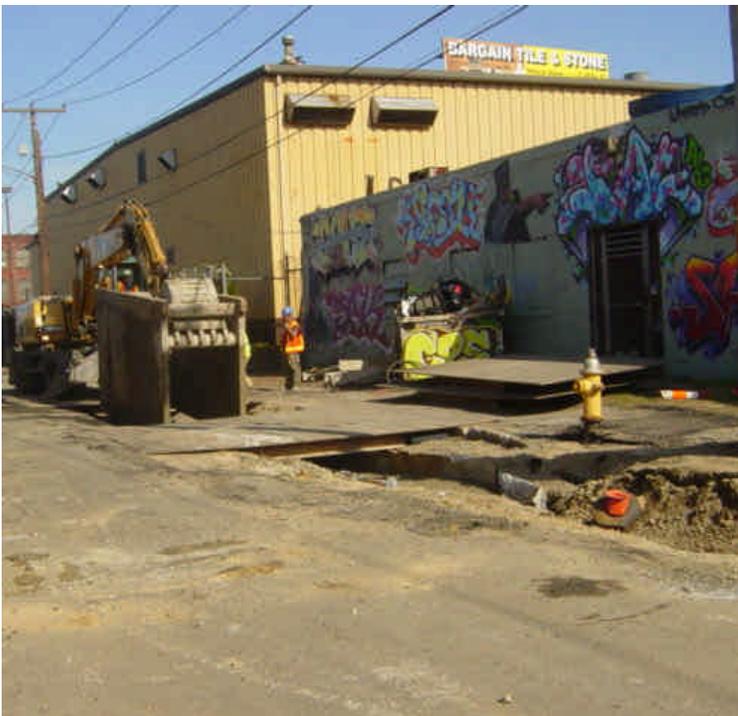
**Trenching and backfilling work continue near sta. #719-720 along Railroad Ave. Accumulated sediment was observed near the stone wall but may not be related to the construction activities. Sweep as needed.**
