Docket No. 272 – Development and Management Plan Inspection

Segment 4a Underground Line

Date: April 17, 2008

Location: Westport Avenue to the Norwalk Substation in the City of Norwalk

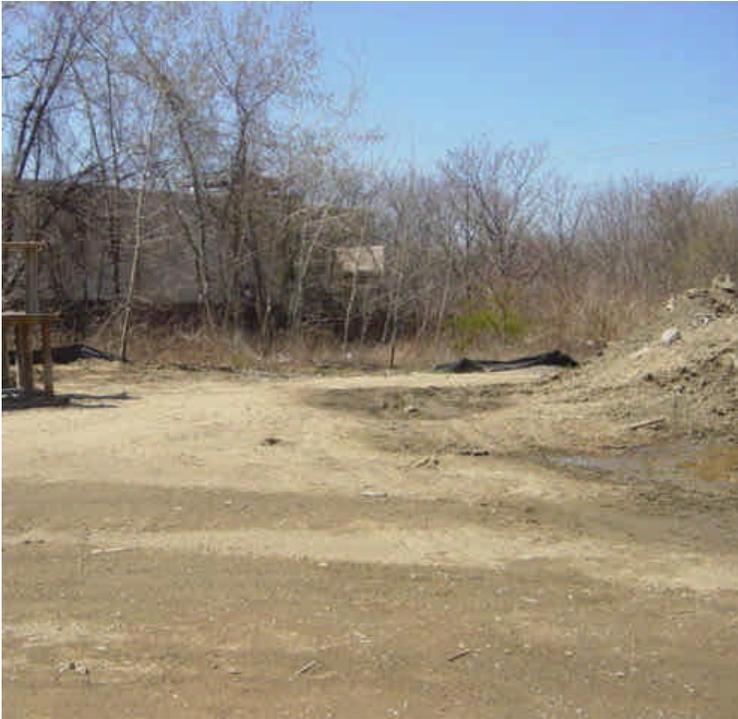
A small area of silt fence is in need of repair near the west side of the Kings Highway Lay-down yard.

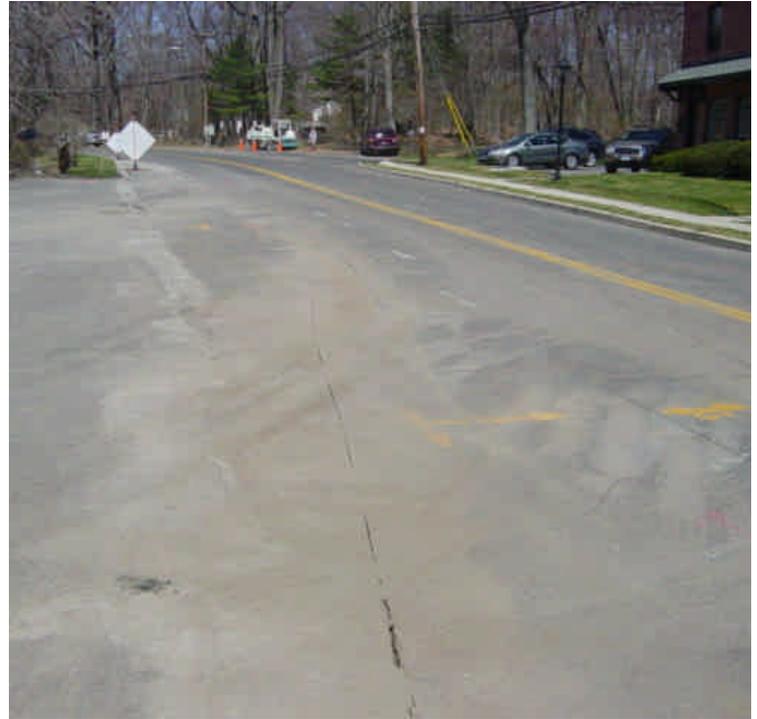
Areas of Inspection	Observation	Recommended Action	Corrected Action
Fairfield	<p>activities has the potential to enter catch basins. Residual dried slurry/ dust from saw cutting was observed along the roadway between sta. #476-478 and was being tracked in some areas. 4/17/08</p>	<p>catch basins and sensitive areas by quickly attending to it as it is generated during cutting. Sweep the dried slurry in this area. 4/17/08</p>	<p>attention.</p>
	<p>Any exposed soils have potential for airborne dust migration. Contractors are aware of the potential. 4/17/08</p>	<p>Prevent dust migration by regularly watering down exposed soils and sweeping immediately. If exposed soils are not to be worked within 21 days, they should be stabilized within 7 days of the last activity. 4/17/08</p>	<p>NA</p>
	<p>Silt fence remains in place along the curb line near sta. #495 in the median area. Even though minor ruts were regraded, large area of soil still remains exposed. 4/17/08</p>	<p>Either temporarily stabilize or permanently restore the exposed soils within the appropriate timelines (since 3/20). Sweep the curb area if needed 4/17/08</p>	<p>Additional work is needed to stabilize exposed soils per D&M timelines</p>

Dried slurry/dust generated from saw cutting activities near sta. #476-478 remains over the roadway and was being tracked in some areas. Sweep as needed.

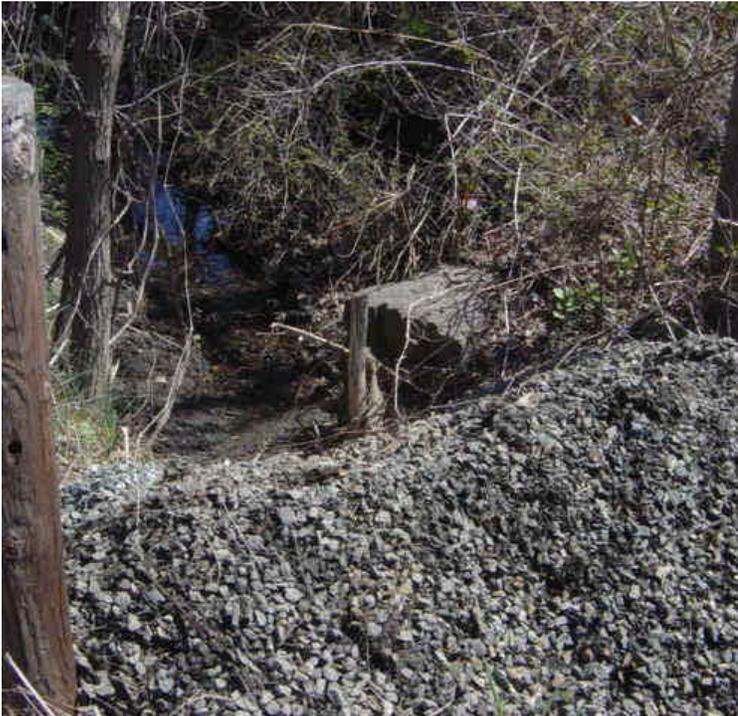
Areas of Inspection	Observation	Recommended Action	Corrected Action
<p>Kings Highway Lay-down Yard (Off Kings Highway, near Rt. 1 rotary)</p>	<p>work on Railroad Ave. this week. 4/17/08</p> <p>Crushed stone remains in several areas throughout the yard to reduce tracking. Sediment tracking was not observed. 4/17/08</p> <p>Perimeter controls remain in place but some sections need repair. 3/20-4/17/08</p>	<p>Continue to maintain controls and sweep the roadway as necessary. 4/17/08</p> <p>Controls need maintenance. 3/20-4/17/08</p>	<p>NA at this time.</p> <p>Needs attention</p>
<p>Inland Wetland and Watercourse encroachment and mitigation</p>	<p>The Kings Highway lay-down yard is located adjacent to potential resource areas and a concrete lined waterway. 4/17/08</p> <p>Crushed stone was previously placed along a drainage swale near sta. #480. The minor amount of stone was inadvertently pushed past the controls and into the adjacent channel (4/3), has now been removed. 4/17/08</p>	<p>See Erosion and Sediment Controls section. 4/17/08</p> <p>Continue to monitor. 4/17/08</p>	<p>NA</p> <p>The crushed stone inadvertently placed in the channel has been removed.</p>

Crushed stone that was inadvertently pushed into a drainage channel a few weeks ago, has been removed.

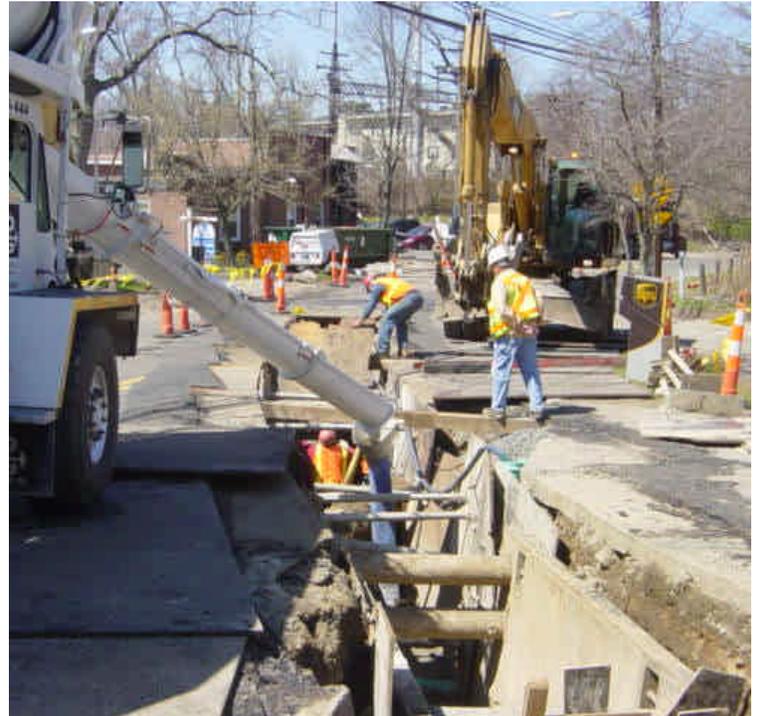
Trenching/backfilling work continues near sta. #481-482.
