Docket No. 272 – Development and Management Plan Inspection

Segment 4a Underground Line

Date: May 8, 2008

Location: Singer Substation to Fairfield/Westport Town Line

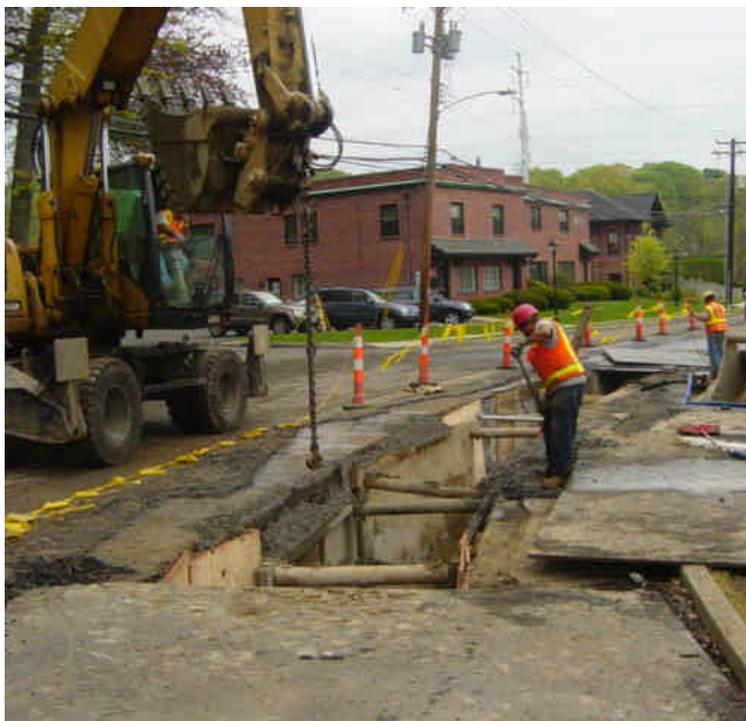
Work continues near sta. #473-480. Crews were trenching and placing sections of the conduit bank. Continue to sweep remnant sediment from adjacent areas at the end of each work day.

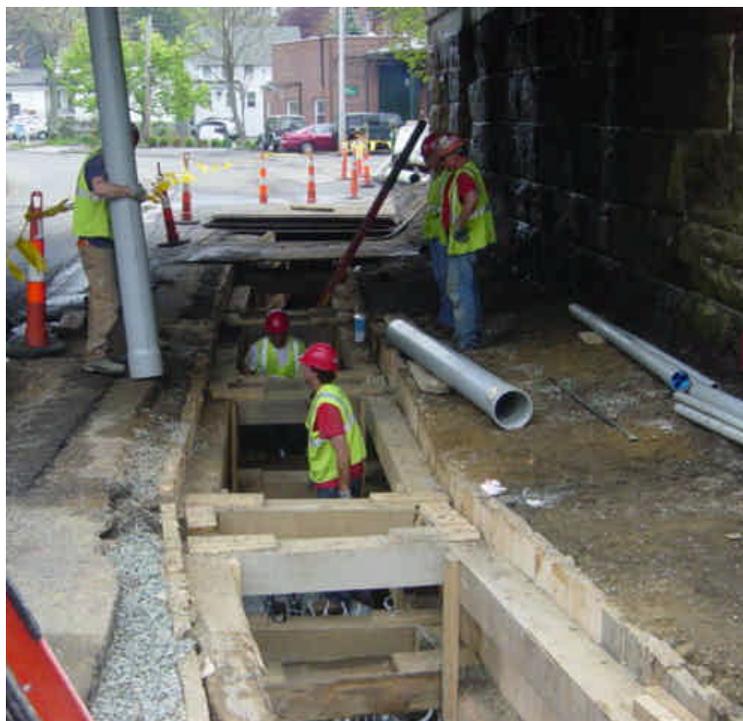
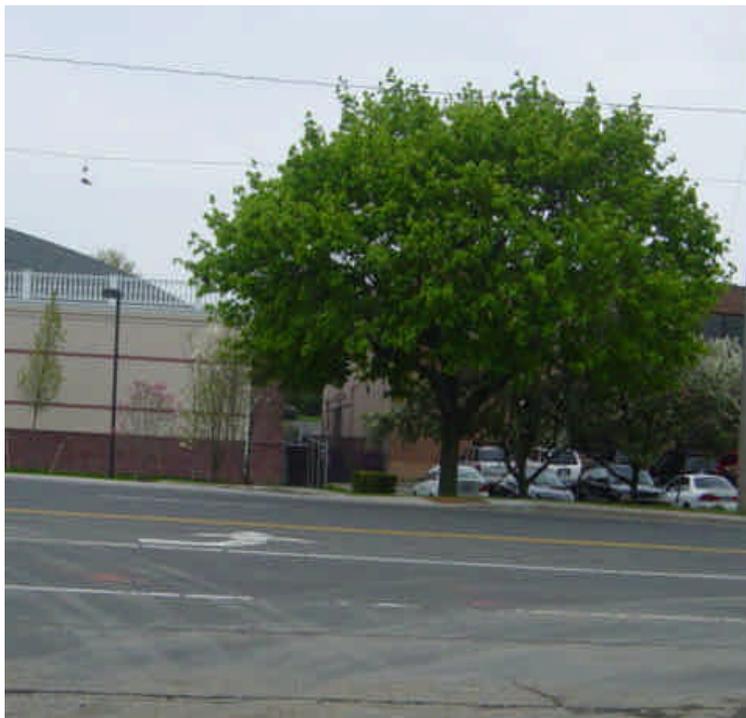
Minor sediment tracking was observed near the entrance to the Kings Highway lay down yard.

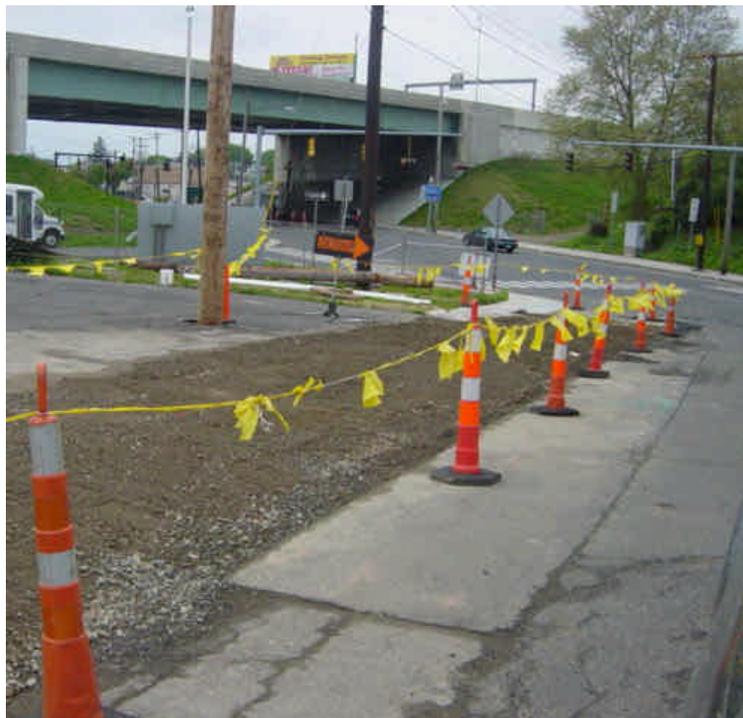
Area near the intersection of Fairfield Ave. and Railroad Ave. near sta. #719-720 has been backfilled with process material and remains stable. Cones were up to prevent vehicles from pulling off the road and tracking through.
