Docket No. 272 – Development and Management Plan Inspection

Segment 4a Underground Line

Date: May 15, 2008

Location: Singer Substation to Fairfield/Westport Town Line

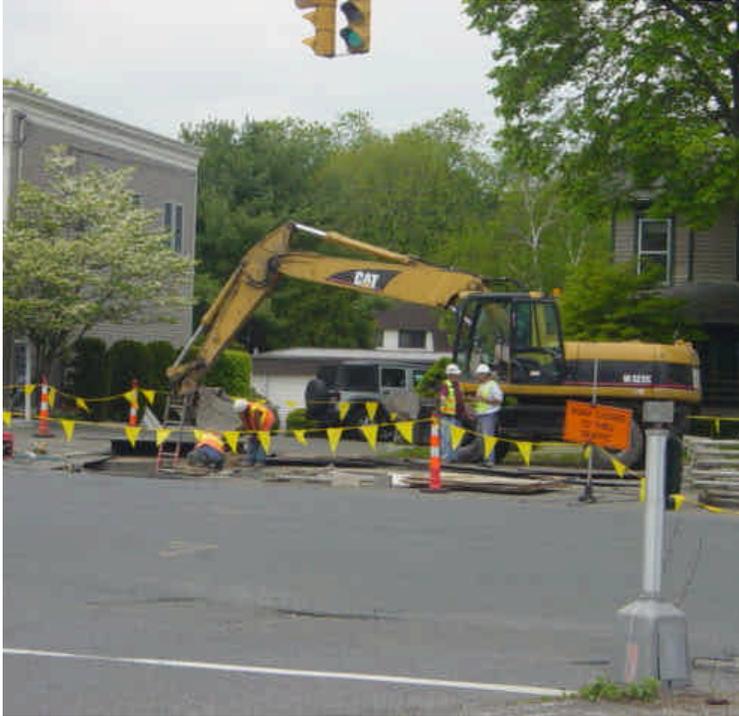
Trenching work continues near sta. #453-454.

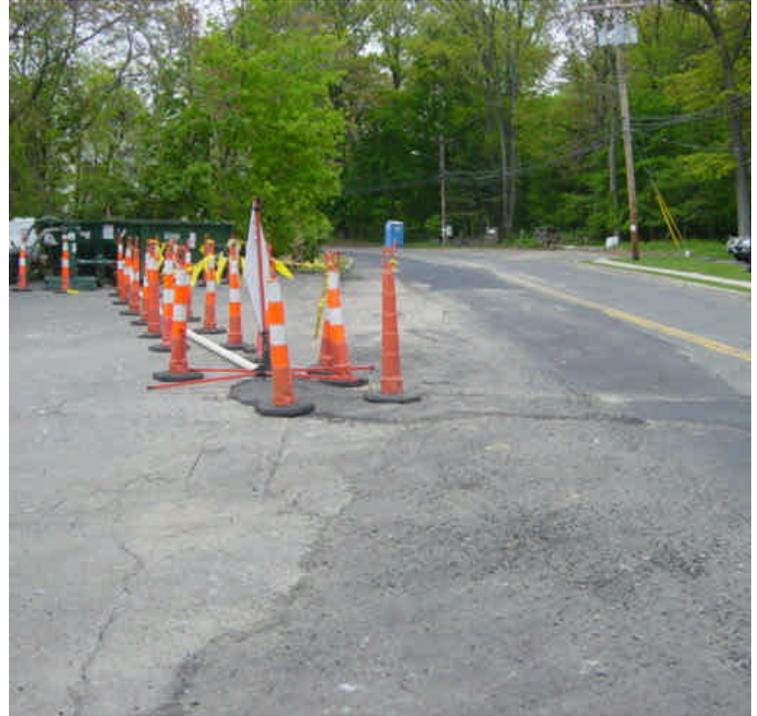
| Areas of Inspection | Observation | Recommended Action | Corrected Action |
|---|---|--|--|
| Bridgeport | <p>A minor amount of gravel and/or cold mix remains along the paved areas between sta. #475-480. 5/15/08</p> | <p>Sweep roadway to remove granular material from the pavement. 5/15/08</p> | <p>Needs attention. Continue to monitor.</p> |

| Areas of Inspection | Observation | Recommended Action | Corrected Action |
|---|---|---|--|
| <p>Dewatering</p> | <p>Dewatering was not observed during this week's inspection. 5/15/08</p> <p>A dewatering basin remains on site near sta. #477. 5/15/08</p> | <p>Continue to properly contain and/or filter discharge water when dewatering is required. 5/15/08</p> <p>None. Restore the area when it is no longer needed. 5/15/08</p> | <p>NA</p> <p>NA</p> |

Work appears to be complete near sta. #477-480. A dewatering tank remains on site. A minor amount of gravel also remains along the roadway near the recently paved areas. Sweep as necessary.

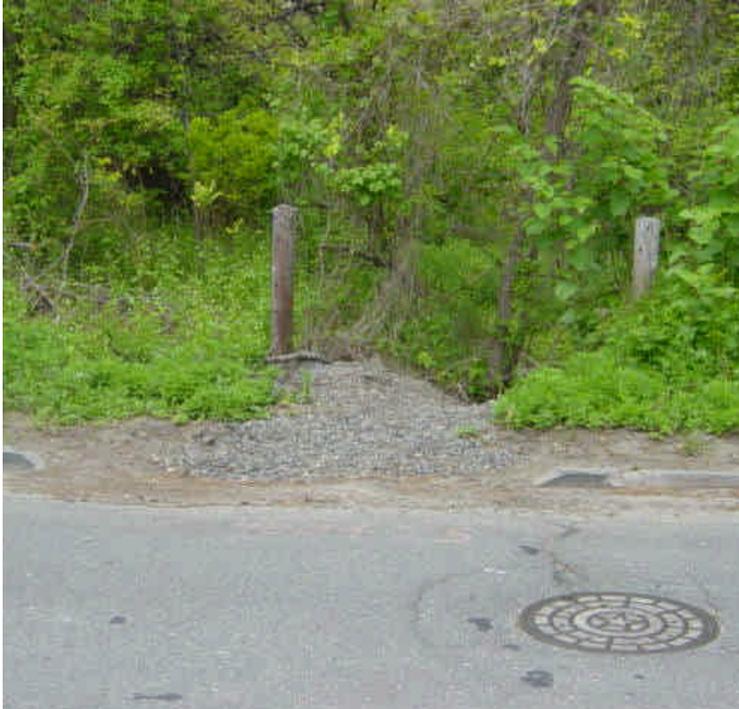
| Areas of Inspection | Observation | Recommended Action | Corrected Action |
|--|--|---|---|
| <p>Inland Wetland and Watercourse encroachment and mitigation</p> | <p>The Kings Highway lay-down yard is located adjacent to potential resource areas and a concrete lined waterway. 5/15/08</p> <p>Ruts and some exposed soil were observed near the drainage swale (near sta. #480) along the roadway. The ruts have been re-graded and the crushed stone has been spread near the edge of the swale. 5/15/08</p> | <p>See Erosion and Sediment Controls section. 5/15/08</p> <p>Continue to monitor for effectiveness. 5/15/08</p> | <p>NA</p> <p>Area has been re-graded and crushed stone has been spread.</p> |

Crushed stone previously piled along the drainage swale near sta. #481 has been spread out.

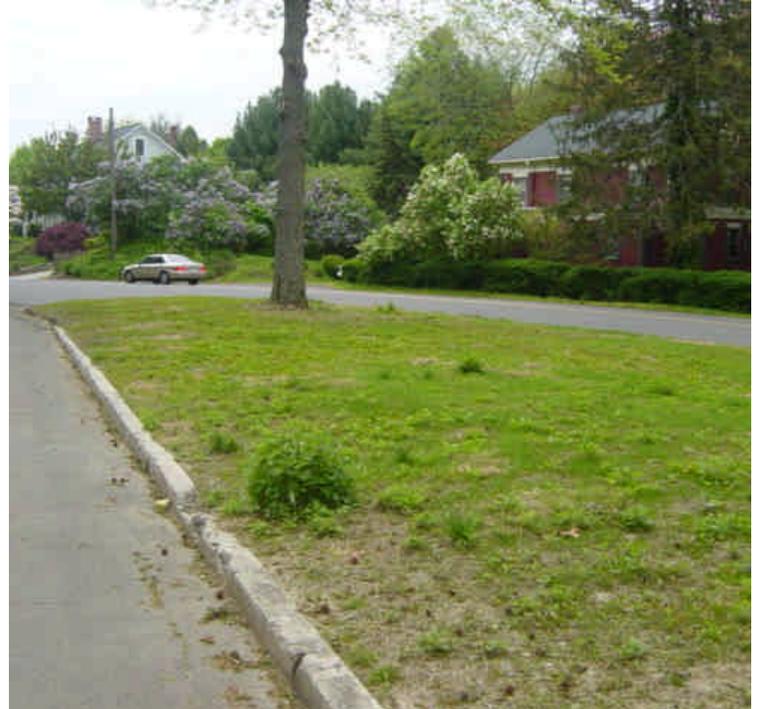
| Areas of Inspection | Observation | Recommended Action | Corrected Action |
|---|---|---|--|
| <p>Vegetative clearing (including trees to save or danger trees noted) or stabilization</p> | <p>The area along Pequot Ave. near sta. #495 is approximately 75% vegetated. 5/15/08</p> <p>Two trees were removed near sta. #462 in accordance with the D&M Plan (3/27/07). One tree was removed near vault #42 (7/25/07). 5/15/08</p> <p>A stone wall, fence, and shrubs had been removed from the work area at sta #503 per the D&M plan. The stone wall has been rebuilt. 5/15/08</p> | <p>Permanently stabilize any remaining exposed/ sparsely vegetated areas when feasible. 5/15/08</p> <p>Vegetation should be restored as necessary upon completion of work in these areas. 5/15/08</p> <p>Replace any removed shrubs per the D&M plan. 5/1-5/15/08</p> | <p>The median is approximately 75% vegetated.</p> <p>NA</p> <p>Needs evaluation/ final cover</p> |

Vegetation is beginning to grow in the recently restored median area near sta. #495.
