**Docket No. 272 – Development and Management Plan Inspection**

**Segment 4a Underground Line**

**Date:** May 22, 2008

**Location:** Singer Substation to Fairfield/Westport Town Line

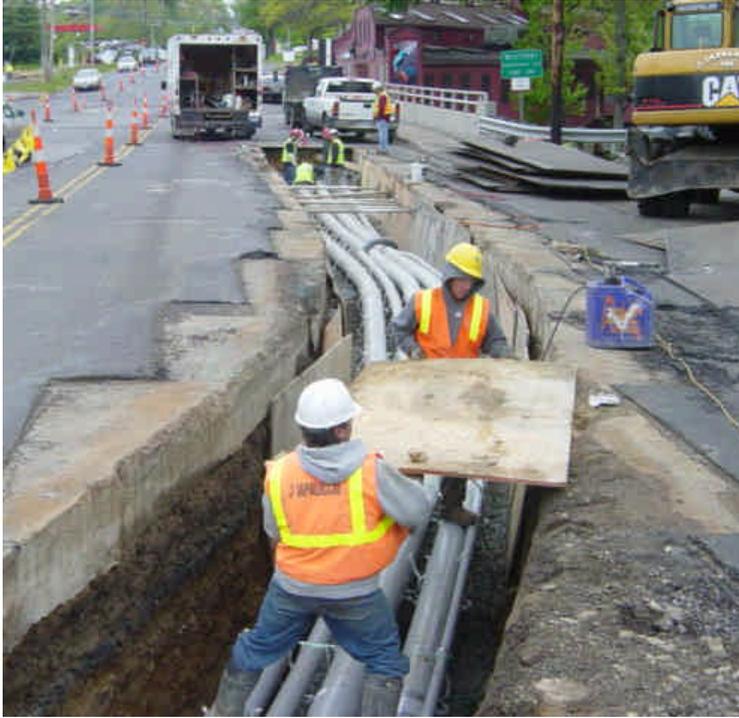
Crews were removing shoring near sta. #442-443 in preparation for backfilling

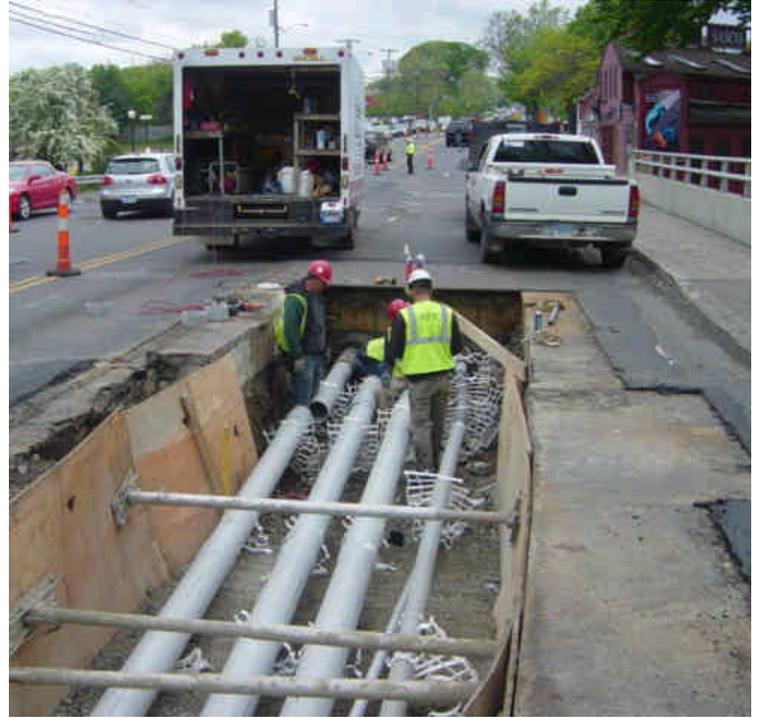
Electrical contractor was installing conduits at sta. #441, connecting to the conduit attached to the bridge deck at Sasco Creek.

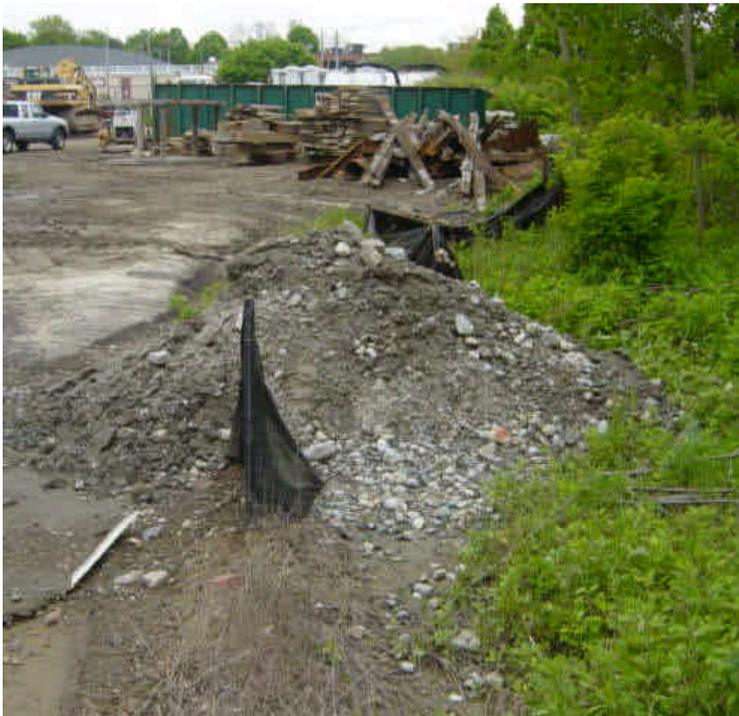
A small stockpile of material has been dumped on top of the silt fence near the NW corner of the Kings Highway lay-down yard. Pull material back and repair the controls.

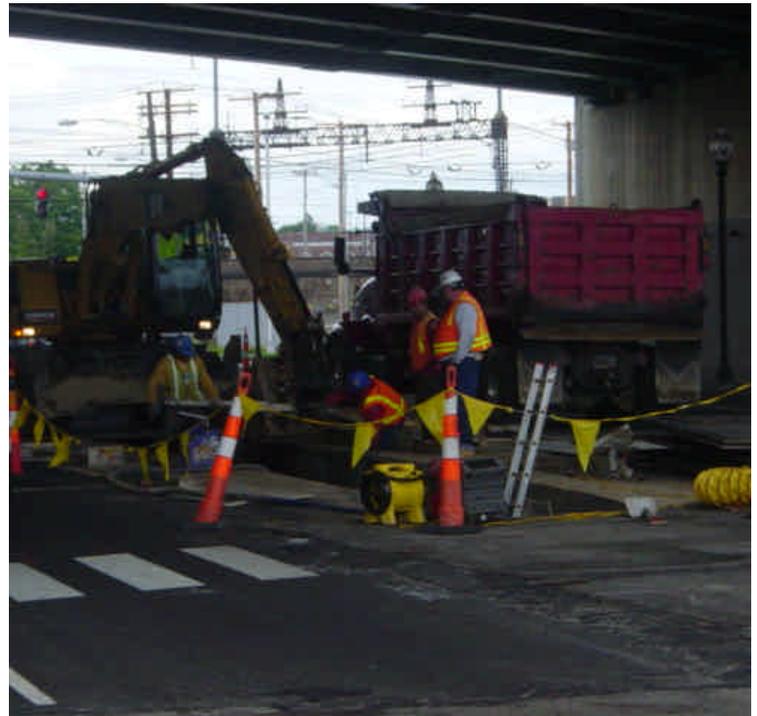
Trenching activities continue along Fairfield Avenue near sta. #716-718.
