Docket No. 272 – Development and Management Plan Inspection

Segment 4a Underground Line

Date: June 12, 2008

Location: Singer Substation to Fairfield/Westport Town Line

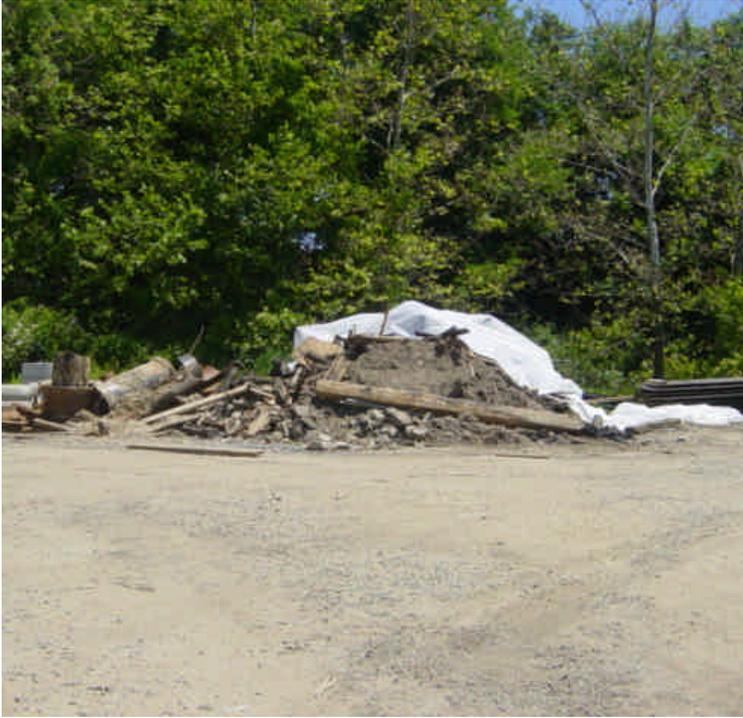
In the King's Highway lay-down yard, soil and additional debris material has been mixed with the railroad tie debris which had been previously sorted for disposal. A tarp has been placed over the stockpile.

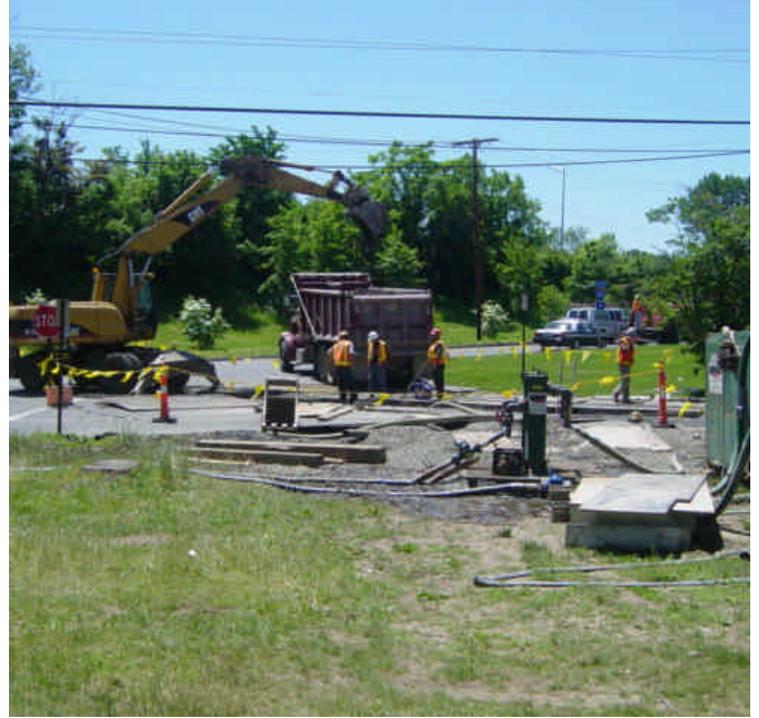
Areas of Inspection	Observation	Recommended Action	Corrected Action
	inspection at sta. #463. A small amount of turbid run-off is still reaching the catch basin in the roadway here. 6/12/08	discharge water when dewatering is required. Consider proactive controls in adjacent catch basins when dewatering is scheduled. 5/29-6/12/08	
Spills and Material Storage	Spill cleanup materials/kits were observed in the storage yards. 6/12/08	Ensure that spill kits are also present with each vehicle during active construction 6/12/08	NA
Additional Observations	None. 6/12/08	None. 6/12/08	NA

Trenching continues near sta. #463. Dewatering was ongoing at the time of the inspection. The site was very muddy but generally well contained.

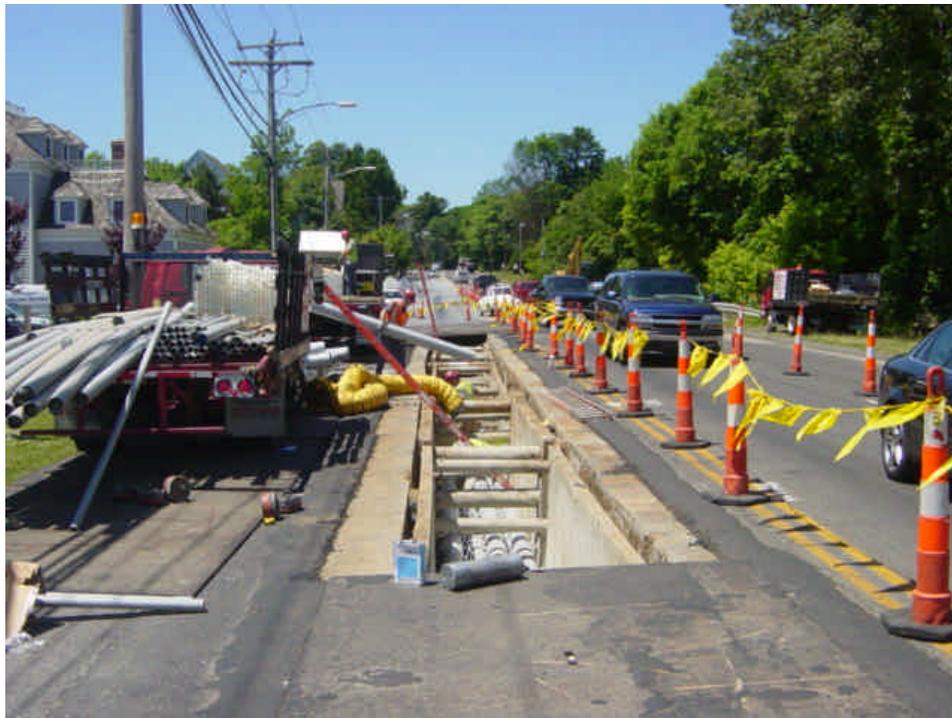
Trenching and conduit bank installation continue near sta. #514-517.
