**Docket No. 272 – Development and Management Plan Inspection**

**Segment 4a Underground Line**

**Date:** June 20, 2008

**Location:** Singer Substation to Fairfield/Westport Town Line

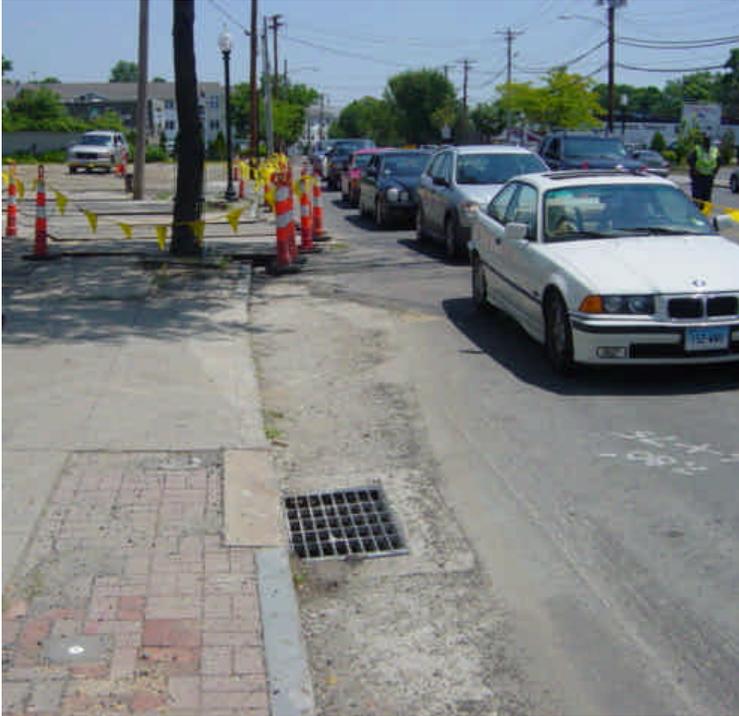
<p>A minor amount of granular material was observed along the curb line near sta. #647. Crews quickly attended to the area. 6/20/08</p>	<p>Sweep roadway to remove granular material. Continue to monitor the area and proactively sweep the roadway as necessary. 6/20/08</p>	<p>Roadway was swept following the observation.</p>
	<p>The work area near the intersection of Railroad Ave and Fairfield Ave (sta #719-720) has been backfilled with process material. Cones were placed to prevent vehicle from pulling off road and creating ruts. However, minor tracking was newly observed near the edge of the trench. 6/20/08</p>	<p>Continue to monitor and provide final cover/restoration when feasible. Sweep roadway as necessary to remove sediment from the roadway. 6/20/08</p>	<p>Needs attention. <i>The city of Bridgeport is concerned about any areas of tracking along Railroad Ave and crews should be sweeping this area.</i></p>

Gravel and sediment has accumulated along the curb line near sta. #647. Crews were later observed sweeping the area.

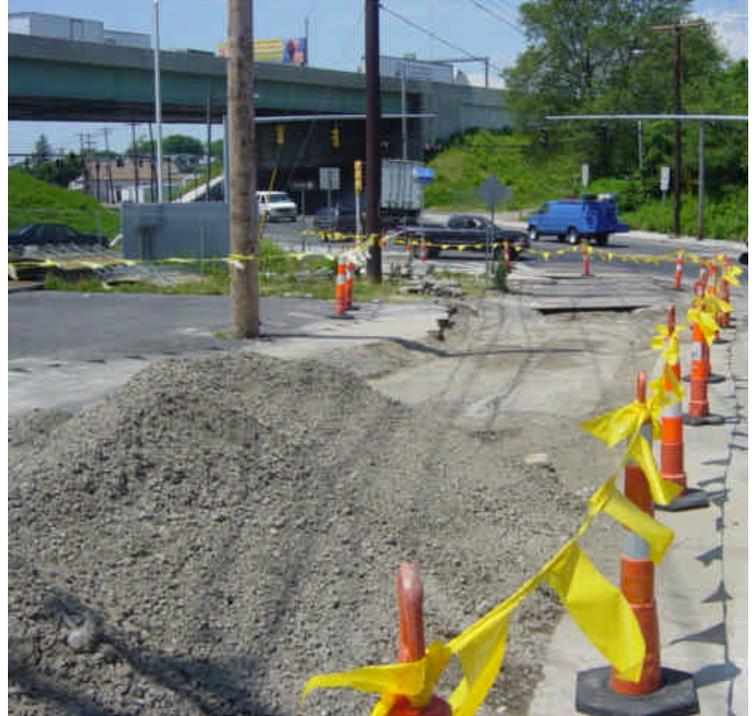
The area near sta. #719 has been partially backfilled. Minor tracking was observed along the edge of the trench.

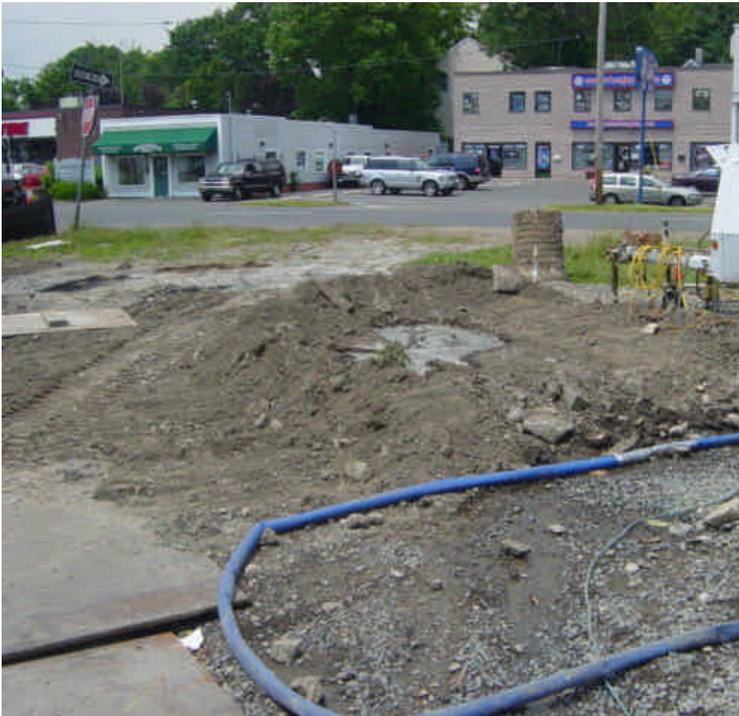
Trenching continues near sta. #463. Dewatering was ongoing at the time of the inspection. A well contained concrete washout area was also observed.
