Docket No. 272 – Development and Management Plan Inspection

Segment 4a Underground Line

Date: July 25, 2008

Location: Singer Substation to Fairfield/Westport Town Line

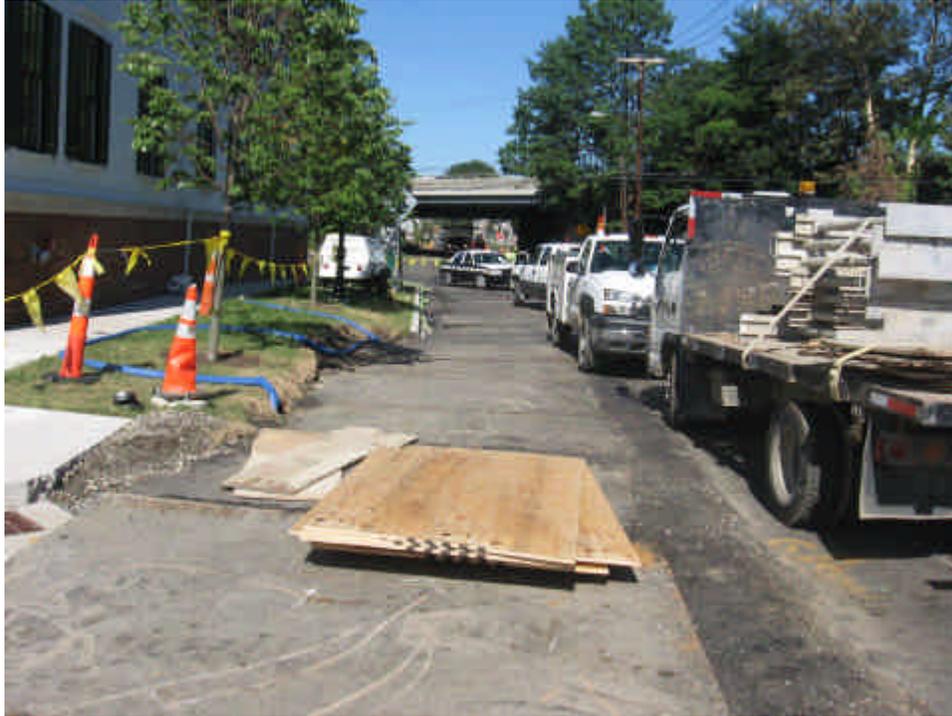
Trenching work continues near sta. #474. Dewatering was observed at the time of the inspection.

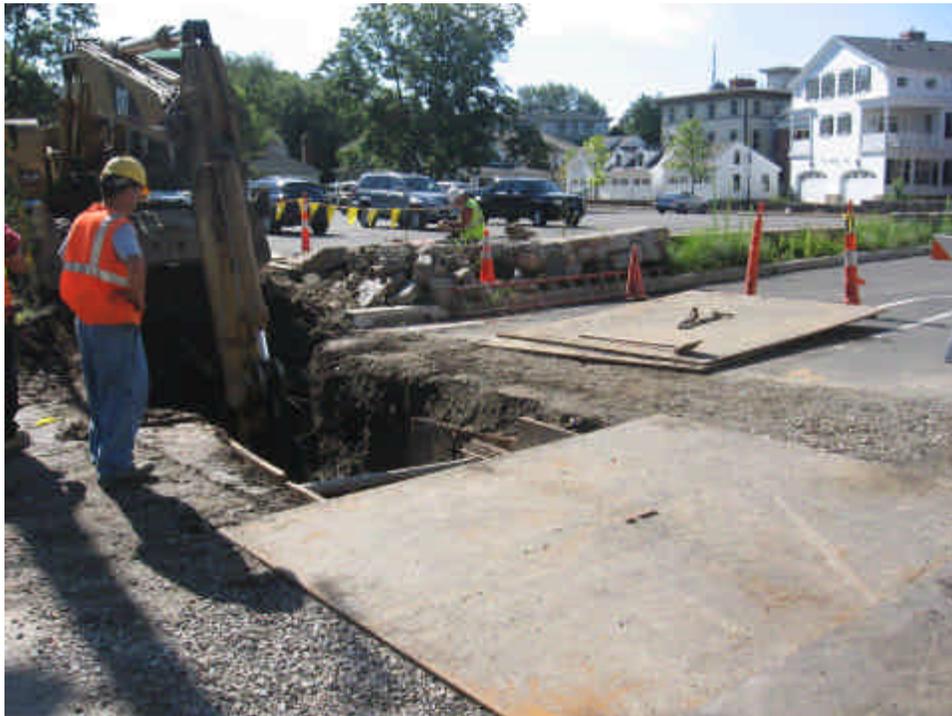
Trenching work continues near sta. #474. Portions of the trench were covered with steel plates.
