Docket No. 272 – Development and Management Plan Inspection

Segment 4a Underground Line

Date: September 5, 2008

Location: Singer Substation to Fairfield/Westport Town Line

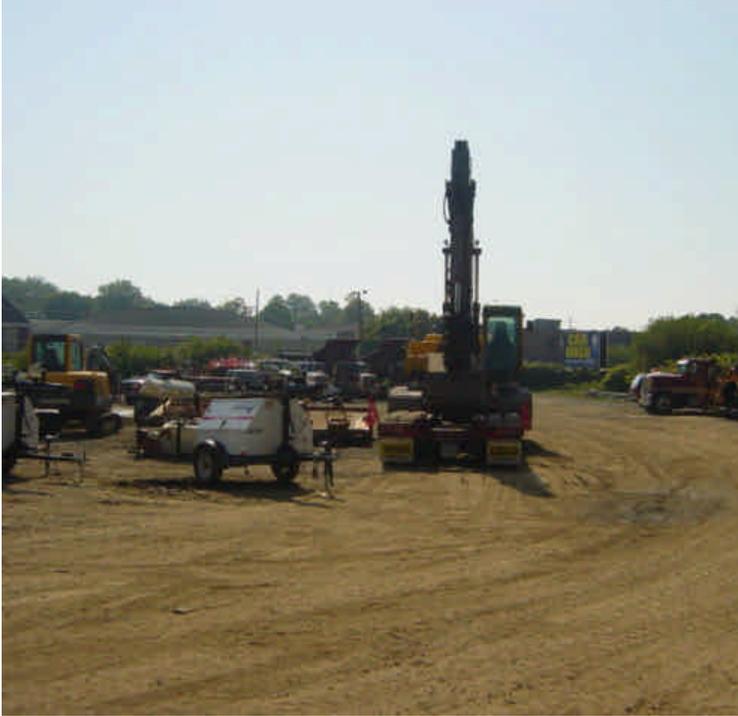
The Kings Highway yard remains in use, but materials and equipment are beginning to demobilize. No issues were observed during this weeks inspection.

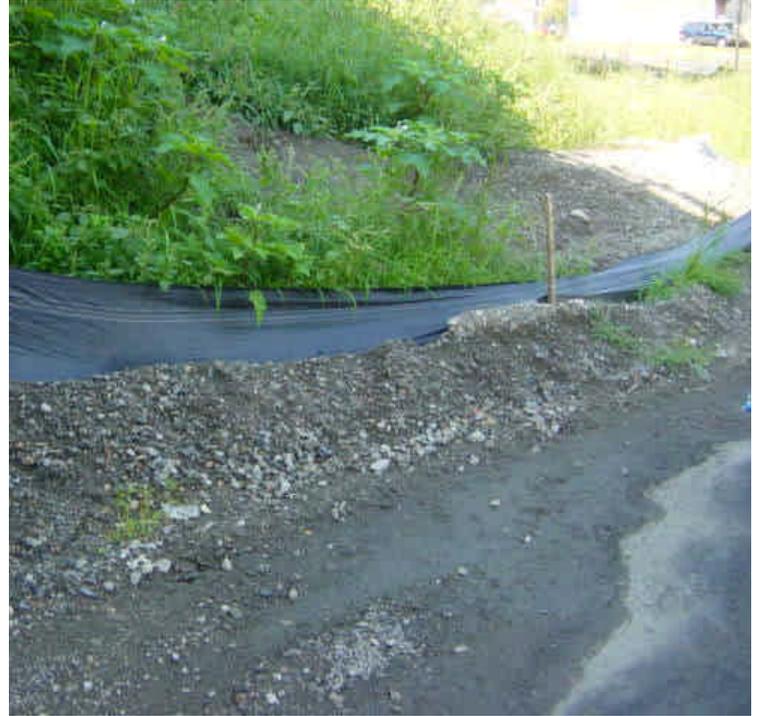
A concrete washout was observed near sta. #465, but may not be project related. The silt fence also needs repair. The slope needs stabilization as well.

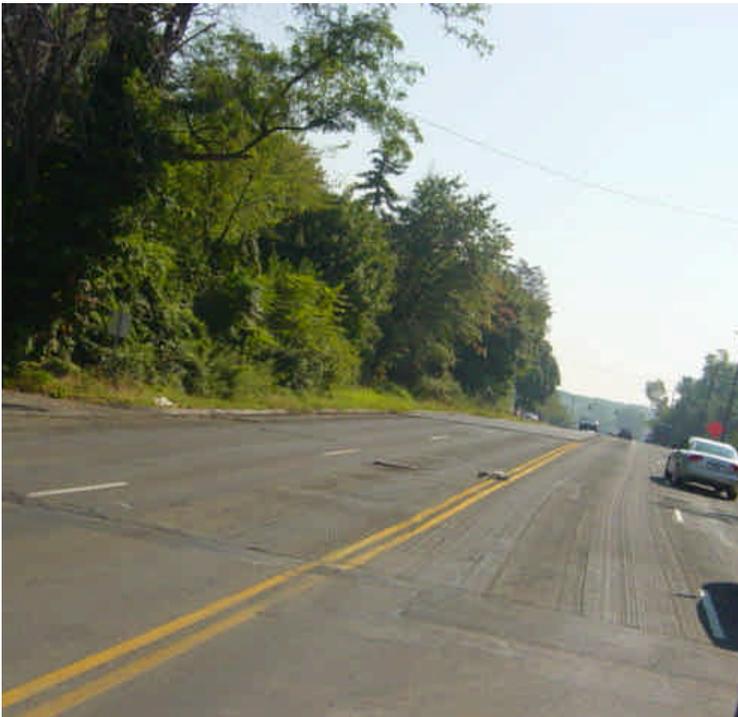
Various portions of Post Road (US Route 1) have been milled in preparation for resurfacing as part of final restoration.

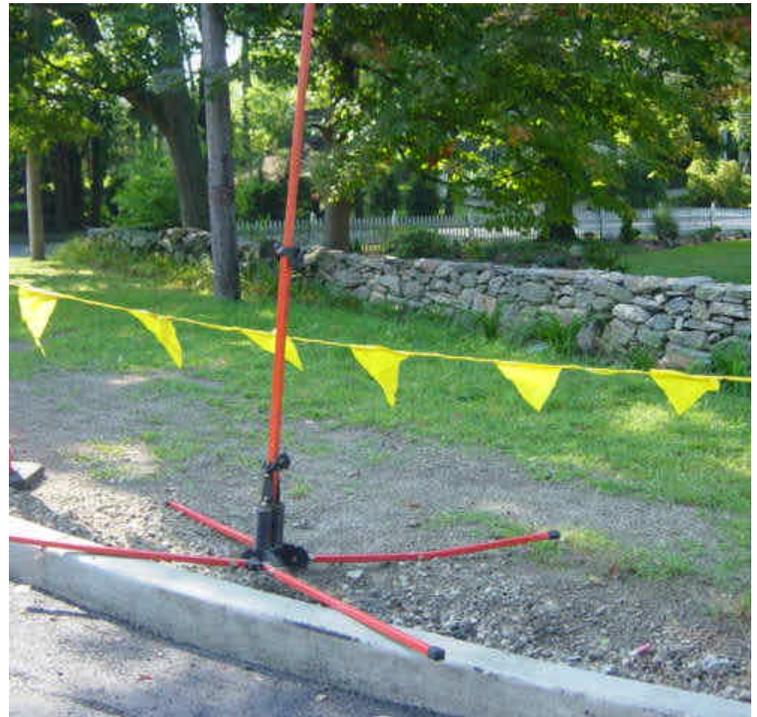
Curbing had been restored near sta. #502-503.
