Docket No. 272 – Development and Management Plan Inspection

Segment 4a Underground Line

Date: September 19, 2008

Location: Singer Substation to Fairfield/Westport Town Line

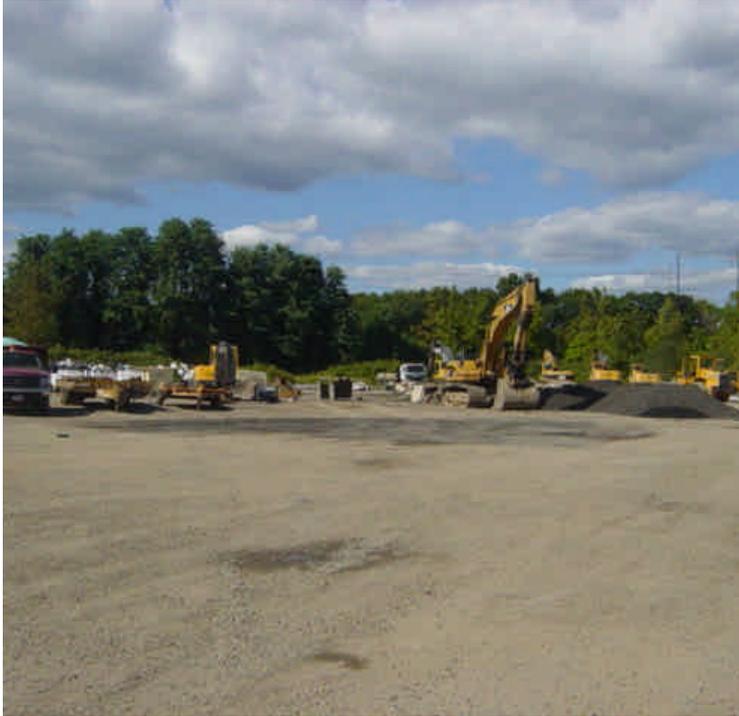
The Kings Highway yard remains in use, but materials and equipment is beginning to demobilize. Portions of the perimeter fence are deteriorating and need maintenance.

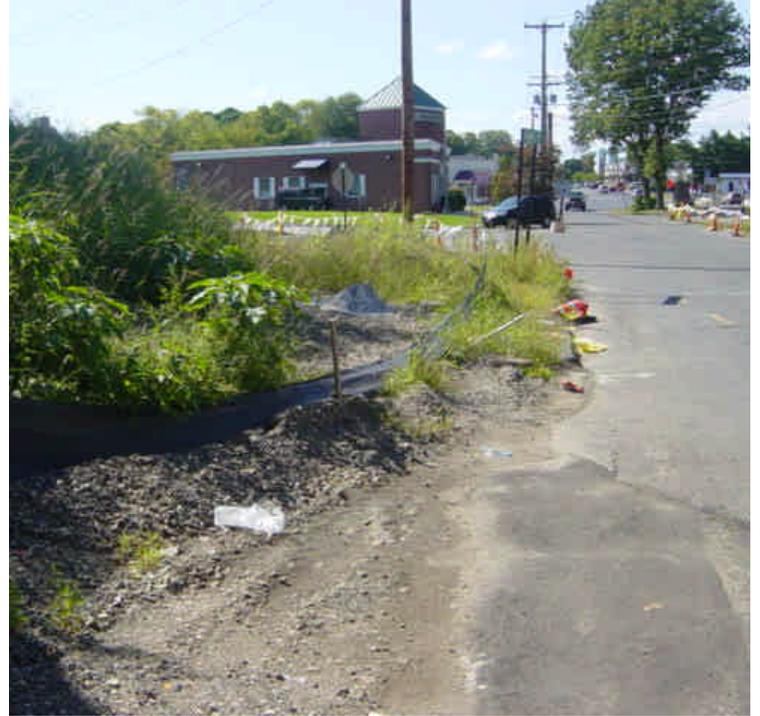
Hardened concrete washout material was observed near sta. #465, but may not be project related. The silt fence also needs repair. Stabilize exposed soil at the base of the slope.

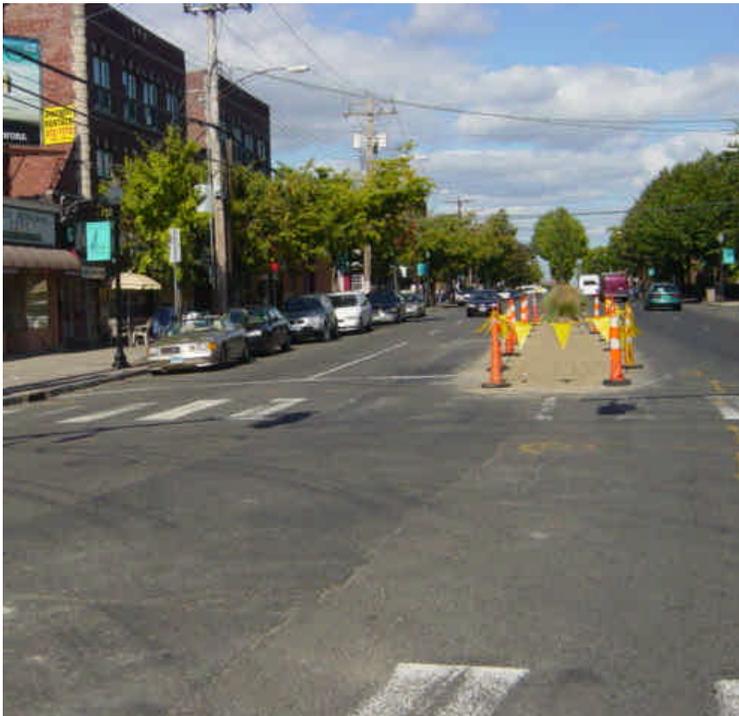
Median and sidewalk restoration was observed at numerous locations along Fairfield Ave.

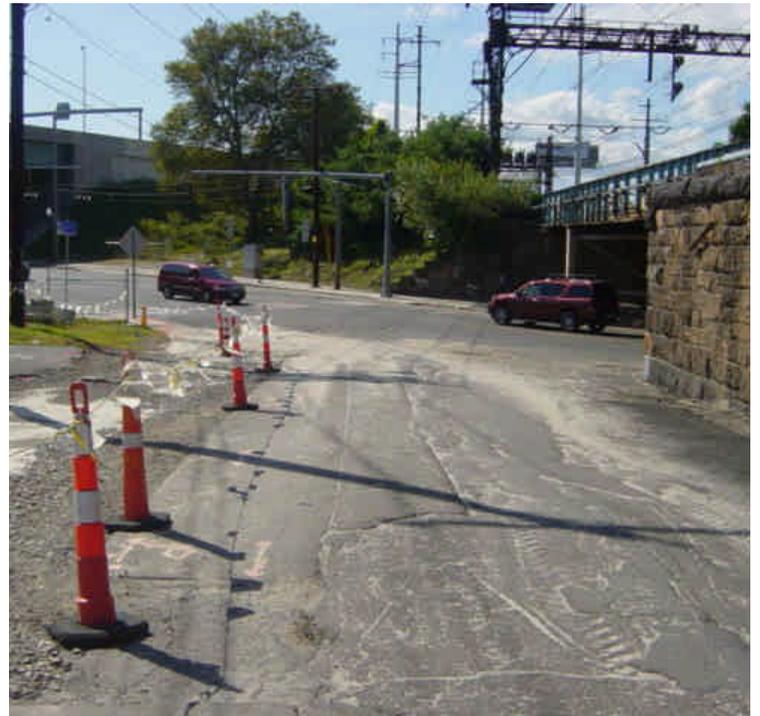
The area near sta. #719-720 remains backfilled with processed material. Some of the material and residual dusty tracking has been washing onto the roadway and into the catch basin. This may be partially related to utility pole relocation. Sweep, stabilize, and clean the catch basin.
