Docket No. 272 – Development and Management Plan Inspection

Segment 4a Underground Line

Date: November 7, 2008

Location: Singer Substation to Fairfield/Westport Town Line

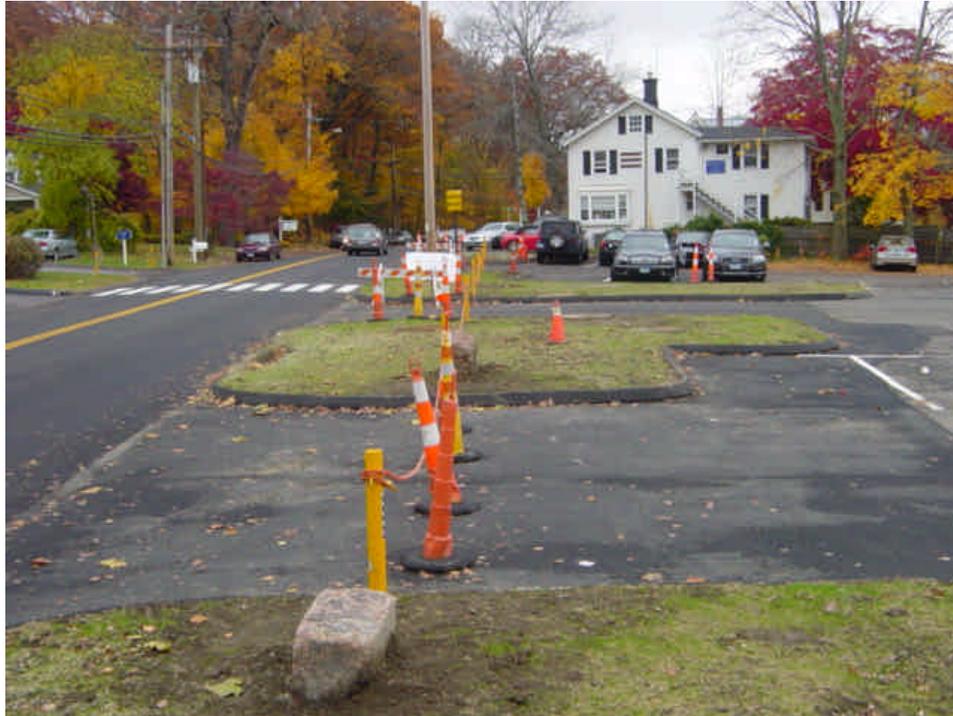
Restoration efforts remain complete near vault #28. The area was previously hydroseeded and is beginning to vegetate.

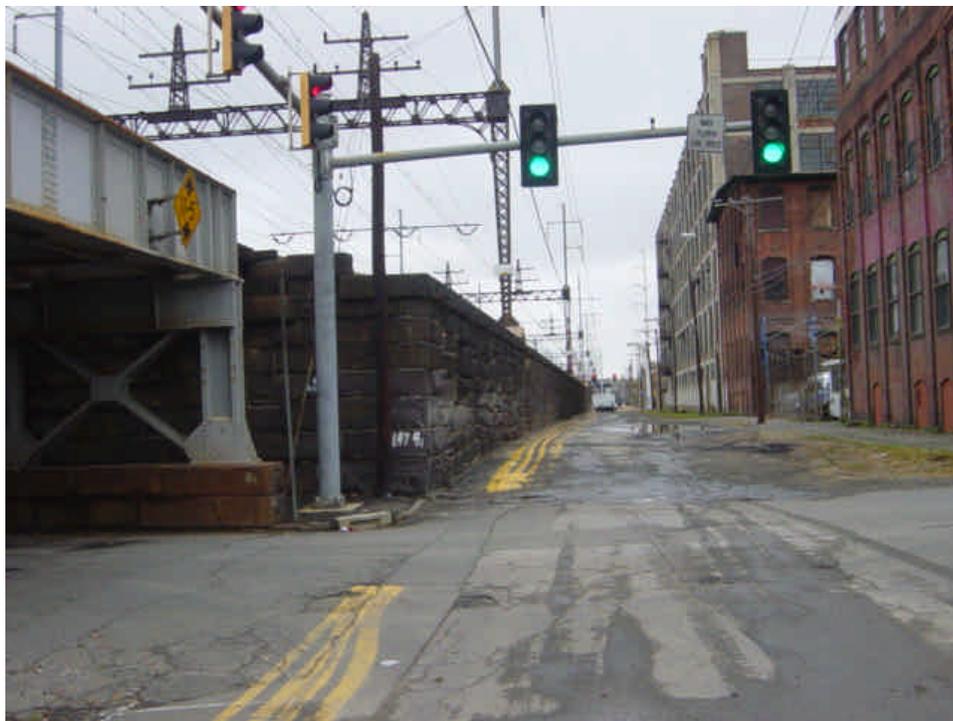
Ruts remain along the shoulder in several locations along Railroad Ave. Contractor had previously backfilled the area with processed material to stabilize the area, but the ruts persists. Contractor should provide information on the timeline and plans for final stabilization.
