Docket No. 272 – Development and Management Plan Inspection

Segment 4b Underground Line

Date: January 11, 2008

Location: Westport Avenue to the Norwalk Substation in the City of Norwalk

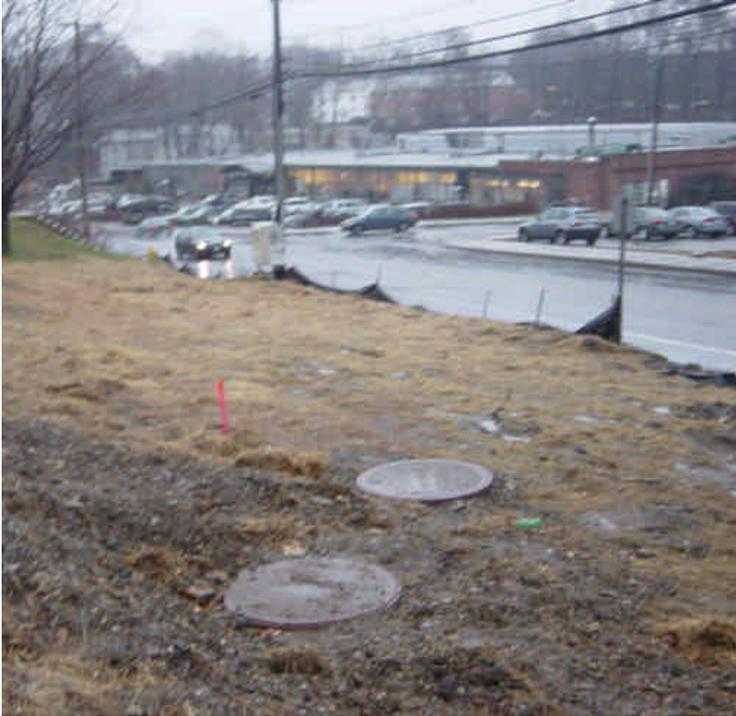
Solutions are being evaluated by the contractors for ruts and sediment issues near station #81. A curb should be considered on the downgradient side along Route 1, or silt fence should be regularly maintained. Continue to stabilize and sweep roadway.

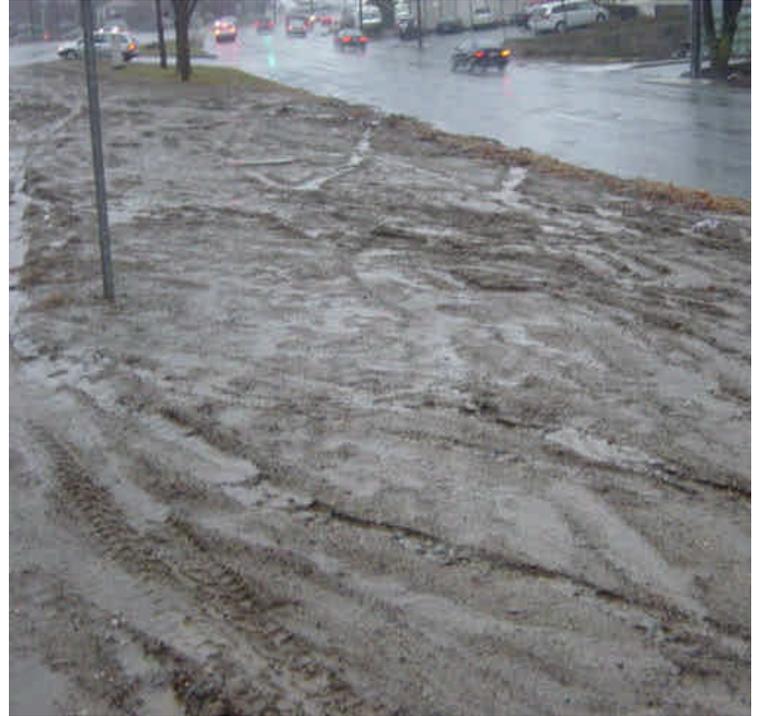
Heavy rutting continues within the median near sta. #316-318. Sediment accumulation was observed along the shoulder of the roadway. Remove sediment on a regular basis and temporarily stabilize inactive areas.

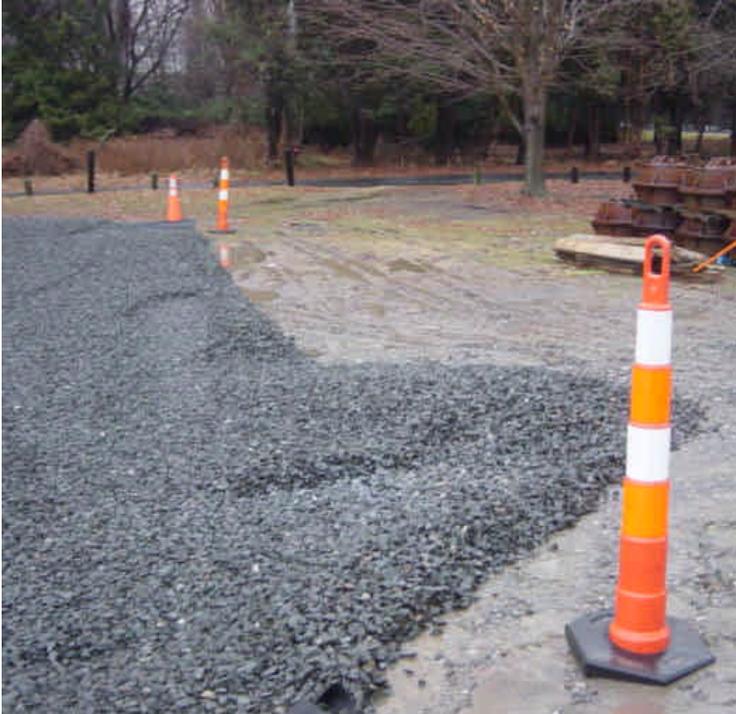
Crushed stone has been installed over a small portion of the exposed soil on one side of the entrance road to the Sherwood Island laydown yard.

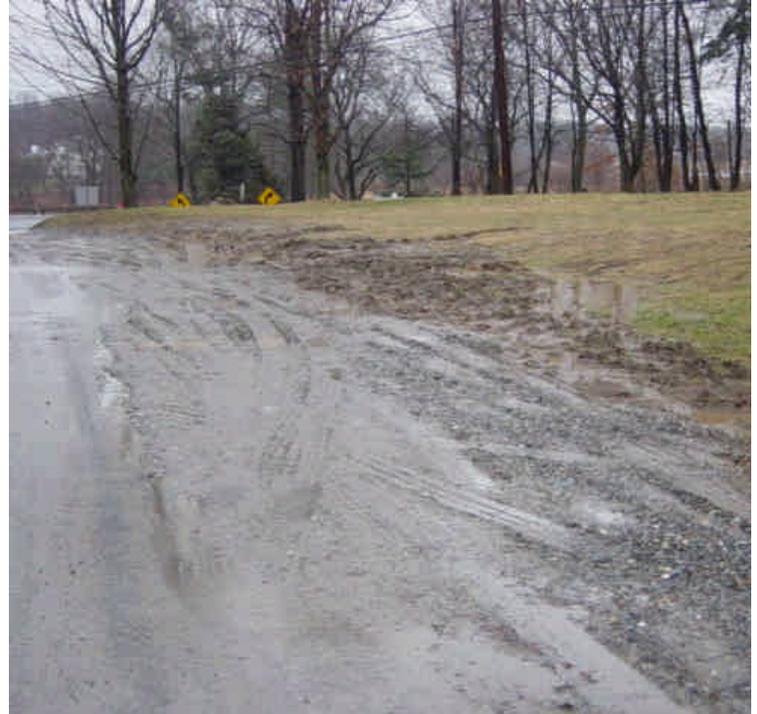
Despite the stone, there are still large areas of exposed soil adjacent to the entrance road of the Sherwood Island laydown yard. Minor sediment tracking was occurring with turbid runoff reaching an unprotected catch basin on the main entrance road to Sherwood Island State Park.
