Docket No. 272 – Development and Management Plan Inspection

Segment 4b Underground Line

Date: January 24, 2008

Location: Westport Avenue to the Norwalk Substation in the City of Norwalk

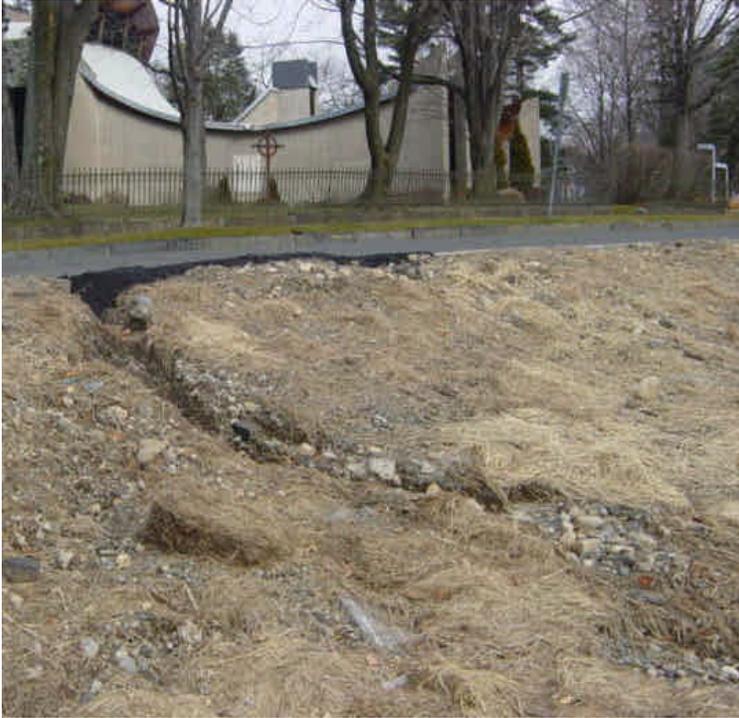
<p>Silt fence near sta. #81 (vault #5) has been re-installed but not properly toed-in. Some soil has eroded and migrated underneath the silt fence and has accumulated along the shoulder. Temporary curbing has been placed along Westport Ave. to minimize the potential for erosion but a gully has already formed. 1/24/08</p>	<p>Continue to stabilize exposed soils sufficiently for the winter. Properly toe-in the silt fence and sweep the roadway. 1/24/08</p>	<p>Temporary curbing was installed. Silt fence and area needs additional attention.</p>
<p>Backfilled soil near sta. #129-131 remains temporarily stabilized with mulch and a bituminous curb. The lot has been temporarily paved but the pavement has settled and created a minor depression. 12/31-1/24/08</p>	<p>Sweep area if necessary and continue to monitor for stabilization. Evaluate any safety issues and take necessary precautions. Repair temporary pavement in parking lot area. 12/31-1/24/08</p>	<p>Pavement issue needs evaluation.</p>

A temporary bituminous curb has been installed along Westport Ave. near sta. #81 to control runoff. A gully has already formed and eroded a portion of the slope. A minor amount of sediment washed into the roadway.

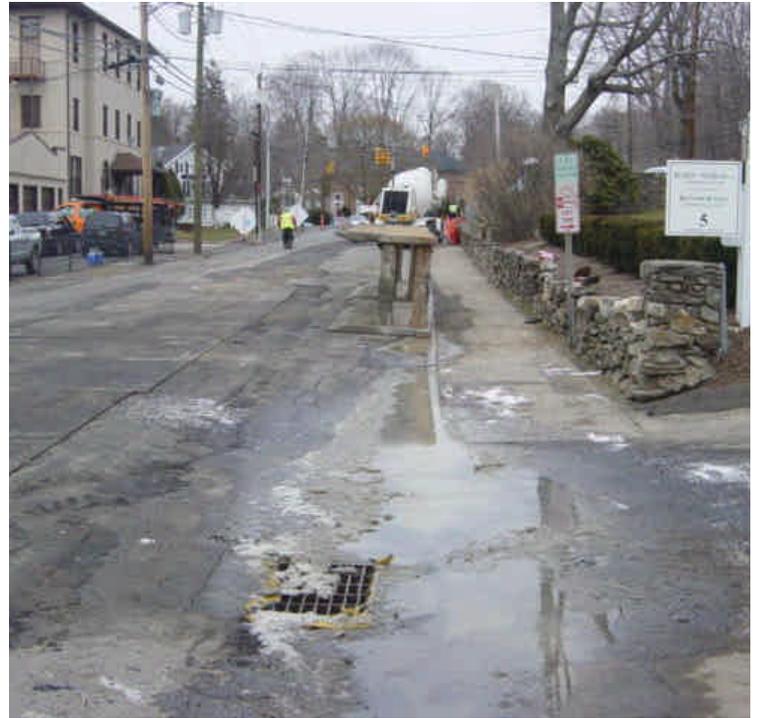
Trenching and backfill work continues along Imperial Ave. near sta. #260-264. A concrete trucking was observed washing off along the side of the roadway and the slurry was flowing towards the catch basin downgradient. Although this inlet has controls for sediment, there are no controls for the high pH washwater.

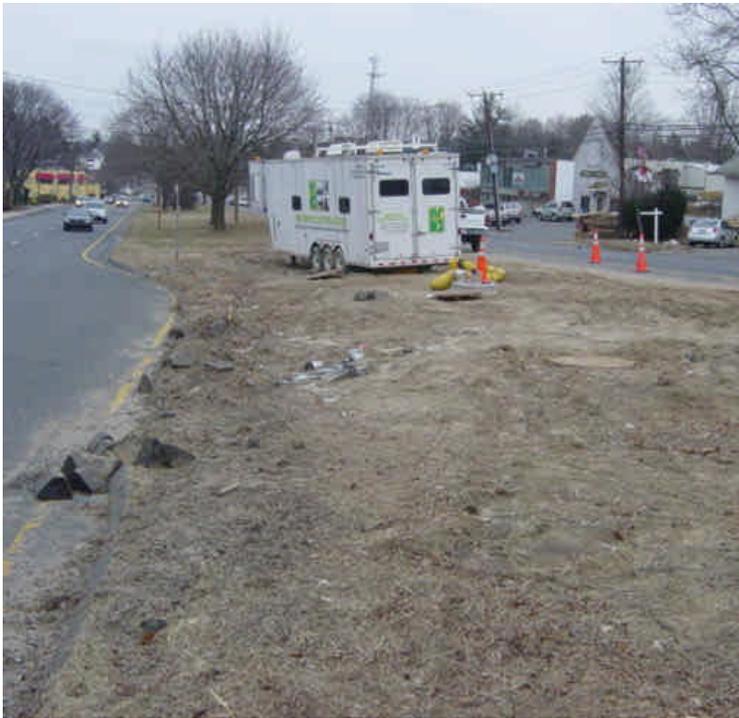
Areas of Inspection	Observation	Recommended Action	Corrected Action
<p>Kings Highway Lay-down Yard (Fairfield) (Currently being used for Segment 4a and 4b operations.)</p>	<p>1/24/08</p> <p>Sediment tracking and heavy rutting was observed in the island near sta. #316-318. Hay mulch was previously applied to stabilize the exposed soils, but ruts and tracking continue (since 11/21). Electrical contractors were set up here but temporarily stabilization in some areas would be advantageous. 1/11-1/24/08</p> <p>Bituminous curbing along the north side of the median is broken and missing in some areas. 1/24/08</p>	<p>Remove the sediment accumulated along the gutter and sweep the roadway as necessary. Even though access and active work are needed at the vault, the remainder of this area needs to be sufficiently stabilized for the winter months. 12/31-1/24/08</p> <p>Replace bituminous curbing when work is complete in this area. 1/24/08</p>	<p>Needs attention.</p>

Heavy rutting and tracking continue at sta. #316-318. Bituminous curbing along the north side of the median is broken and missing in some areas.

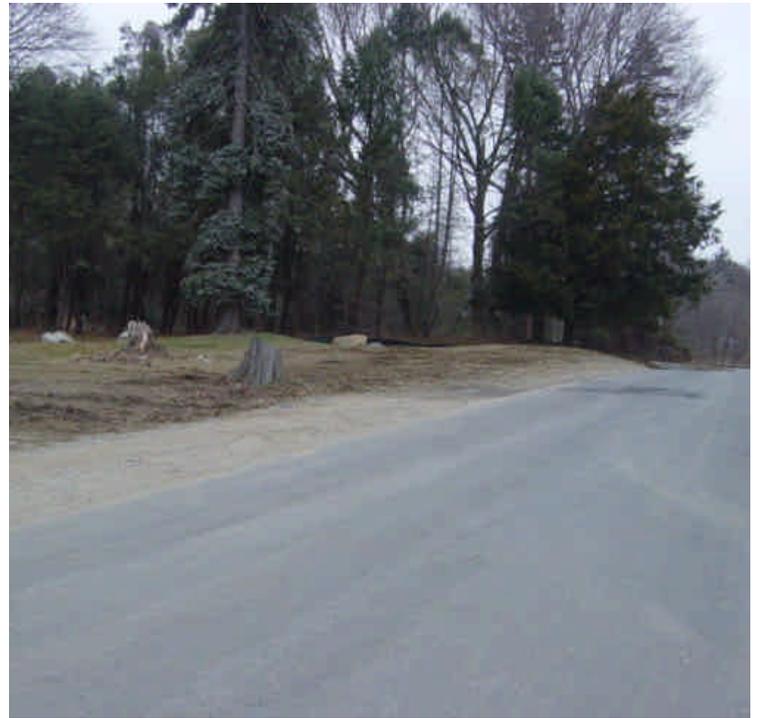
Vehicles and equipment continues to park in areas adjacent to the access road to the Sherwood Island yard. Stone has been placed in some areas, but others remain heavily rutted and muddy.
