Docket No. 272 – Development and Management Plan Inspection

Segment 4b Underground Line

Date: January 31, 2008

Location: Westport Avenue to the Norwalk Substation in the City of Norwalk

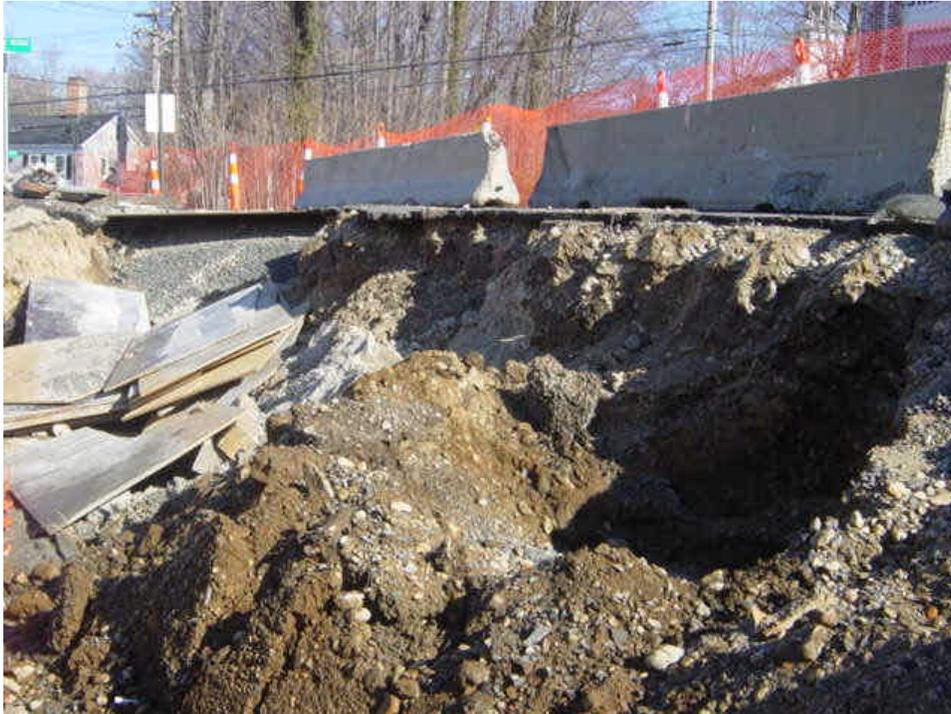
Areas of Inspection	Observation	Recommended Action	Corrected Action
		roadways. 1/31/08	
Spills and Material Storage	<p>Spill cleanup materials/kits were observed in the storage yard. 1/31/08</p> <p>Last week, a concrete truck was observed washing off on the side of the roadway near station #260-264. A designated concrete washout area has since been established along the shoulder of Imperial Ave. 1/31/08</p> <p>A light post and associated concrete footings were being stored at sta. #148. Materials appear to be project related. 10/4/07-1/31/08</p>	<p>Ensure that spill kits are also present with each vehicle during active construction. 1/31/08</p> <p>Continue to perform concrete truck washouts in designated and contained areas. 1/31/08</p> <p>Remove or attend to materials when feasible. 10/4/07-1/31/08</p>	<p>NA</p> <p>A designated concrete washout area has been established.</p> <p>Needs attention when feasible</p>

A temporary concrete washout area has been established along the shoulder of Imperial Avenue. The washout area was providing adequate containment.

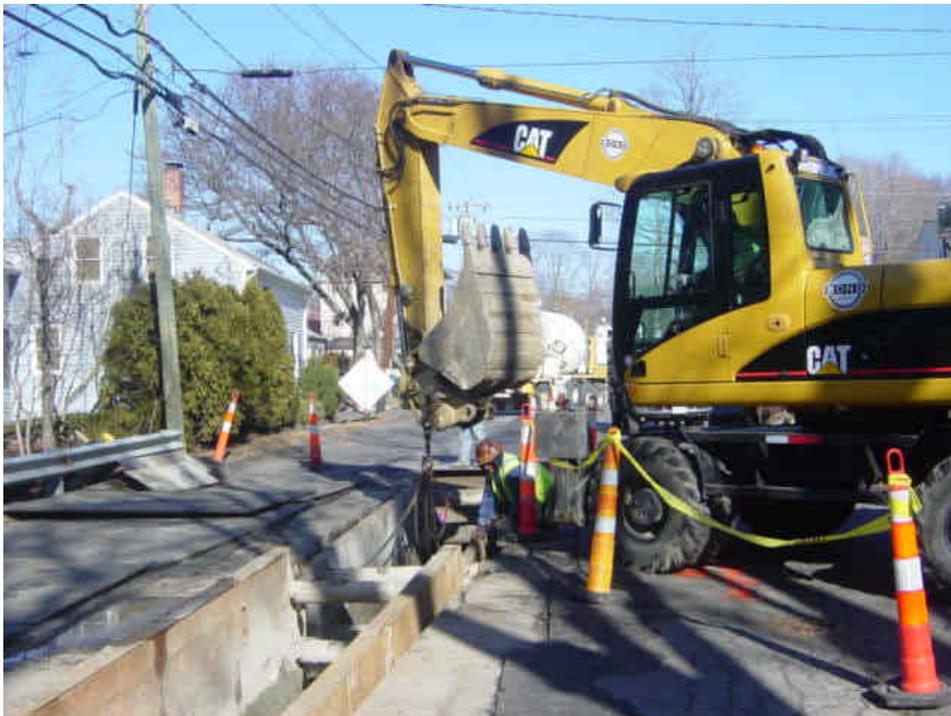
Trenching and backfill work continues along Imperial Ave. near sta. #260-264.
