Docket No. 272 – Development and Management Plan Inspection

Segment 4b Underground Line

Date: February 7, 2008

Location: Westport Avenue to the Norwalk Substation in the City of Norwalk

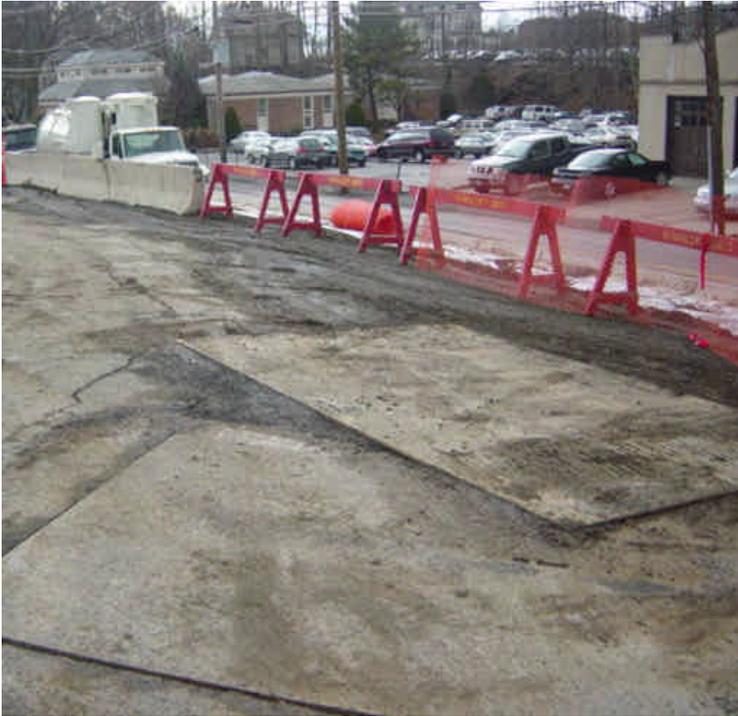
Retaining wall has been replaced at the corner of Imperial Ave. and Rte. 1 between sta. #264 to 265. Two steel plates remain in the Parking lot and a minor amount of sediment was observed being tracked from the parking lot area.

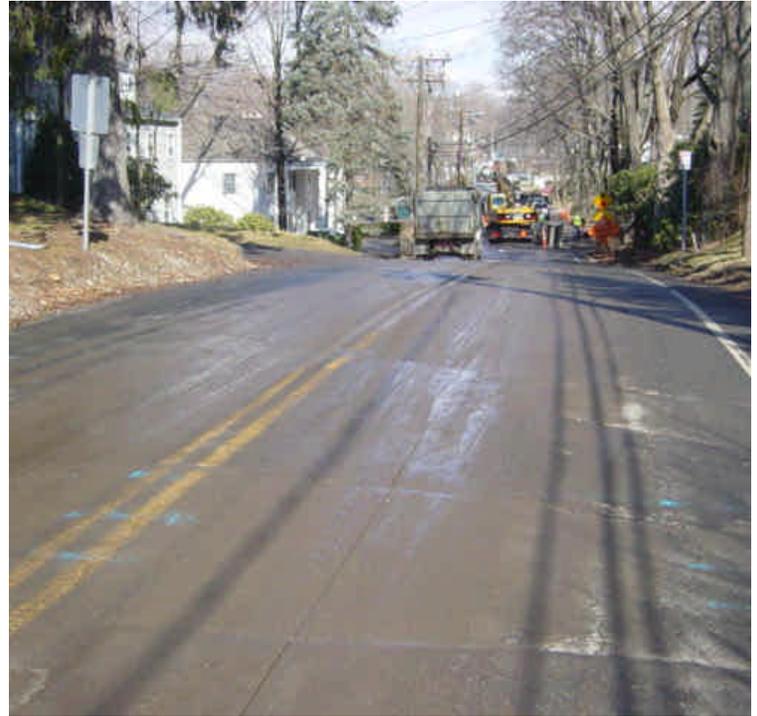
Trenching activities continue along Imperial Ave. near sta. # 257 to 258. The pavement was recently saw cut between sta. #254-257 and a minor amount of residual slurry was observed on the pavement. This portion of the roadway was temporarily closed and tracking was therefore not an issue. However, sweep the remaining slurry before it can run-off to catch basins.

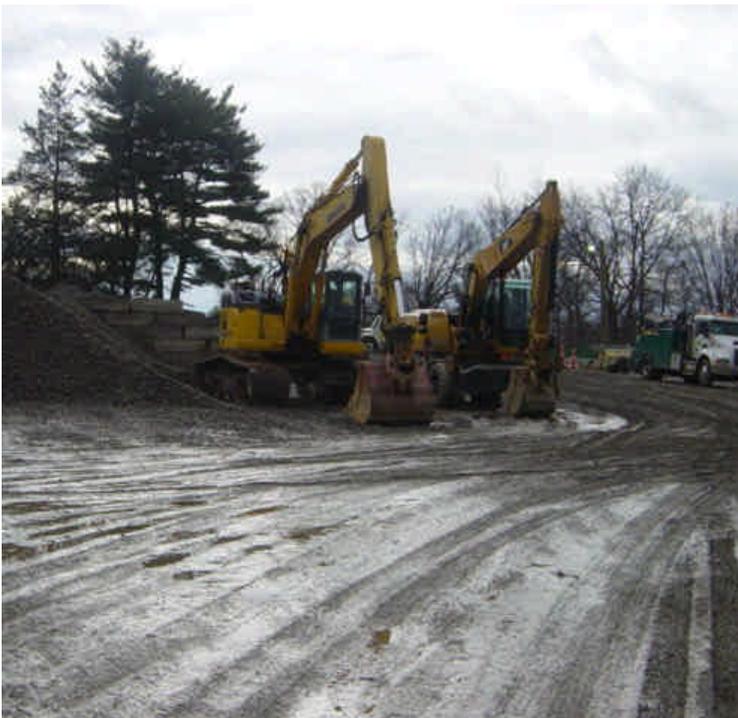
The Sherwood Island lay-down yard was very muddy due to the recent rain event. Heavy sediment tracking was observed along the access road to the yard and along Sherwood Island Connector. The areas along the shoulders of the access road remain heavily rutted and muddy.
