**Docket No. 272 – Development and Management Plan Inspection**

**Segment 4b Underground Line**

**Date:** February 14, 2008

**Location:** Westport Avenue to the Norwalk Substation in the City of Norwalk

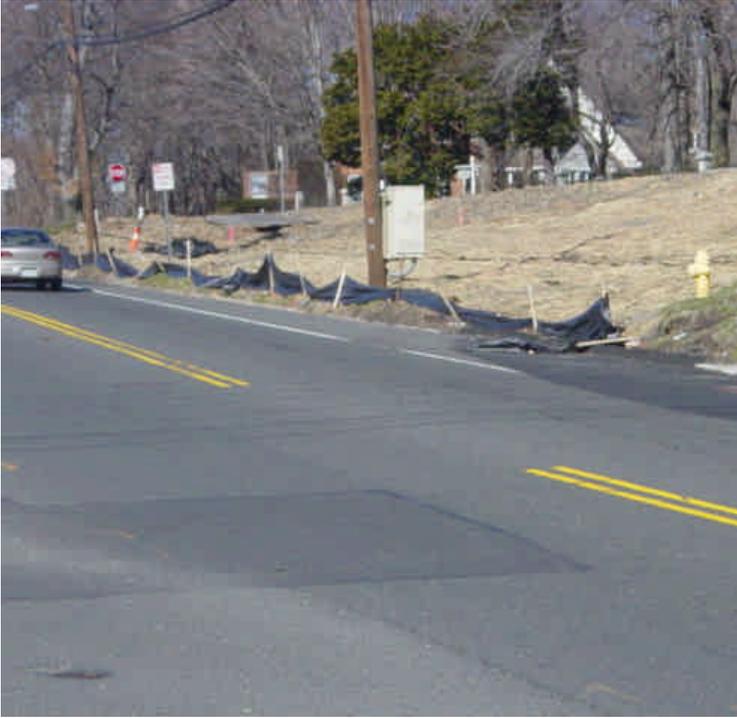
**Silt fence remains along the edge of the roadway near sta. #81. Portions of the silt fence are in need of repair.**

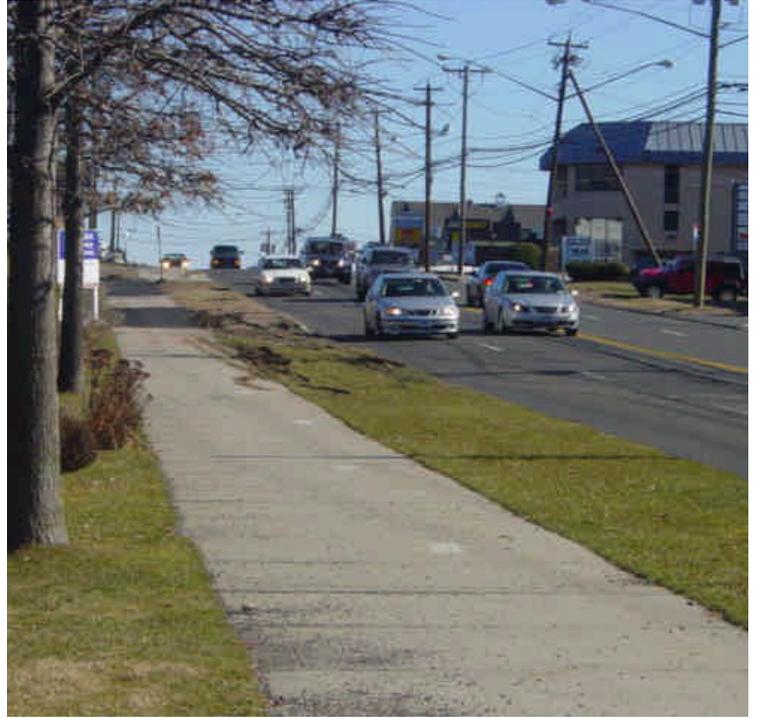
**Work has been completed near sta. #129 to 130 and the area has been temporarily stabilized with mulch. Ruts were observed along the parkway area, with a minor amount of sediment tracked into the roadway.**

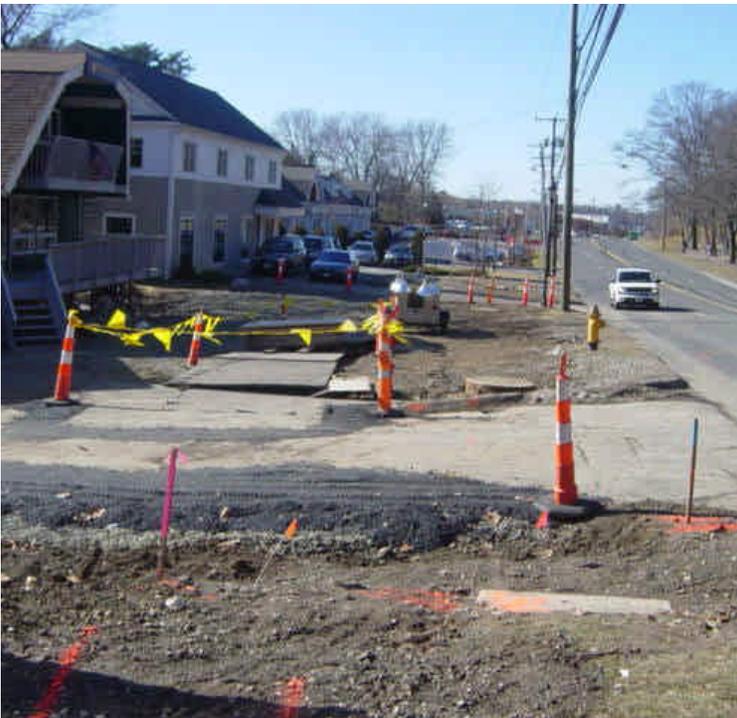
**Vault tie-in work continues near vault #11. Steel plates remain in place over portions of the trench.**

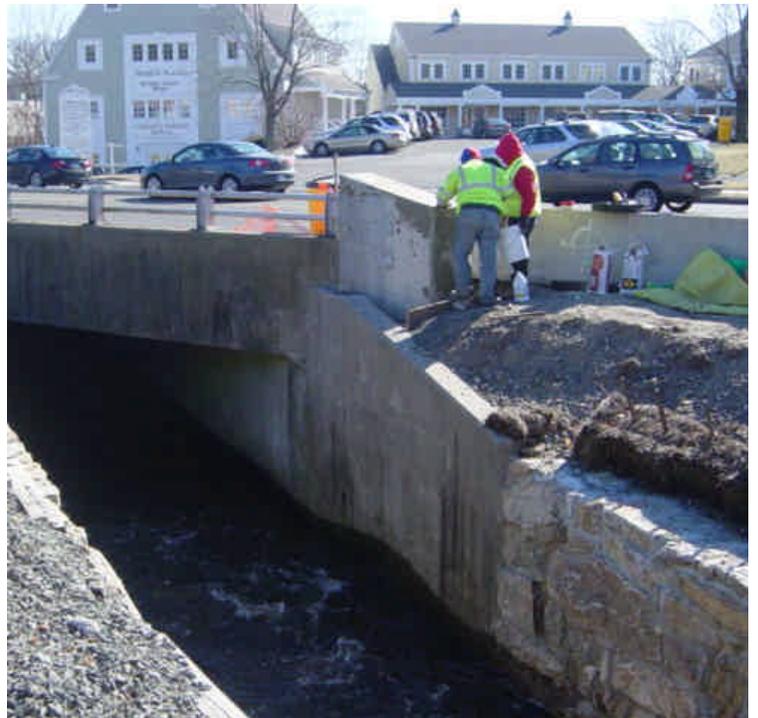
**Crews continue concrete work on the existing structure near Stony Brook, sta. #213. Adjacent process material/exposed soil areas have the potential to wash into the stream. Provide further stabilization or improve controls.**

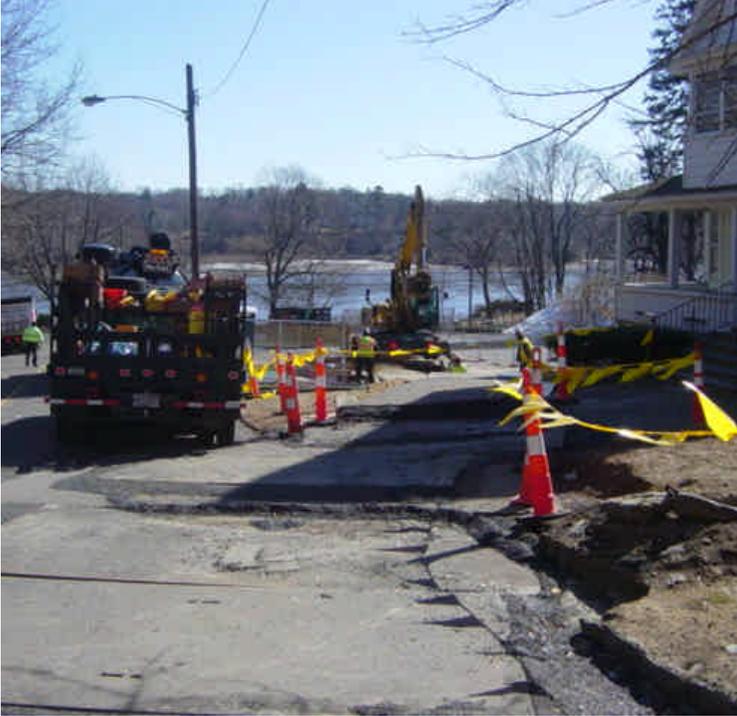
**Trenching continues along Lincoln St. near sta. #231 to 233. Steel plates were in place along the roadway.**

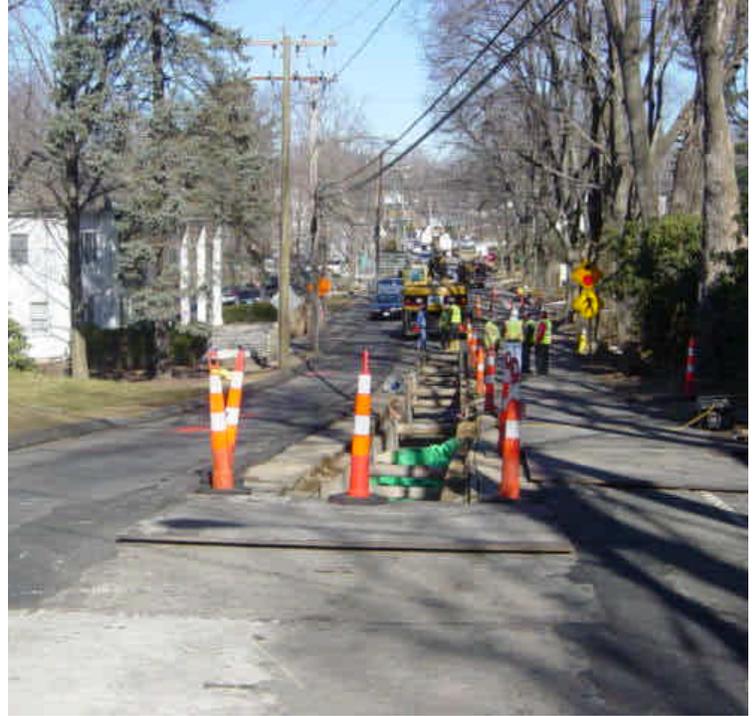
**Trenching and backfilling activities continue along Imperial Ave. between sta. #255 to 256.**

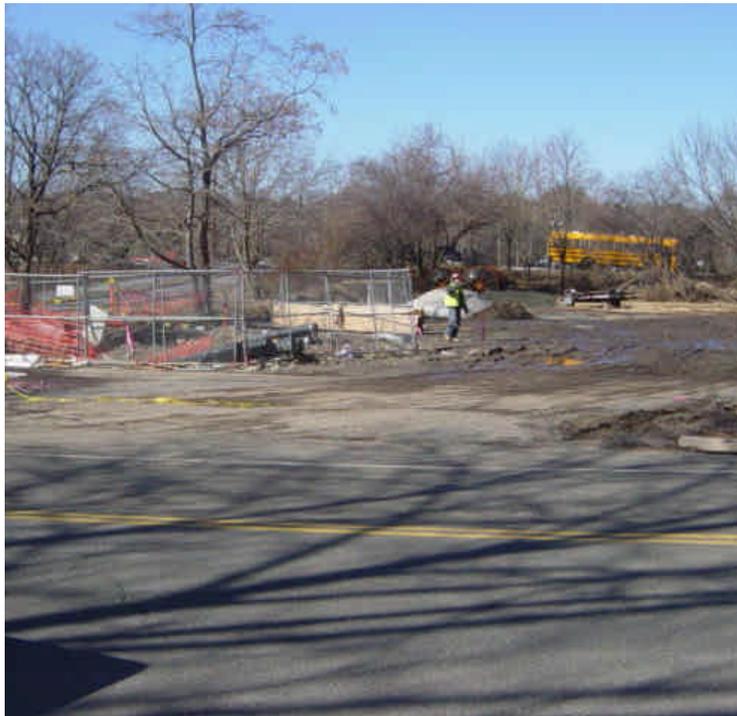
**Crews are staging equipment and materials in the lay-down yard on the east side of the Saugatuck River. The area was very muddy and tracking was becoming an issue. Frac tanks were being delivered at the time of the inspection. Providing clean stone at the entrance could help alleviate tracking.**

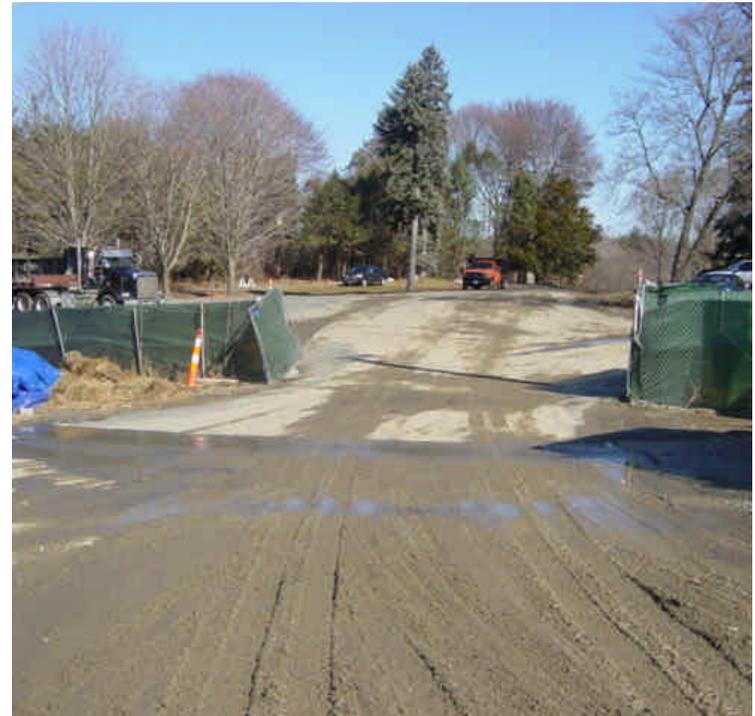
**The Sherwood Island lay-down yard was very muddy. Heavy tracking was observed along the access road to the yard and along Sherwood Island Connector.**
