Docket No. 272 – Development and Management Plan Inspection

Segment 4b Underground Line

Date: March 28, 2008

Location: Westport Avenue to the Norwalk Substation in the City of Norwalk

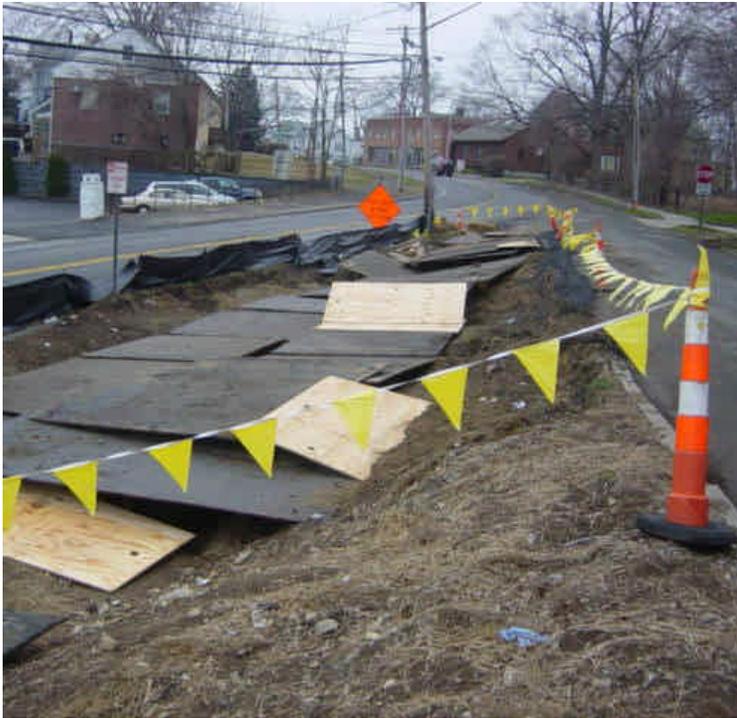
Steel plates remain in place over the trench work at sta. #80-81. The silt fence has been repaired.

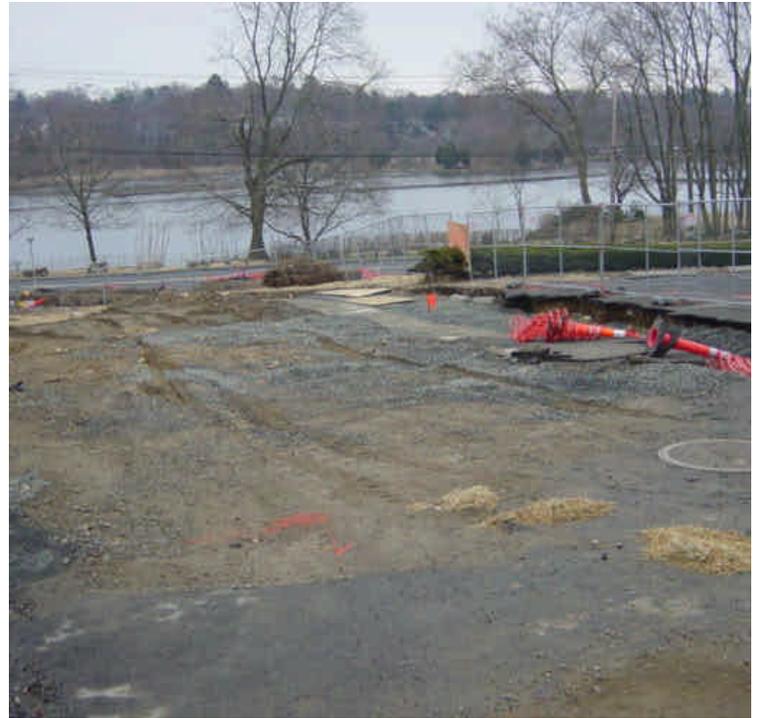
On the west side of the Saugatuck River near sta. #234, the drill pits have been backfilled and are ready to be paved.

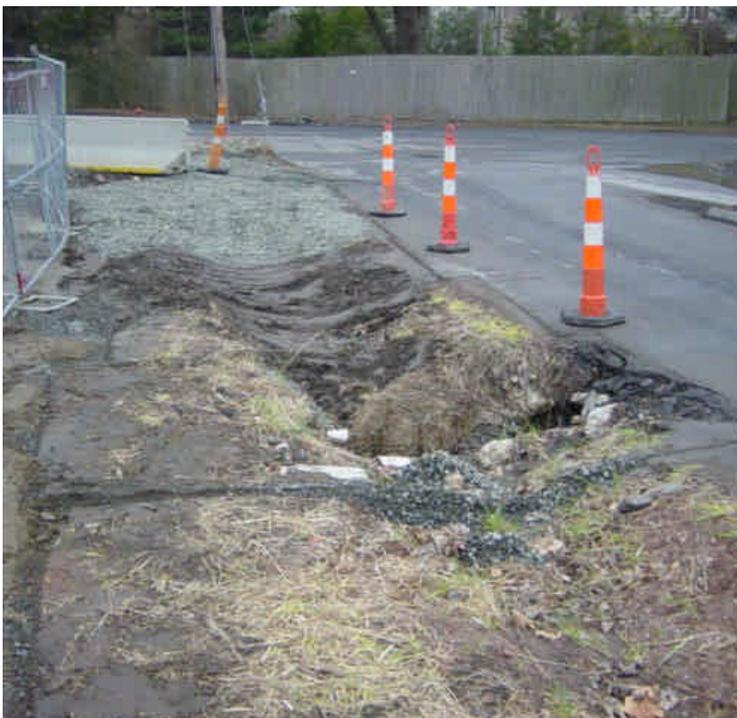
The drainage swale has been restored along the access drive near sta. #251. Crushed stone has been added to stabilize the swale. Revegetate the remaining areas of exposed soil as soon as feasible.

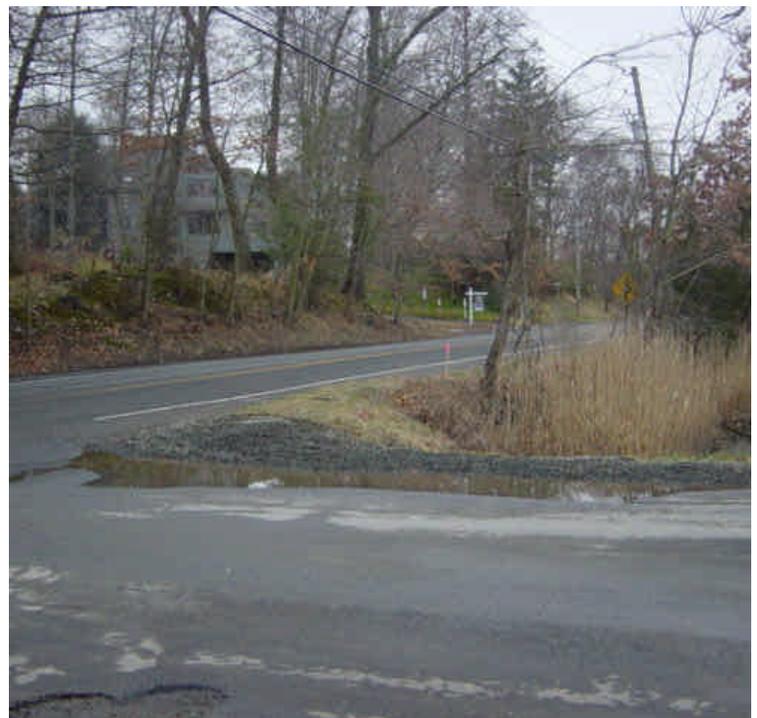
Crushed stone is also in place near the corner of the access drive which was previously rutted from heavy vehicle traffic. The stone should help to reduce the potential for sediment tracking.
