Docket No. 272 – Development and Management Plan Inspection

Segment 4b Underground Line

Date: April 17, 2008

Location: Westport Avenue to the Norwalk Substation in the City of Norwalk

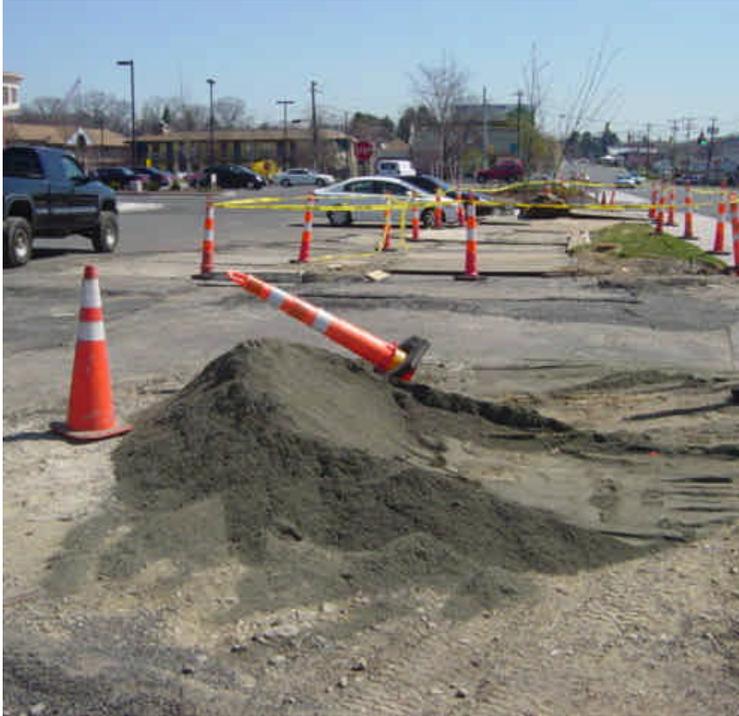
Trenching continues near sta. #147. Plywood is being used to temporarily cover the catch basin during construction activities. However, evaluate whether this is adequate for control. A small stockpile of stone dust was being temporarily stored on an adjacent parking island.

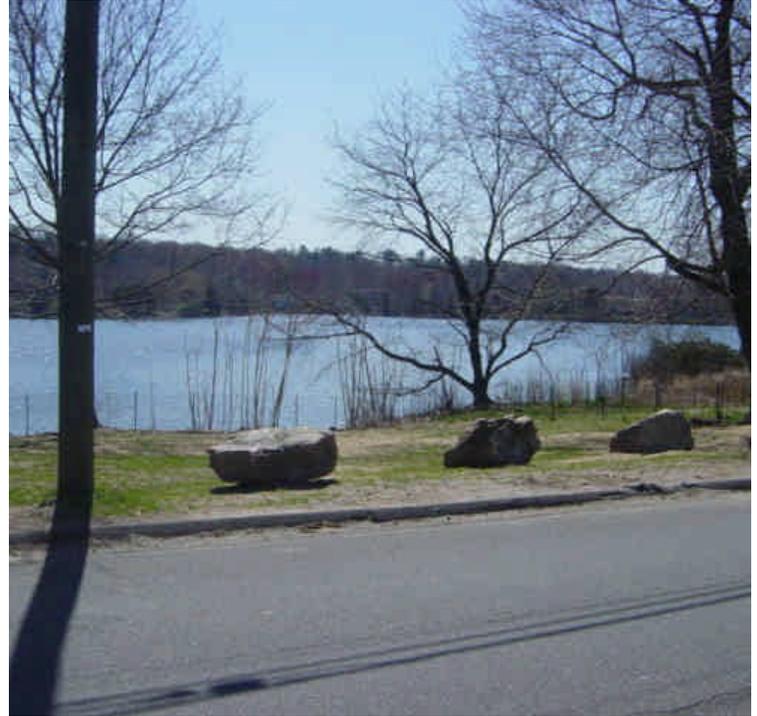
The park area near sta. #235 was previously seeded and grass cover is beginning to grow in the warmer weather.

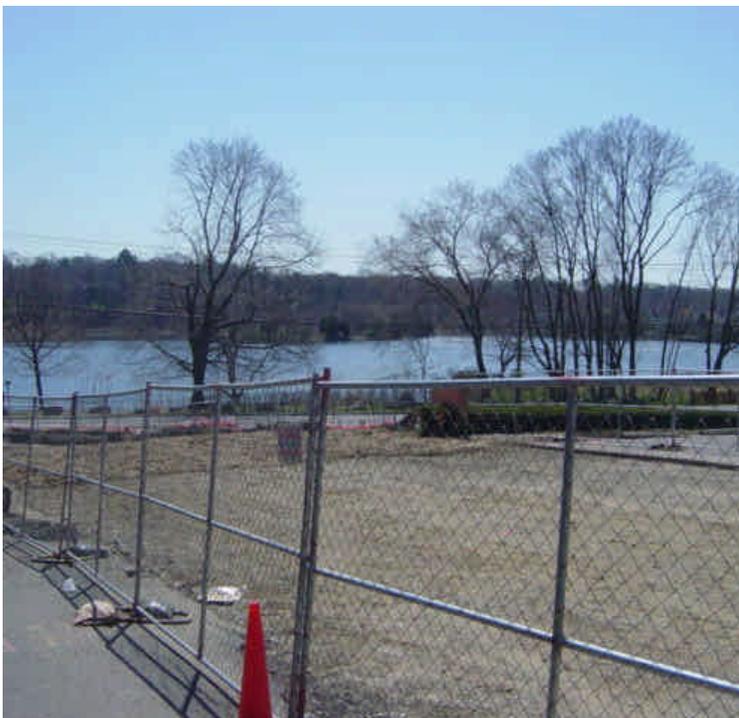
Tie-in work has been completed for several weeks near sta. #234. The area has been backfilled and this portion is ready to be paved.

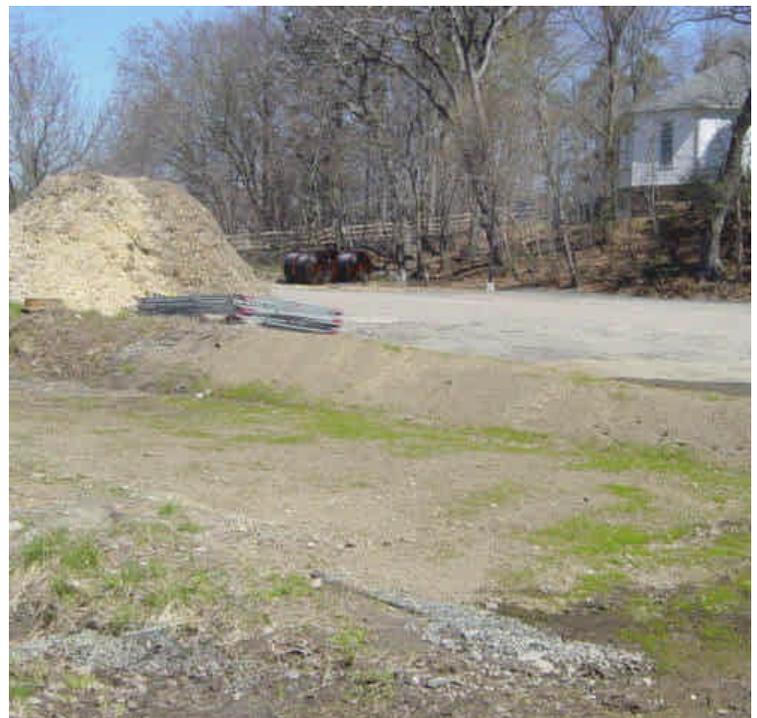
Tie-in work is complete near sta. #251. The area has been partially restored. Wood chips and chain link fencing remain stockpiled in the staging area. A dirt berm was recently re-graded and vegetation is beginning to grow. Add controls if stabilization does not occur quickly enough.
