**Docket No. 272 – Development and Management Plan Inspection**

**The Connecticut Light and Power Company Certificate of Environmental Compatibility and Public Need for the construction of a new 345-kV electric transmission line and associated facilities between Scovill Rock Switching Station in Middletown and Norwalk Substation in Norwalk, Connecticut, including reconstruction of portions of existing 115-kV and 345-kV electric transmission line, the construction of Beseck Switching Station in Wallingford, East Devon Substation in Milford, (and Singer Substation in Bridgeport), modifications at Scovill Rock Switching Station and Norwalk Substation, and the reconfiguration of certain interconnections.**

**Segment 4b Underground Line**

**Date:** May 1, 2008

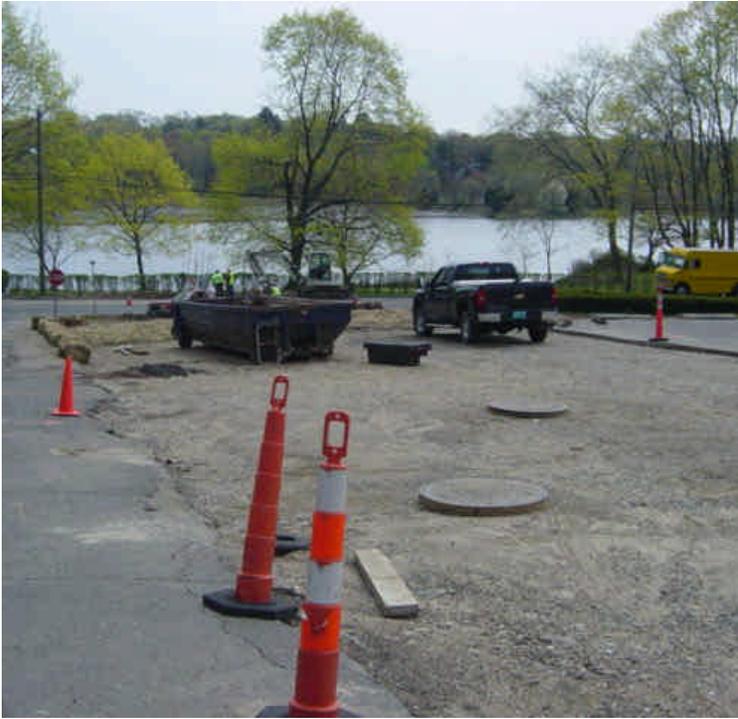
**The area near sta. #231-234 remains prepared for paving for several weeks. Seed and mulch were previously spread over the portion of exposed soil that is not slated for paving.**

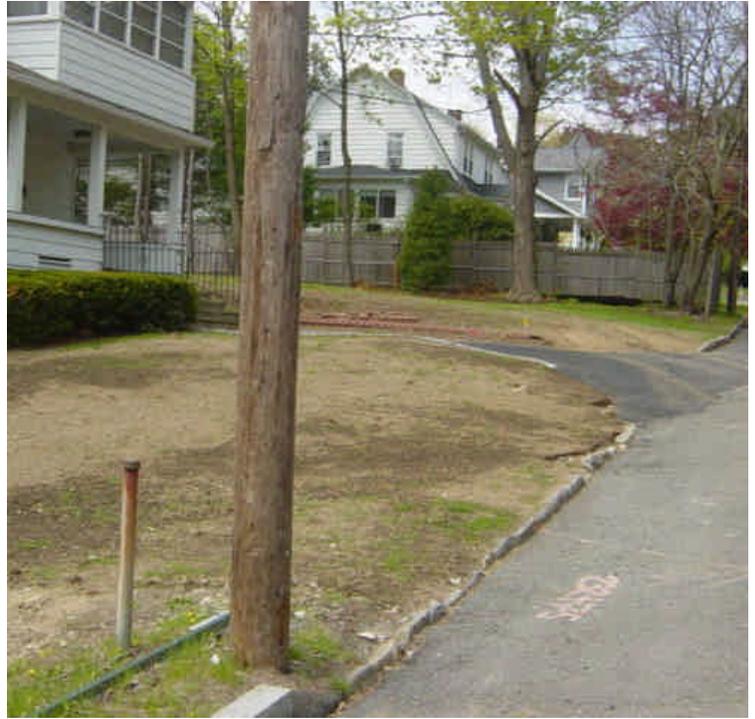
**Area of exposed soil near sta. #231 was previously seeded and is beginning to vegetate. Continue to monitor.**

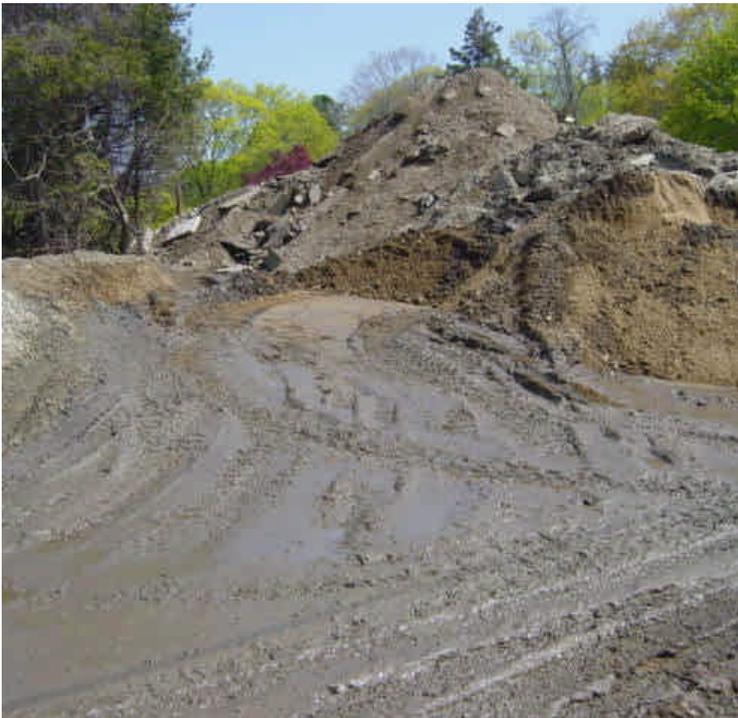
**Frac tank washout water has been mixed with the material stockpile in the Sherwood Island yard to bind the material for disposal.**

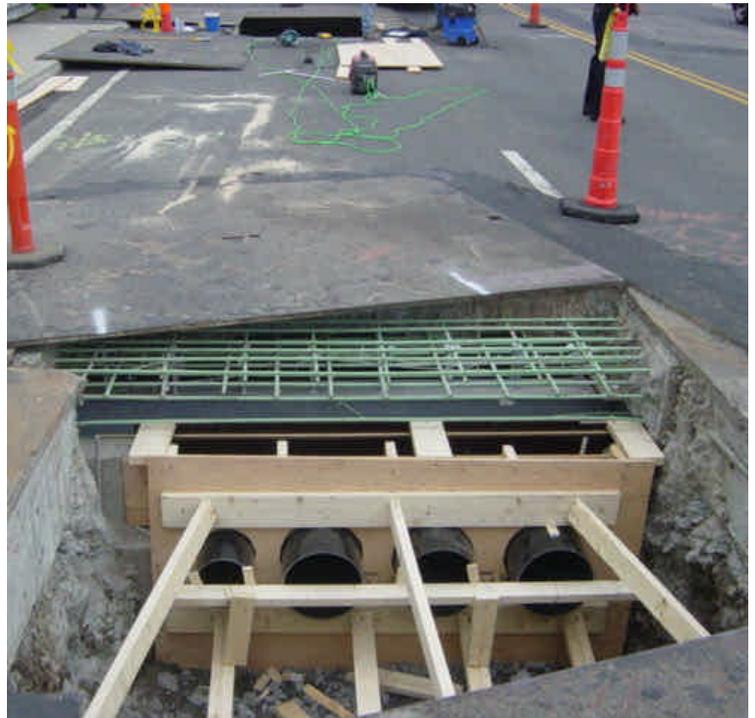
**Work continues on both sides of the bridge over Sasco Creek near sta. #435 in preparation for hanging the conduit from the bridge deck.**
