**Docket No. 272 – Development and Management Plan Inspection**

**Segment 4b Underground Line**

**Date:** May 22, 2008

**Location:** Westport Avenue to the Norwalk Substation in the City of Norwalk

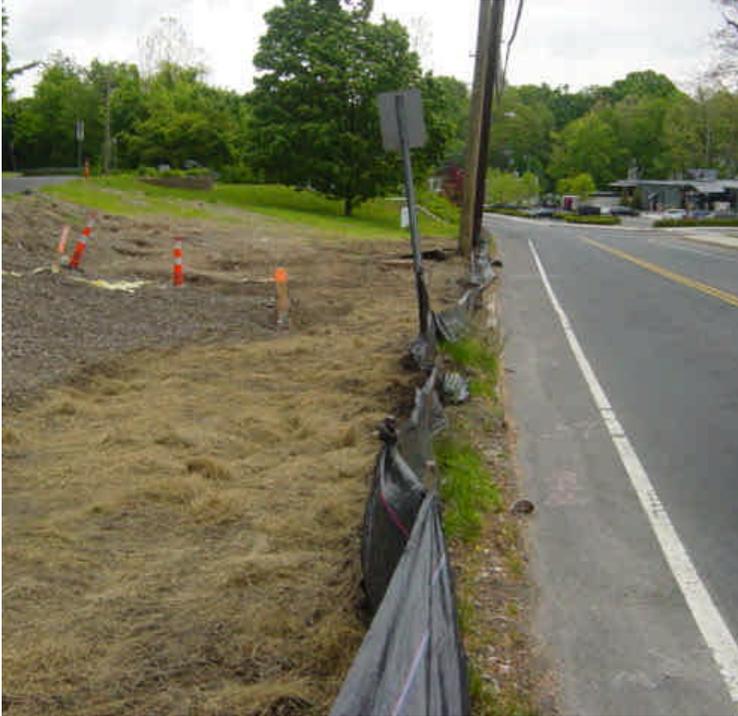
Concrete washouts have been removed from the area near sta. #81. Some sections of silt fence are sagging and still need repair.

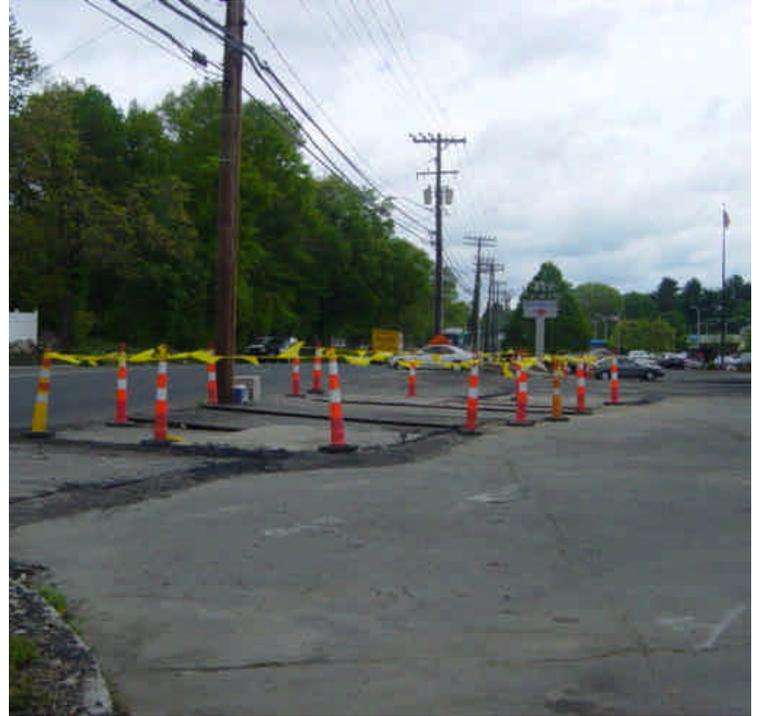
Steel plates remain in the parking lot area near sta. #163-166. Gravel cold-mix were accumulating in the parking lot area

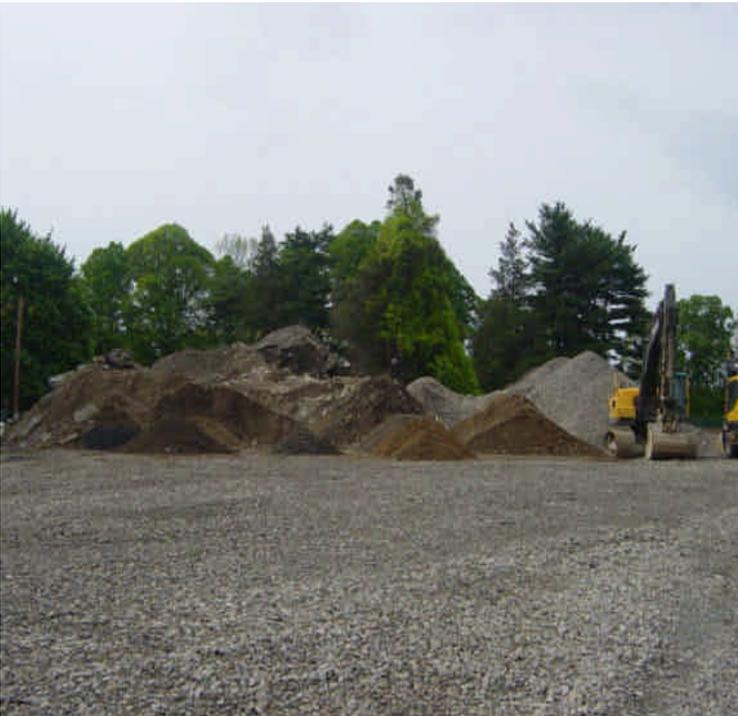
<p><b>Sherwood Island lay-down yard</b></p>	<p><b>Perimeter controls remain in place. Minor sediment tracking was observed along the access road. Crushed stone remains throughout the yard. Vehicles, equipment and materials are being stored along the access road. Washout water from cleaning the frac tanks</b></p>	<p><b>Continue to sweep the roadway and monitor and maintain controls as necessary. Continue spreading crushed stone where equipment is being stored to reduce tracking. Full restoration (including stone removal) will be needed when access needs are</b></p>	<p><b>Needs regular attention.</b></p>

Debris material stockpile at the Sherwood Island yard continues to increase in size but remains within the yard.
