**Docket No. 272 – Development and Management Plan Inspection**

**Segment 4b Underground Line**

**Date:** June 12, 2008

**Location:** Westport Avenue to the Norwalk Substation in the City of Norwalk

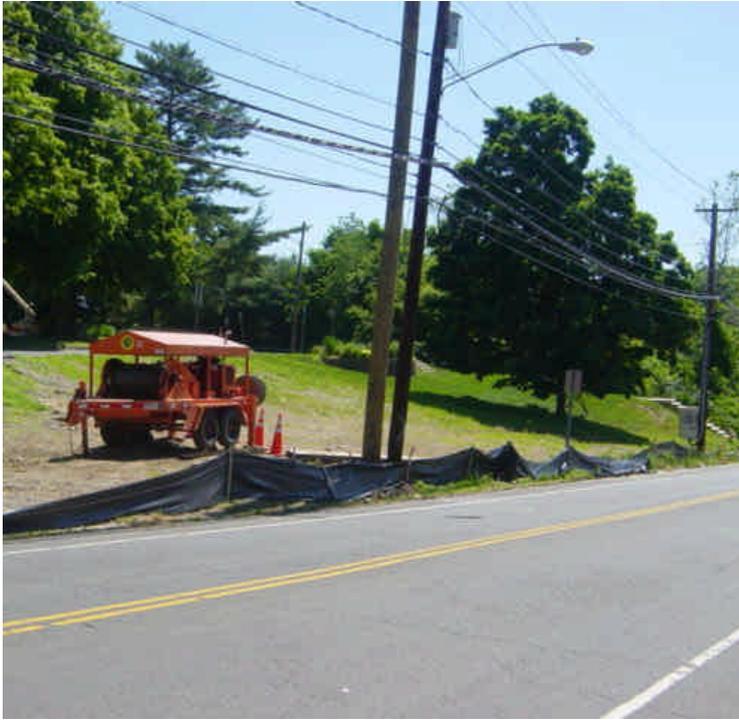
**Temporary curbing remains along Westport Ave. near sta. #81 (vault #5) to minimize the potential for erosion. Area has been backfilled with processed material.**

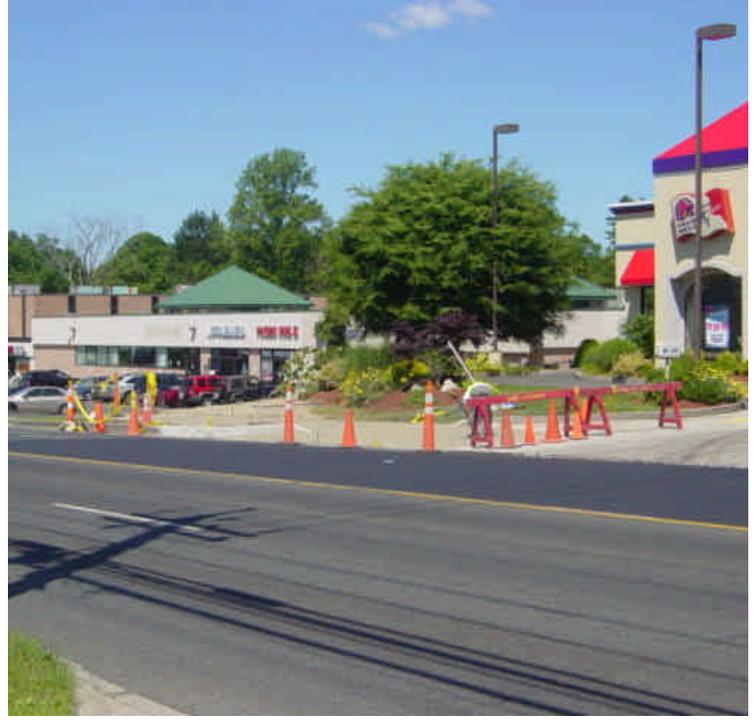
**Curb and sidewalk restoration continues near sta. #130-132.**

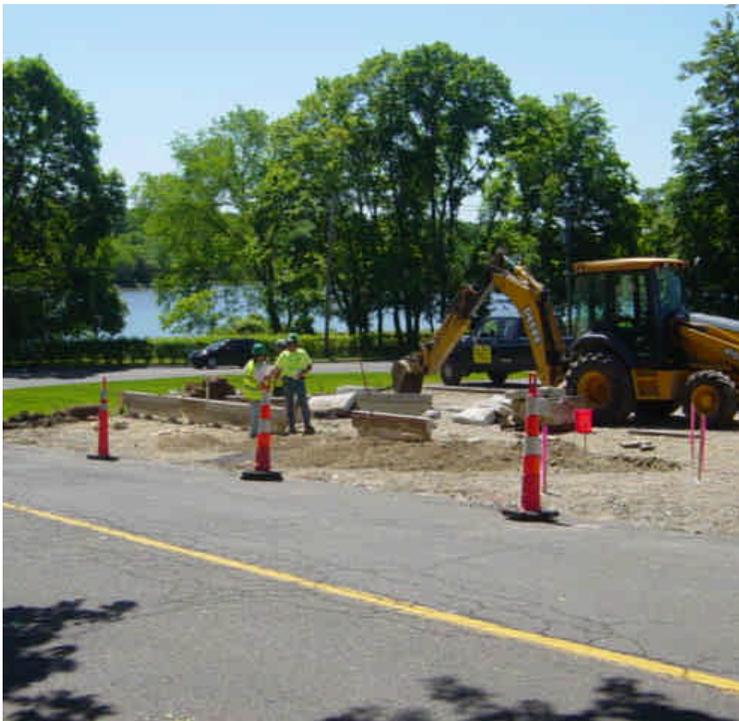
<b>Crews were setting stone curbing at sta. #234,</b>	<b>None. 6/12/08</b>	<b>NA</b>

**Crews were setting stone curbing near sta. #234 and the electrical contractor was on-site pulling wire. Adjacent residential structure was being re-sided by other contractors.**
