Docket No. 272 – Development and Management Plan Inspection

Segment 4b Underground Line

Date: July 25, 2008

Location: Westport Avenue to the Norwalk Substation in the City of Norwalk

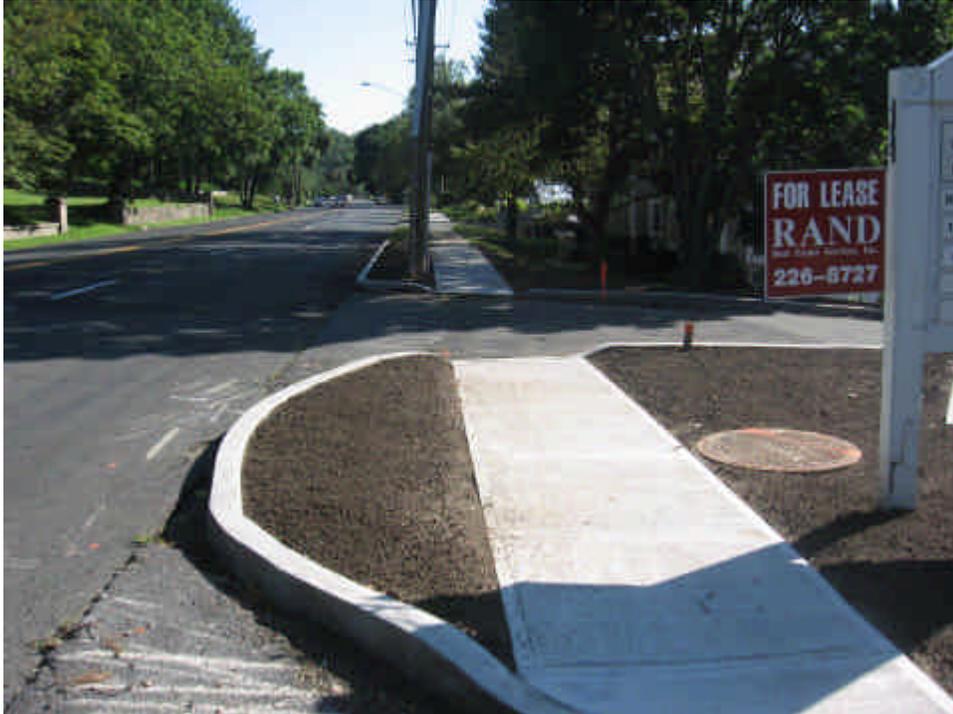
| Areas of Inspection | Observation | Recommended Action | Corrected Action |
|---|--|---|---|
| Vault Openings and Trench Construction Westport/Norwalk | New River Electrical was on site and working at vaults #14 & #15. Restoration work had occurred at vault #12. New sidewalk and curbing were installed. | None. 7/25/08 | NA |

The area near vault #12 has been partially restored. New sidewalk and curbing has been placed and topsoil has been spread in the median area. Establish vegetation as soon as feasible.

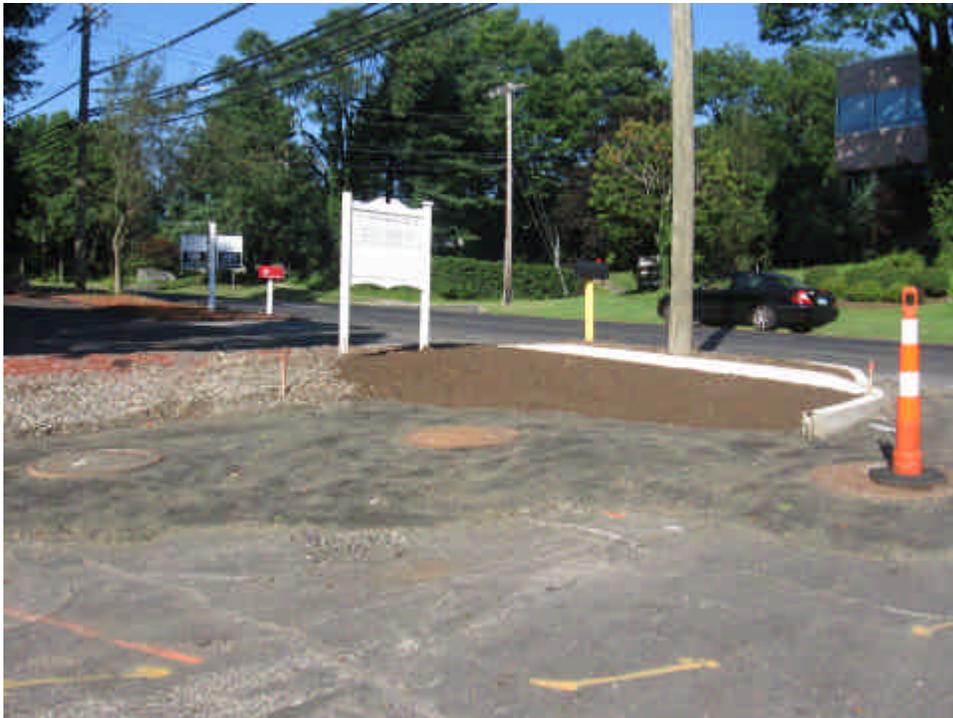
| Areas of Inspection | Observation | Recommended Action | Corrected Action |
|---|--|--|---|
| <p>Vegetative clearing (including trees to save or danger trees noted) or stabilization</p> | <p>Trees were previously removed near vault #12 to accommodate work. The area is being restored at this time. Topsoil was spread over the area but remains exposed. 7/25/08</p> <p>Some areas near vault #20 are approximately 75% vegetated, while others have failed to vegetate due to vehicles parking in these areas from adjacent businesses. 7/25/08</p> | <p>Restore as required by the D & M plan when feasible. Establish vegetative cover and plantings as soon as feasible. 7/25/08</p> <p>Areas can be considered stable once it has reached 75% cover. See Soils section. Work on solutions with the landowner. 7/25/08</p> | <p>Area was being restored.</p> <p>Needs attention when feasible.</p> |

Restoration efforts continue near vault #12. Stabilize exposed soils as soon as feasible or it will likely run-off to the parking lot.
