Docket No. 272 – Development and Management Plan Inspection

Segment 4b Underground Line

Date: October 10, 2008

Location: Fairfield/Westport Town Line to Westport Avenue in Norwalk

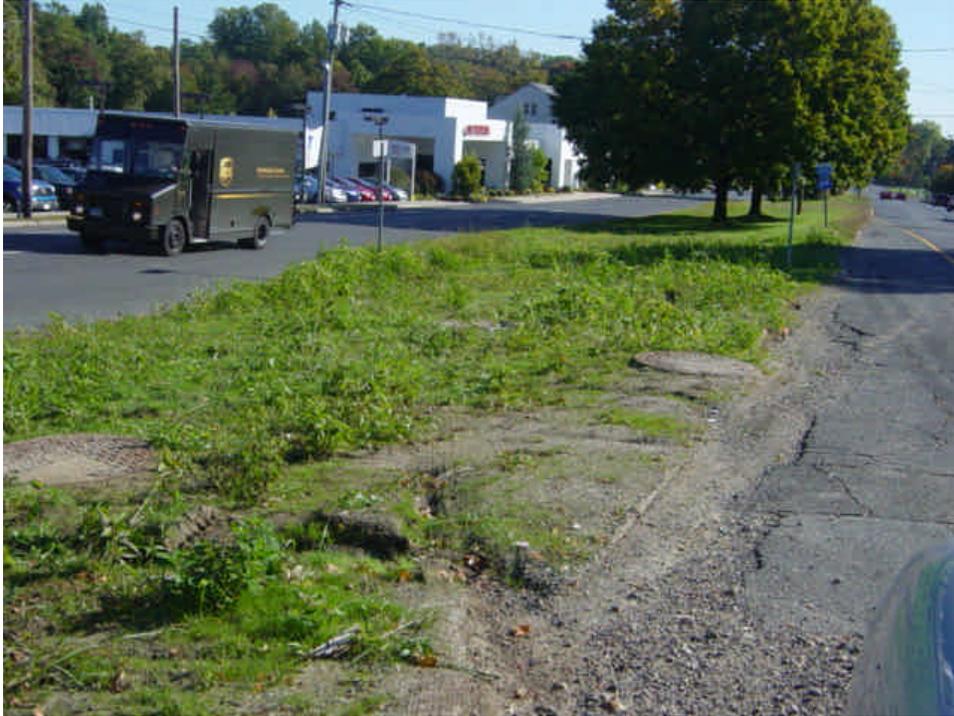
The area near sta. #316-318 has vegetated with weedy growth. Bituminous curbing still needs to be restored and the area near the curb should be swept.

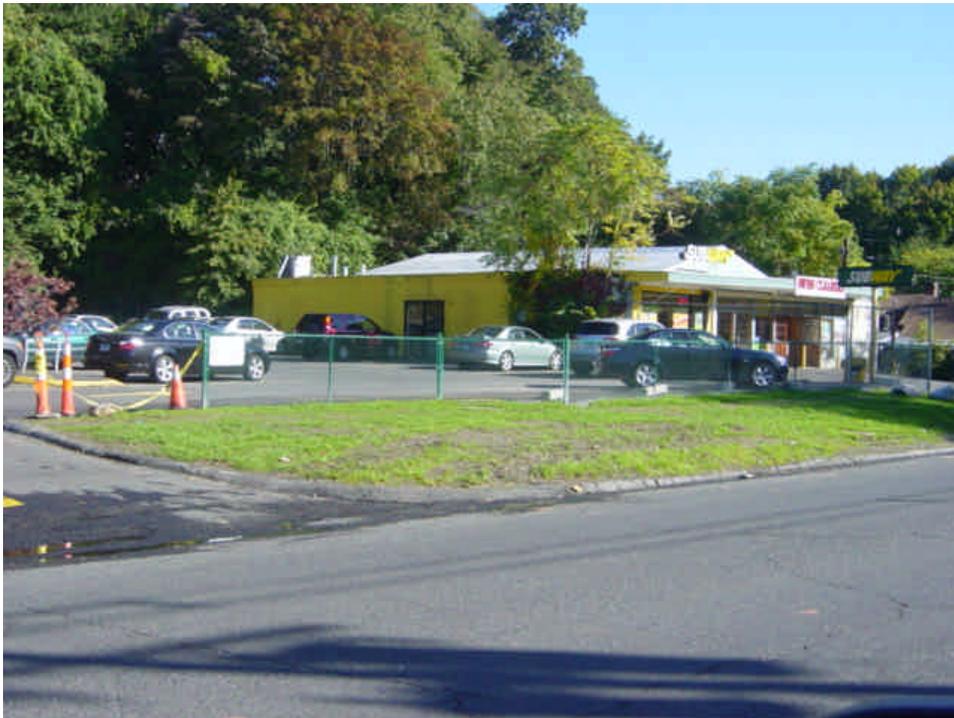
The area near sta. #334 has been restored. Multiple attempts have been made to prevent vehicles from parking in the restored area.
