Docket No. 272 – Development and Management Plan Inspection

Segment 4b Underground Line

Date: October 30, 2008

Location: Westport Avenue to the Norwalk Substation in the City of Norwalk

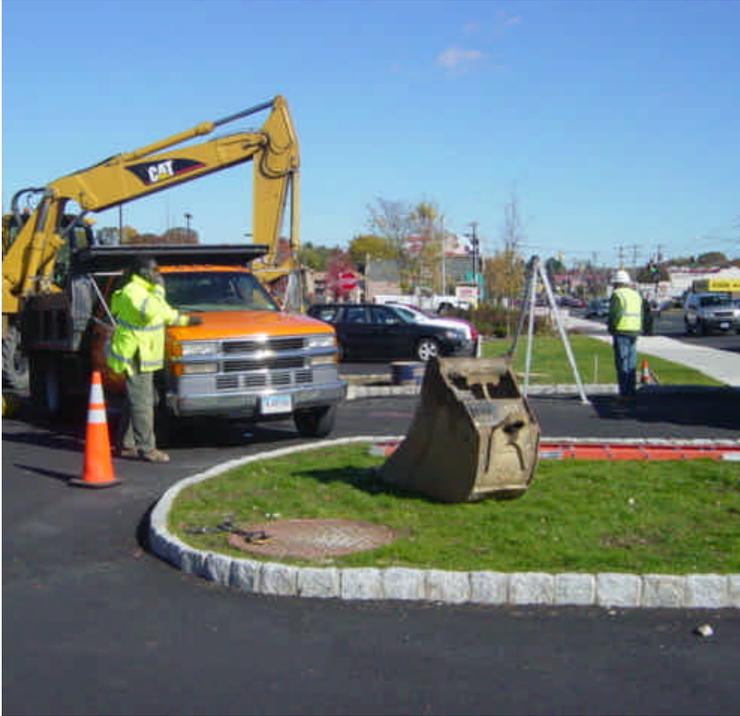
Final restoration work was observed near sta. #146 as a foundation for a sign was being adjusted.

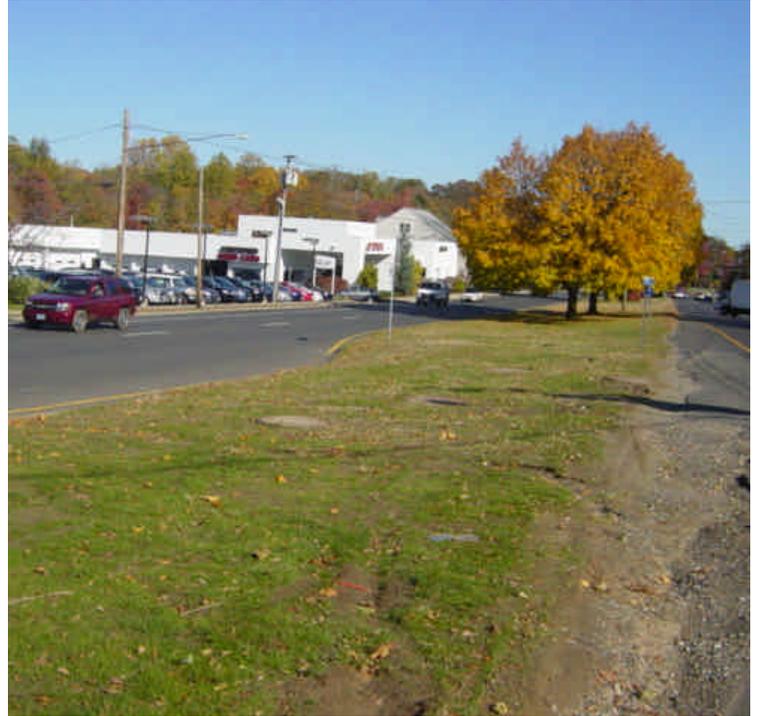
The area near sta. #316-318 has vegetated with weedy growth. Ruts and eroded gullies were observed in a few locations. Bituminous curbing and edge of pavement still needs to be restored.

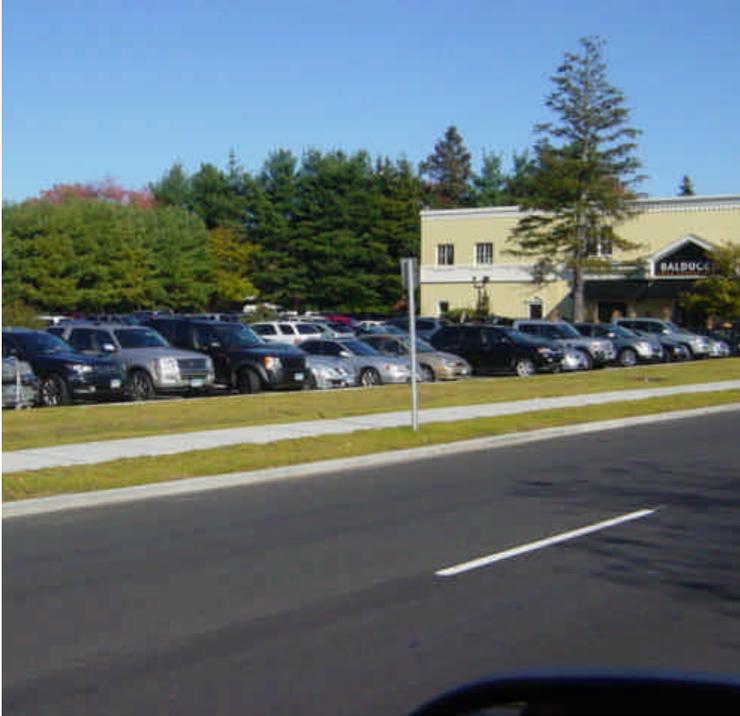
The area near sta. #381 was seeded and the area has vegetated.

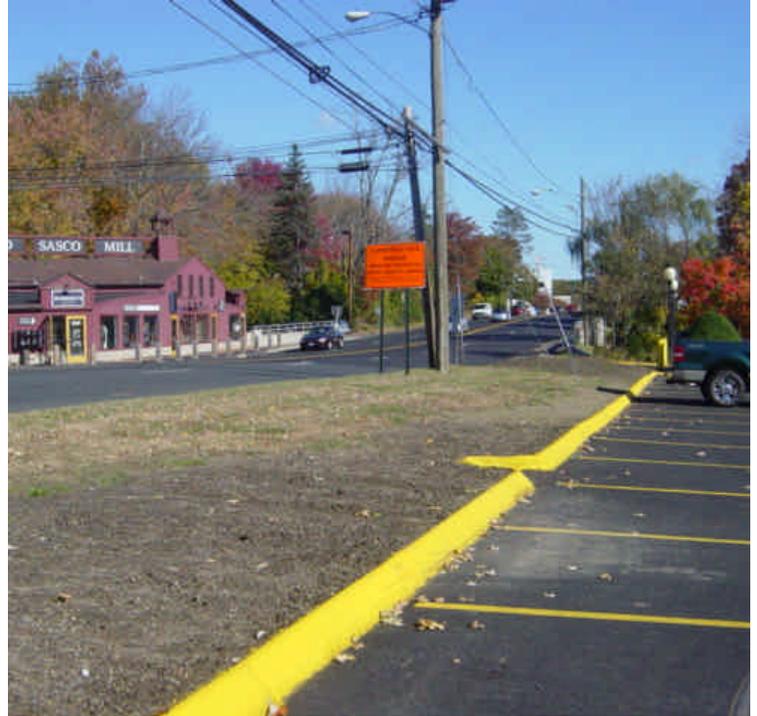
Topsoil has been spread over the area near sta. #433. The exposed soil needs to be seeded and temporarily stabilized.
