Docket No. 272 – Development and Management Plan Inspection

Segment 4c Underground Line

Date: January 18, 2008

Location: Westport Avenue to the Norwalk Substation in the City of Norwalk

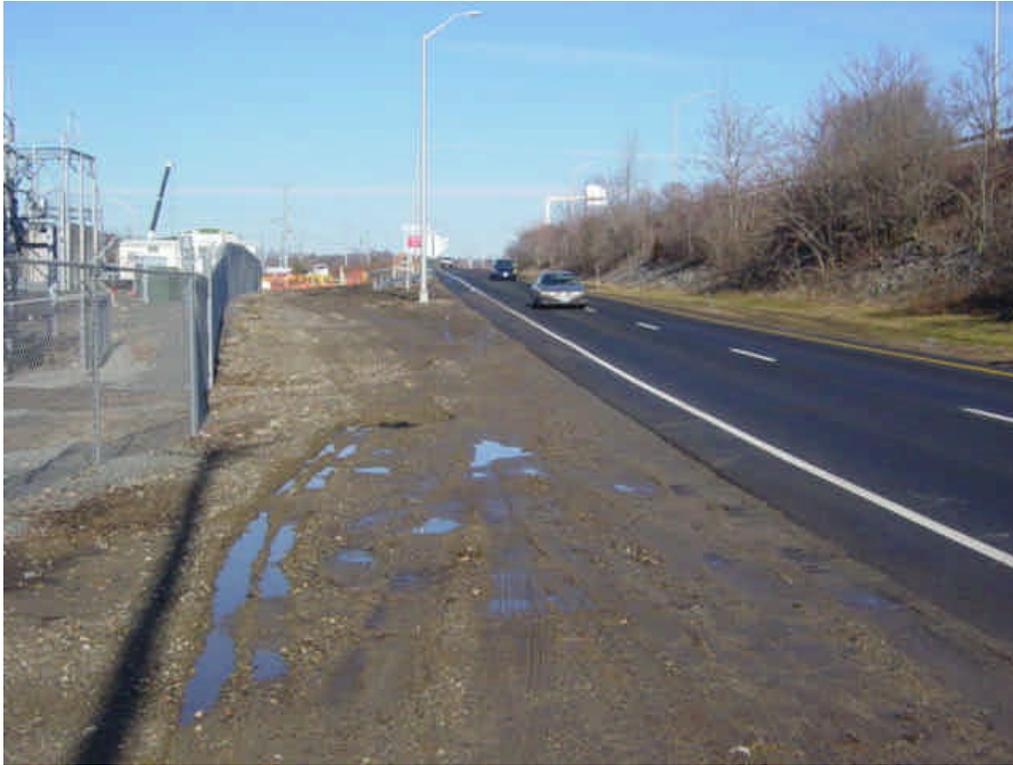
At stations #5-9, adjacent to the off-ramp for Route 7, exposed soil should be temporarily stabilized with either crushed stone or mulch. The drainage swale will also need restoration here when activities are complete.

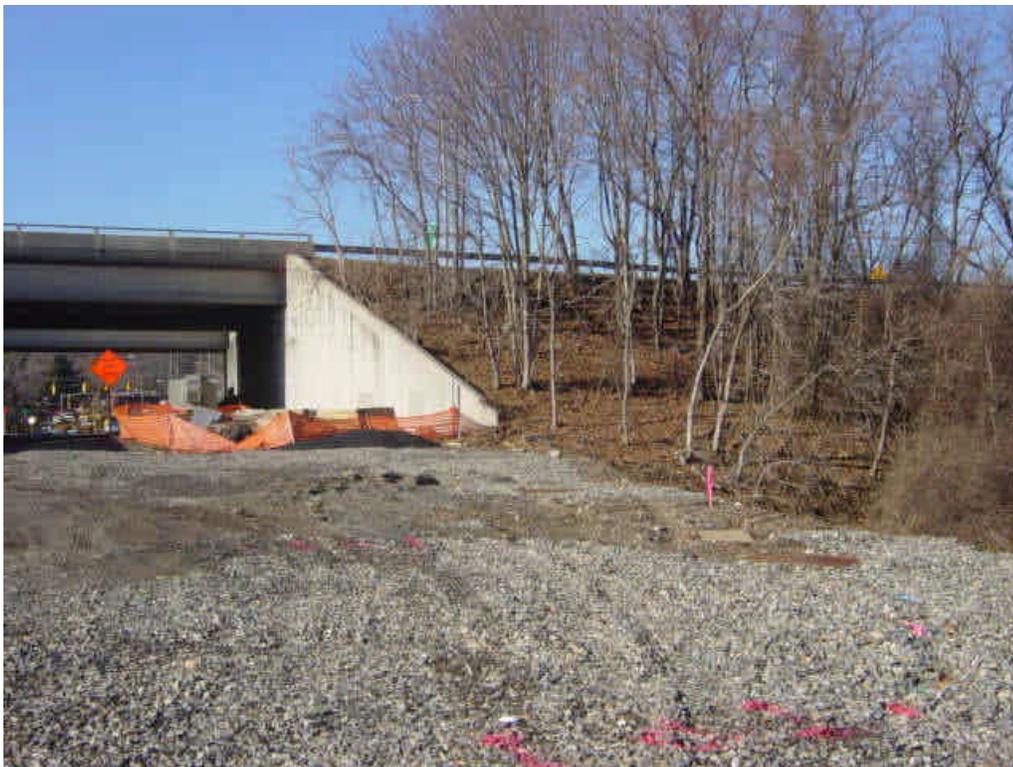
In the area where vault 1 is located, crushed stone has been used to stabilize the exposed soils. Ruts still occur due to vehicles parking in this area.
