**Docket No. 272 – Development and Management Plan Inspection**

**Segment 4c Underground Line**

**Date:** February 21, 2008

**Location:** Westport Avenue to the Norwalk Substation in the City of Norwalk

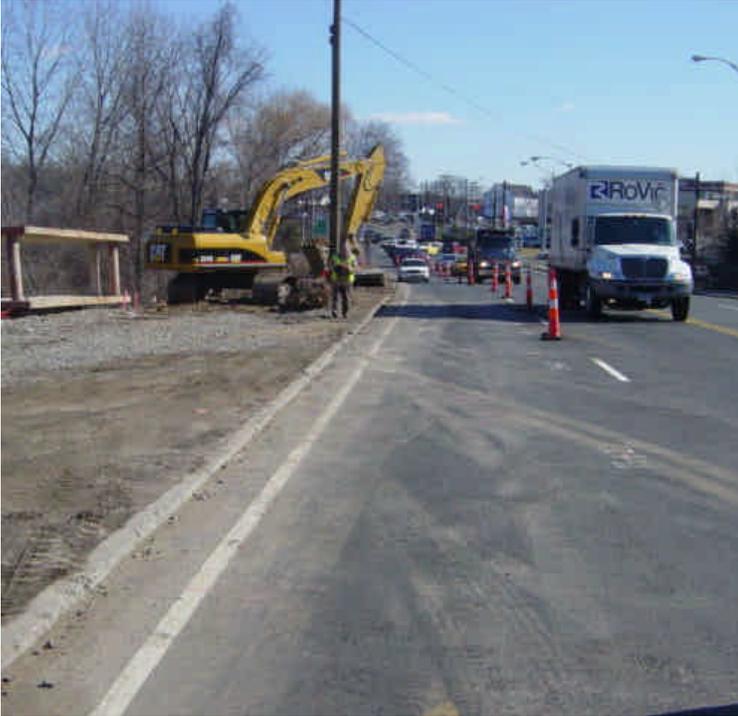
**Temporary lane closure was in place near sta. #16-17 to facilitate trench work. A minor amount of sediment tracking was observed within the closed lane.**

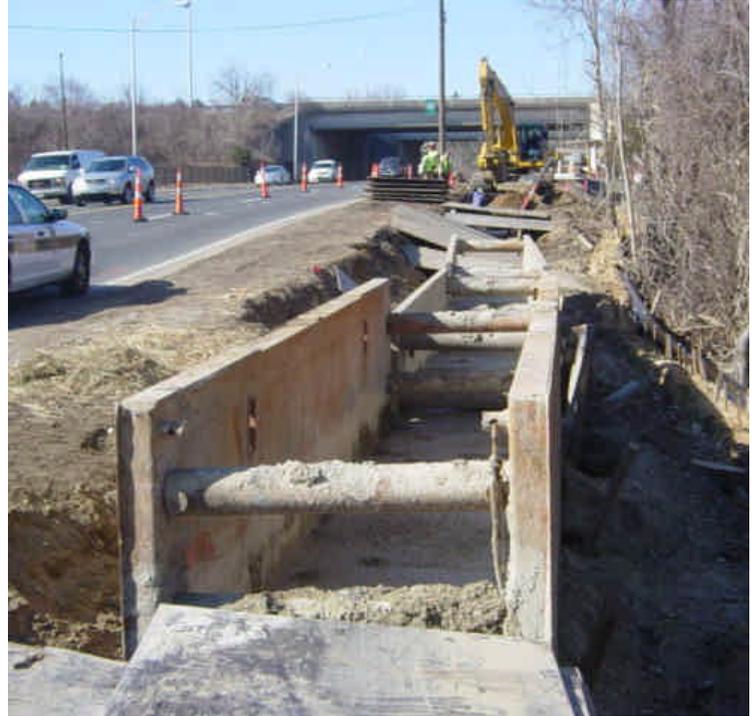
**The trench between sta. #17-18 has been partially backfilled.**

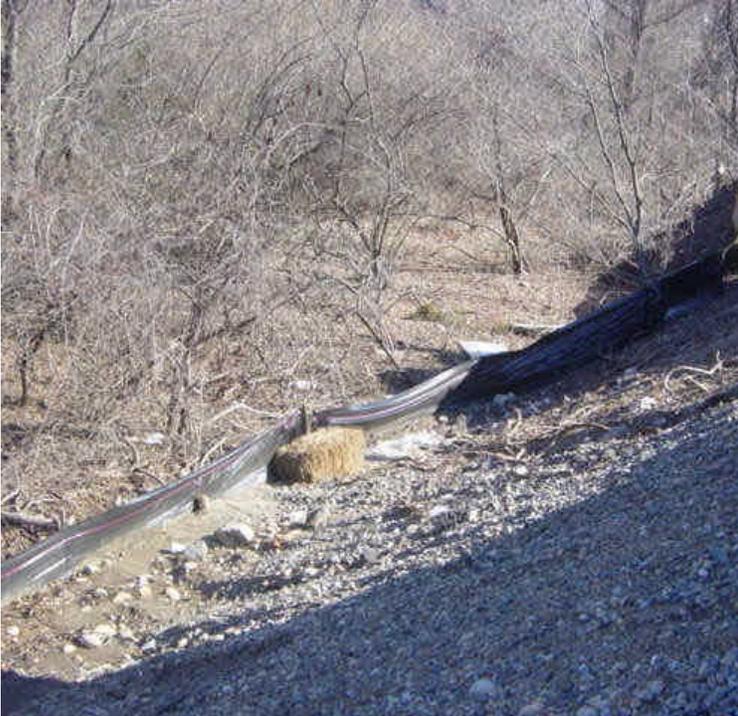
<b>Although a small break in the silt fence at sta. #15-</b>	<b>Continue to monitor and reinforce controls as</b>	<b>The gully was partially regraded..</b>

**A small break in the silt fence at sta. #15-16 was previously repaired with a haybale to reinforce the controls. The minor gully that had formed on the slope was partially regraded to prevent future erosion.**

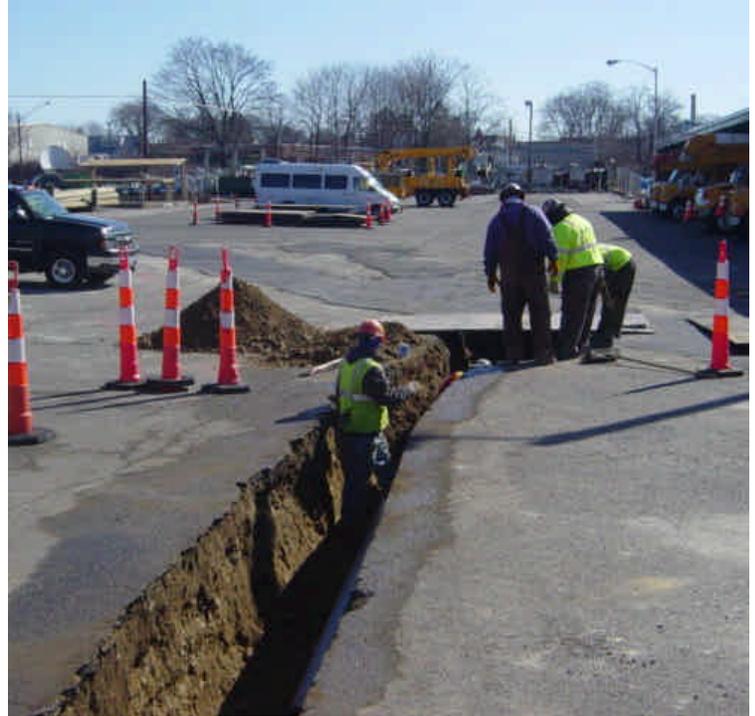
**Trench work continues within the CL&P yard near sta. #25.**
