**Docket No. 272 – Development and Management Plan Inspection**

**The Connecticut Light and Power Company Certificate of Environmental Compatibility and Public Need for the construction of a new 345-kV electric transmission line and associated facilities between Scovill Rock Switching Station in Middletown and Norwalk Substation in Norwalk, Connecticut, including reconstruction of portions of existing 115-kV and 345-kV electric transmission line, the construction of Beseck Switching Station in Wallingford, East Devon Substation in Milford, (and Singer Substation in Bridgeport), modifications at Scovill Rock Switching Station and Norwalk Substation, and the reconfiguration of certain interconnections.**

**Segment 4c Underground Line**

**Date:** March 6, 2008

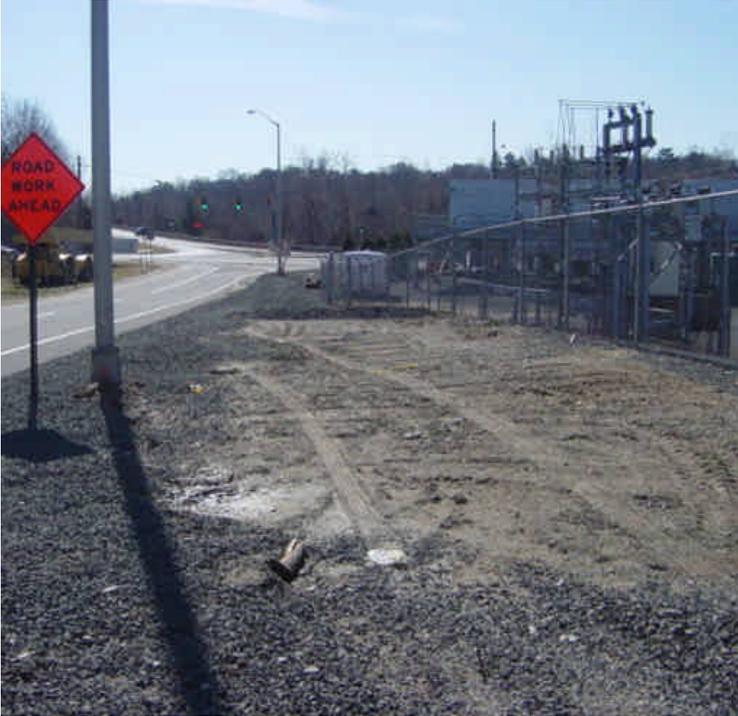
**Crushed stone remains over portions of the exposed soil near sta. #6-8. A stone check dam is also in place and continues to function.**

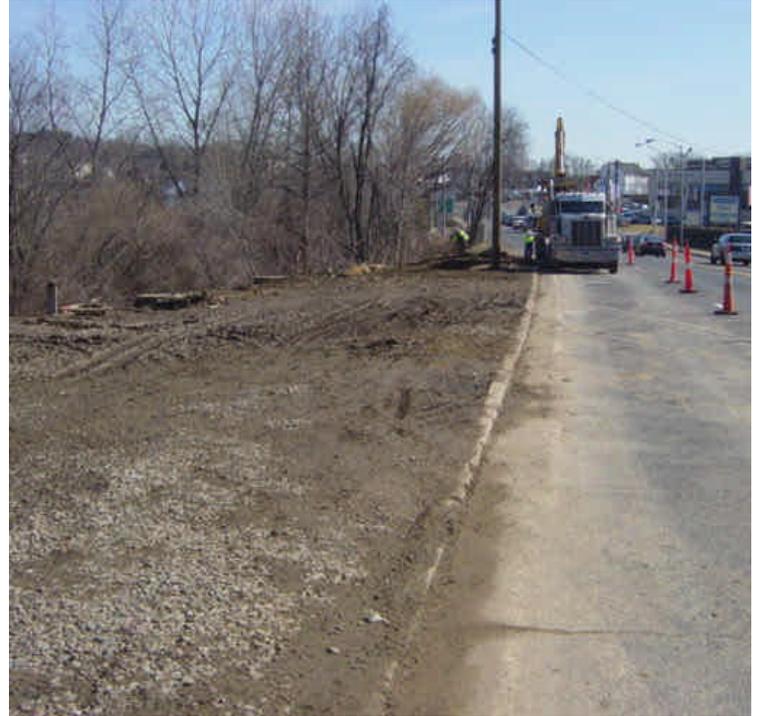
**Work is nearing completion between sta. #15-18. The area has been backfilled and crews were loading trench-boxes and steel plates onto a truck for removal. A minor amount of sediment has accumulated along the curb line.**

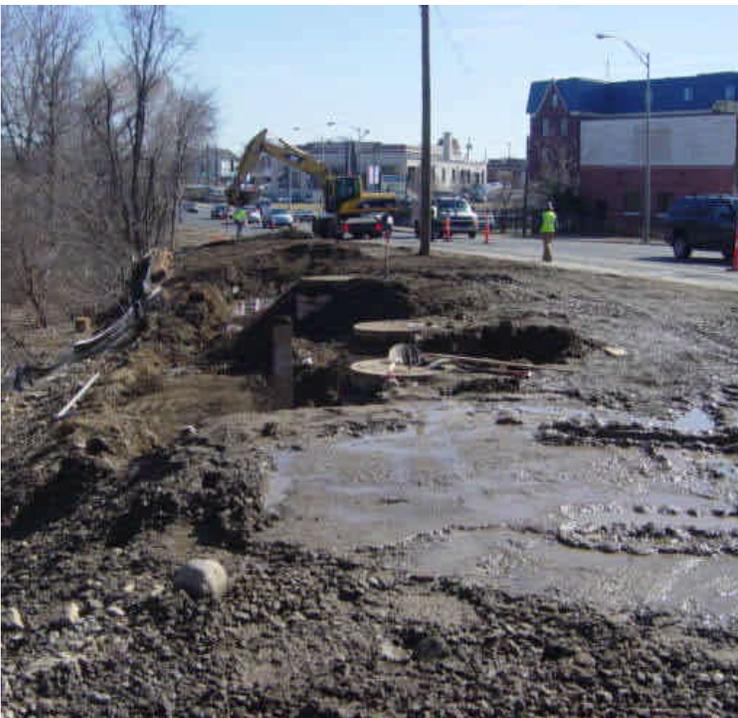
**Vault tie-in work is nearing completion at sta. #15. The area was very muddy at the time of the inspection. Once backfilled, the exposed soil will need to be temporarily stabilized.**

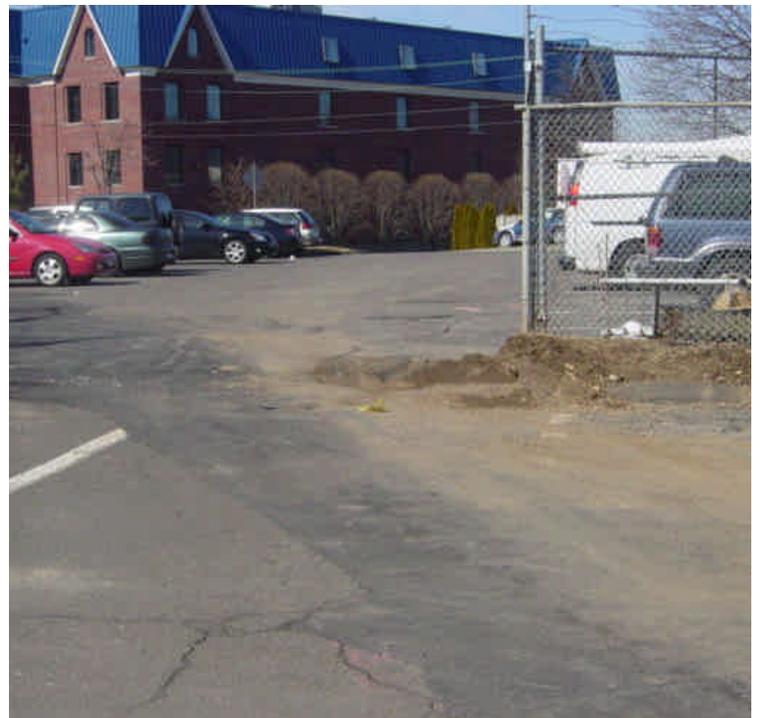
**Trenching continues near sta. #25. A temporary gate has been set-up to access the CL&P yard. A minor amount of sediment was being tracked near this entrance from the adjacent landscaped island.**
