Docket No. 272 – Development and Management Plan Inspection

Segment 4c Underground Line

Date: March 13, 2008

Location: Westport Avenue to the Norwalk Substation in the City of Norwalk

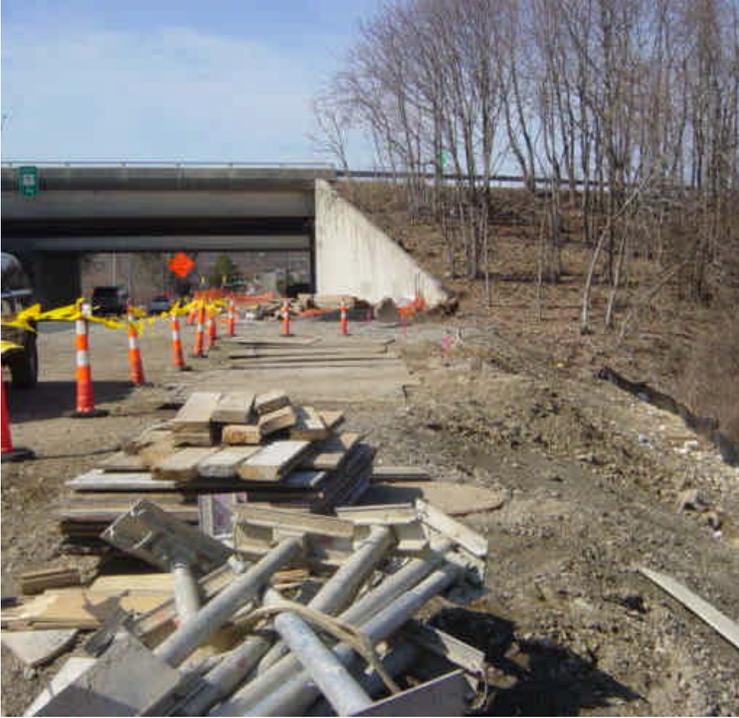
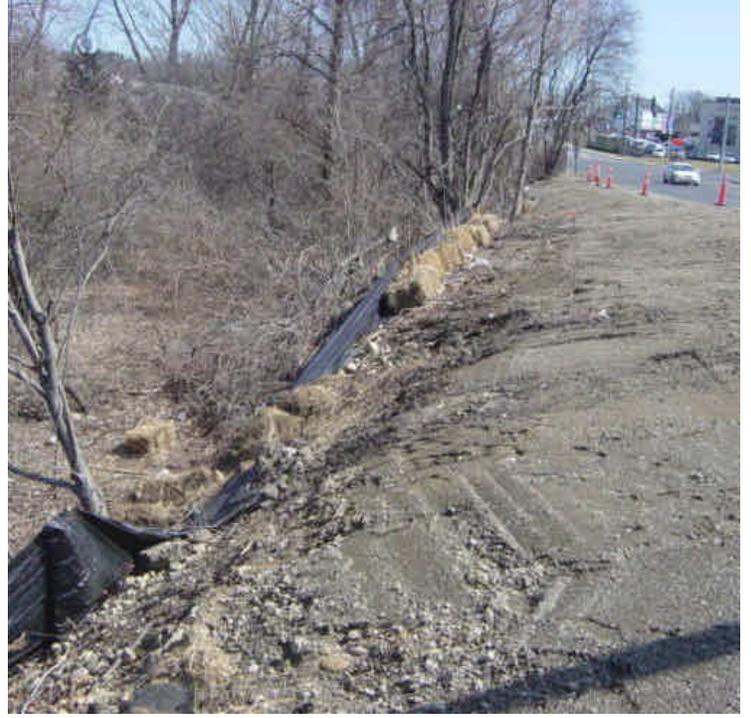
Work is nearing completion between sta. #15-18. The area has been backfilled and the area was inactive. A small section of silt fence is in need of repair and the haybales will need to be reset. Temporarily or permanently stabilize the soil surface as soon as feasible.

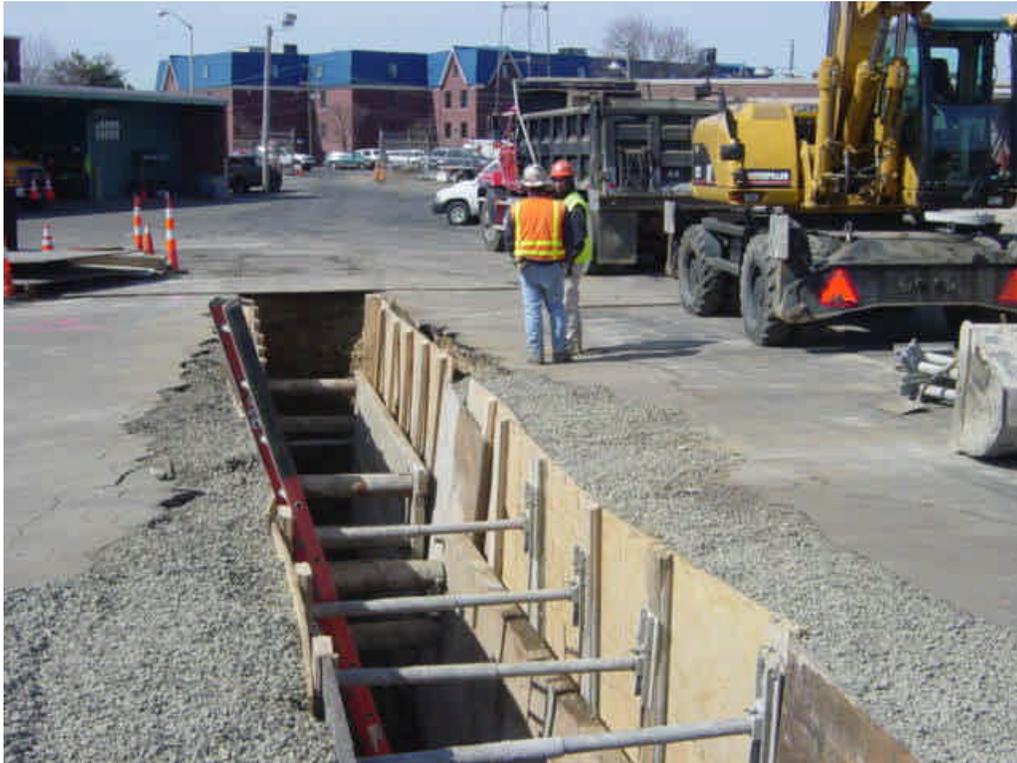
Trenching continues near sta. #25.
