Docket No. 272 – Development and Management Plan Inspection

Segment 4c Underground Line

Date: March 20, 2008

Location: Westport Avenue to the Norwalk Substation in the City of Norwalk

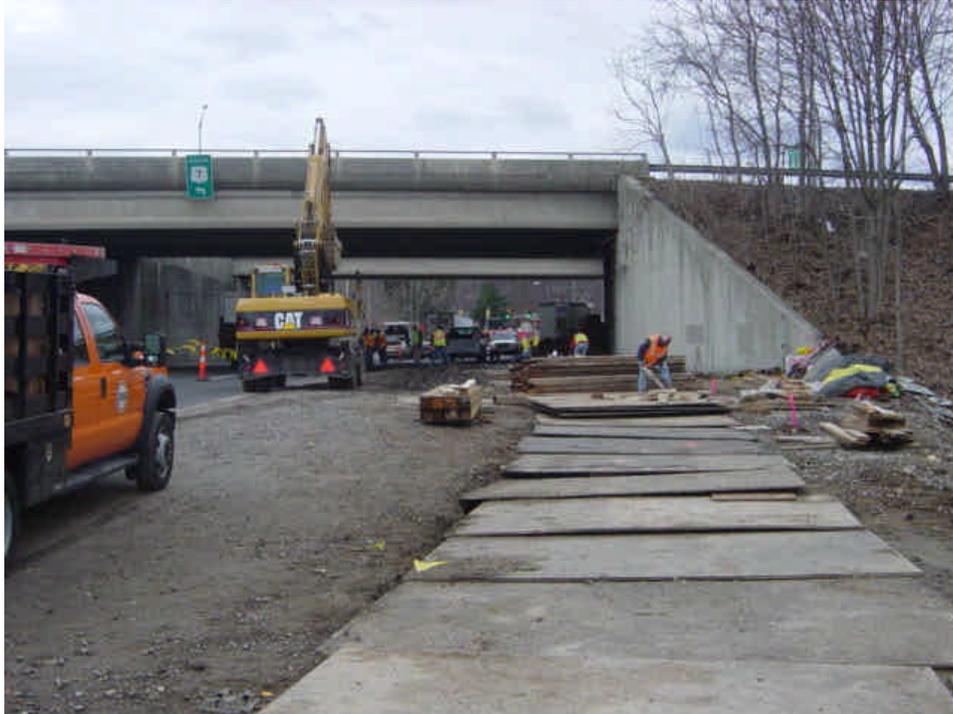
Areas of Inspection	Observation	Recommended Action	Corrected Action
	<p>issue. 3/20/08</p> <p>Work is nearing completion in the area between sta. #15-18. Plates are in place over the open trench. Silt fence and haybale barrier remains along the graded slope. Processed material is in place to stabilize the large amounts of exposed soil. 3/20/08</p> <p>A drainage inlet near sta. #9+50 was protected with silt fence and hay bales, but accumulated sediment remains in the inlet. 12/5-3/20/08 Hay bales are deteriorating. 1/11-3/20/08</p> <p>The inlet at #9+50 was associated with a pre-construction drainage swale. Trench work has modified the grades in the area (removing the swale). A portion of the swale has been temporarily re-established between sta. #4+50 to 6+50 and lined with crushed stone. 3/20/08</p> <p>A stone check dam is in place near sta. #8 to direct runoff away from the entrance gate. Crushed stone remains over some areas of the exposed soil between sta. #6-10 along the shoulder of the Rt. 7 off-ramp. Graded processed material remains in other areas. Tracking was not an issue. 3/20/08</p>	<p>Monitor and maintain silt fence, install additional erosion control measures as necessary. Temporarily stabilize exposed soils as soon as feasible, until they can be permanently stabilized in the spring. 3/20/08</p> <p>Remove accumulated sediment from the drainage inlet. Continue to monitor controls and refresh as necessary. From past observations during the Bethel- Norwalk project, this inlet receives high velocity run-off. 12/5-3/20/08</p> <p>Contractors have stated they plan to restore the drainage swale to pre-construction conditions when work is complete. Continue to ensure that drainage does not cause issues on the roadway. 3/20/08</p> <p>Discuss options with CL&P on how to address the material that has previously eroded into the substation. Ensure that the berm does not cause sedimentation to the roadway instead. 3/20/08</p>	<p>Continue to monitor and stabilize.</p> <p>Needs additional attention to remove accumulated sediment and refresh hay bales.</p> <p>Continue to monitor. (See Norwalk 9S Phasing and Erosion Control Plan rev. 10/30/03 from the Bethel-Norwalk project as reference)</p> <p>Discuss options with CL&P on clean-up efforts within substation.</p>

Vault tie-in work is nearing completion at sta. #15. Steel plates remain over the trenched area. Haybales and silt fence remain along the bottom of the slope.

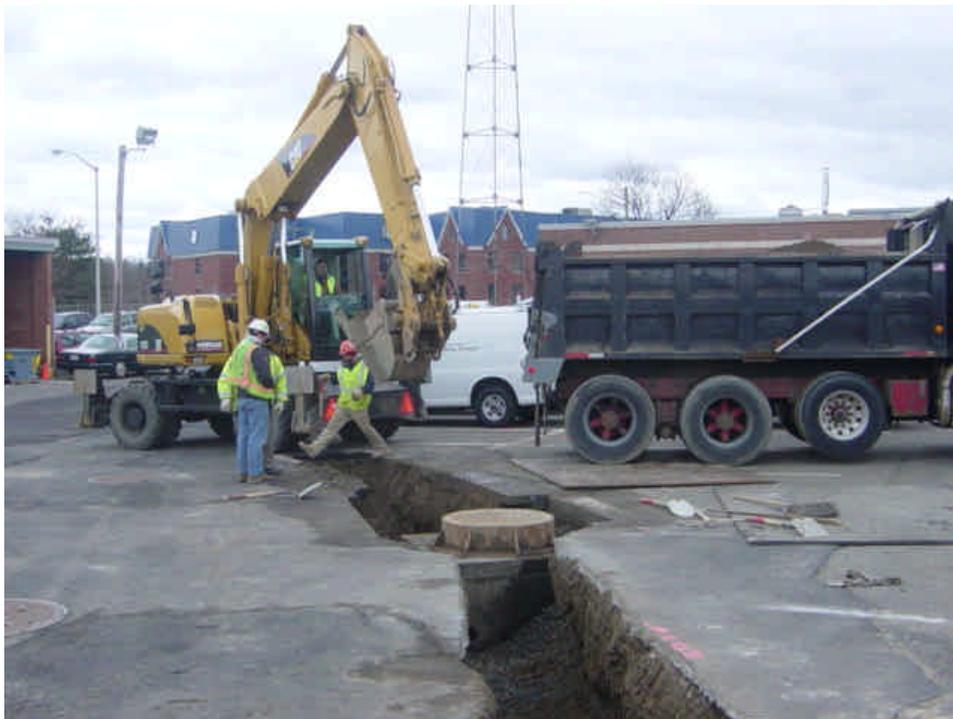
Minor amount of sediment tracking was observed near sta. #25 near the temporary access drive to the CL&P yard. Field supervisor was proactively addressing the	Continue to sweep parking lot as necessary to reduce tracking and remove accumulated sediment. 3/20/08	Needs regular attention. A field supervisor was working on the issue.

Crews are installing hand holes within the paved area near sta. #25.
