Docket No. 272 – Development and Management Plan Inspection

Segment 4c Underground Line

Date: March 28, 2008

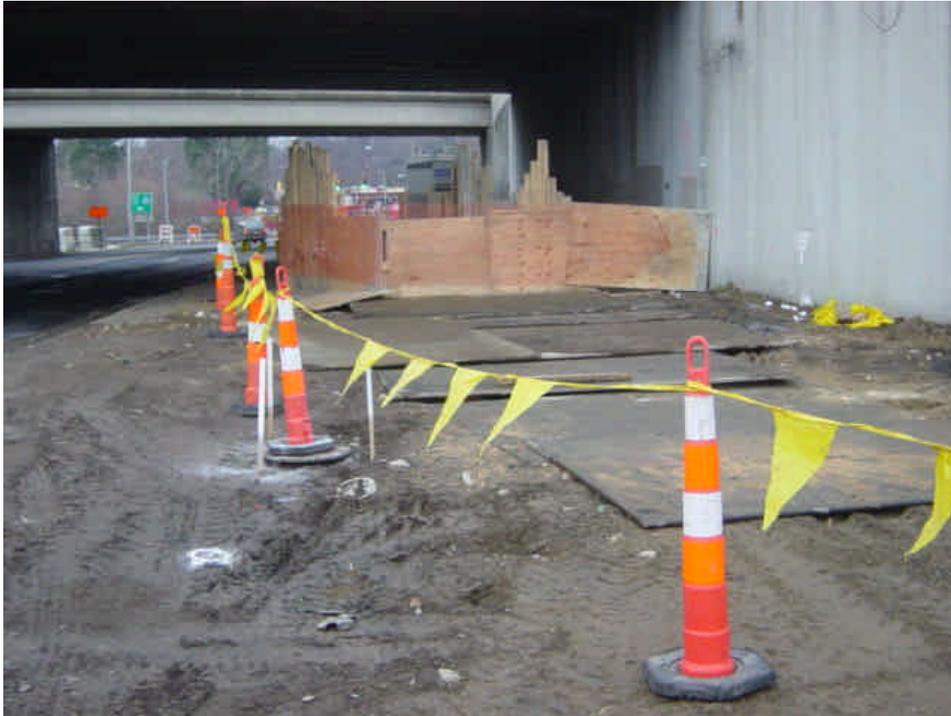
Vault tie-in work continues at sta. #14-15. Steel plates remain over the trenched area. Stabilize the adjacent exposed soil when feasible.

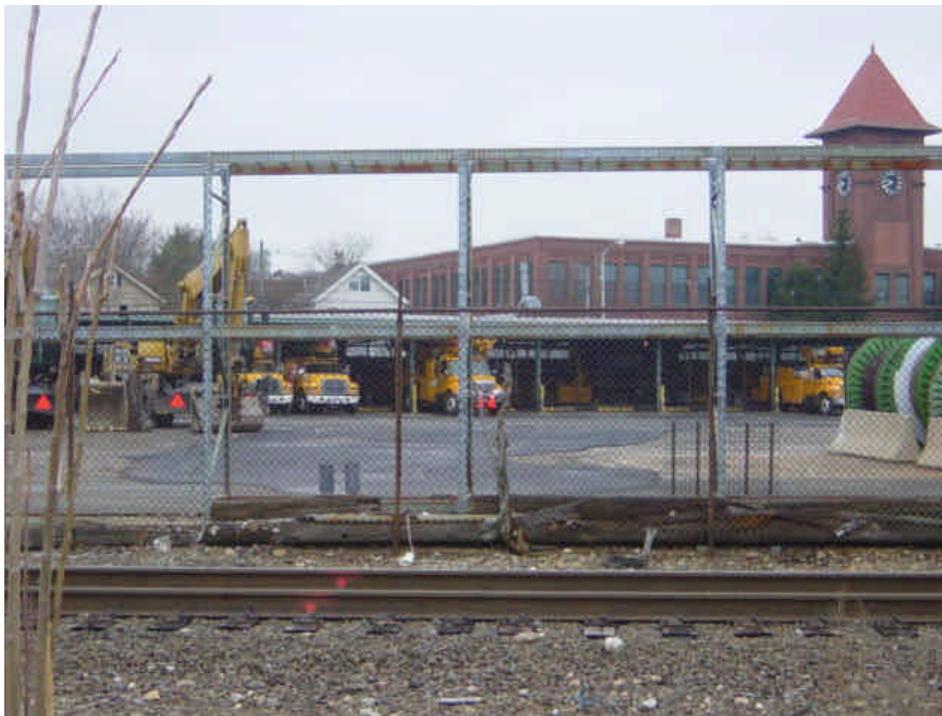
Work within the CL&P yard has been completed.
