Docket No. 272 – Development and Management Plan Inspection

Segment 4c Underground Line

Date: April 3, 2008

Location: Westport Avenue to the Norwalk Substation in the City of Norwalk

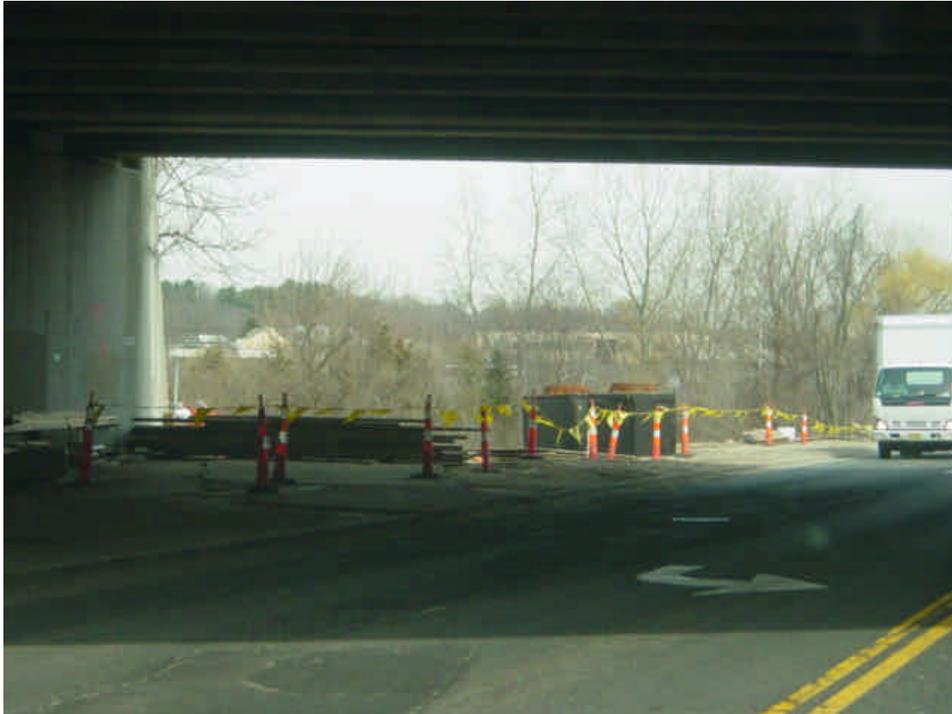
A minor amount of sediment was observed along the curblin near active work at sta. #13-15. 4/03/08	Sweep roadway as necessary to remove accumulated sediment. 4/03/08	Needs attention.
	Work is complete in the	Monitor and maintain silt	Needs attention/

Trenching continues near sta. #13-15. Steel plates remain over the trenched area. A minor amount of sediment has accumulated along the curb line. Large areas of exposed soil remain between #15-18.

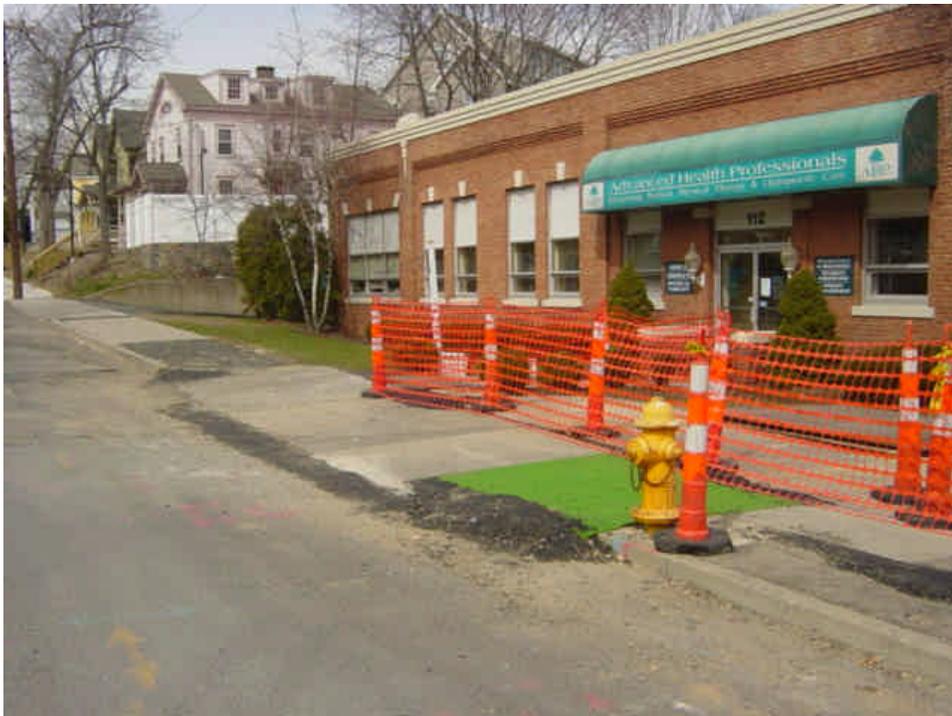
Trenching has begun near sta. #50-51. Steel plates remain over the trenched area. A minor amount of sediment/material has accumulated along the curb line and should be swept.
