**Docket No. 272 – Development and Management Plan Inspection**

**Segment 4c Underground Line**

**Date:** April 24, 2008

**Location:** Westport Avenue to the Norwalk Substation in the City of Norwalk

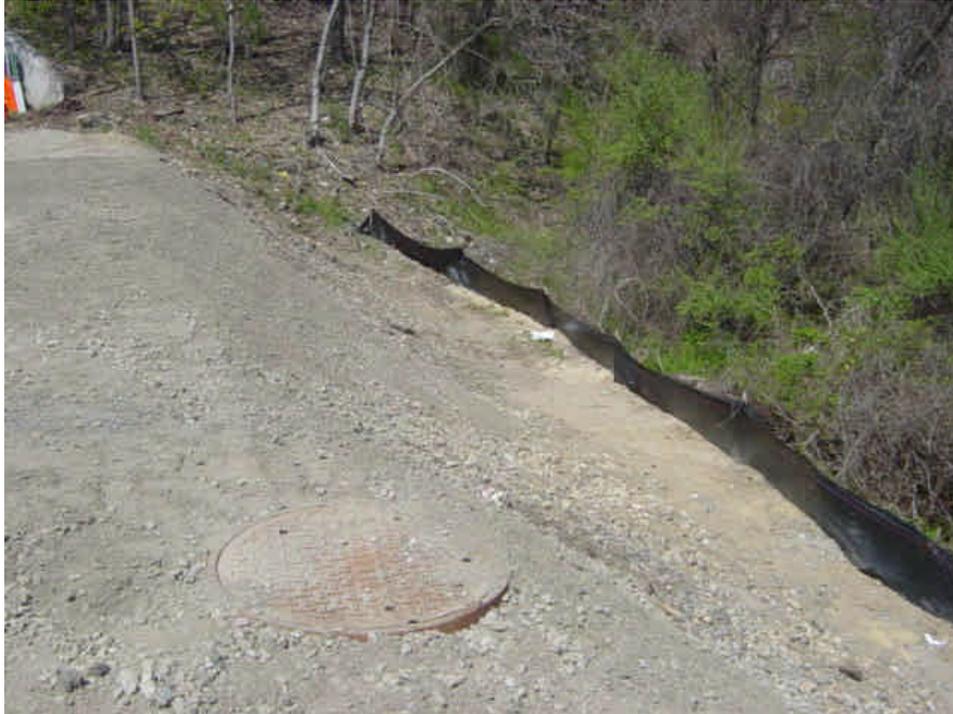
**Debris has been removed from along the silt fence near sta. #15-18.**

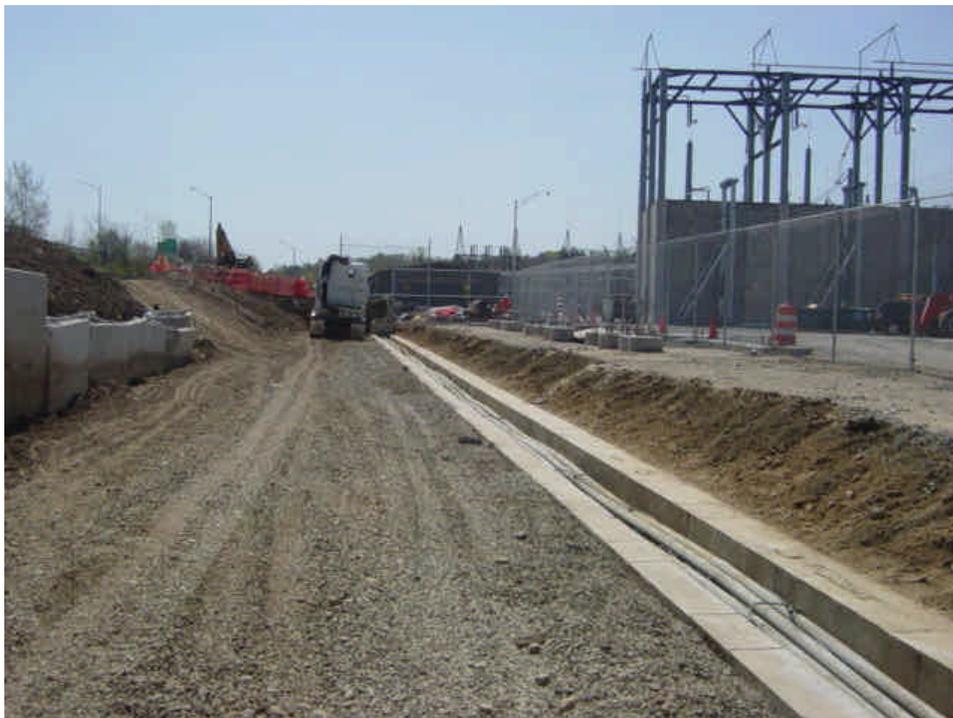
**Pre-cast concrete retaining wall has been temporarily removed from along the perimeter of the Norwalk substation to accommodate trenching activities between sta. #0-4.**
