Docket No. 272 – Development and Management Plan Inspection

Segment 4c Underground Line

Date: May 1, 2008

Location: Westport Avenue to the Norwalk Substation in the City of Norwalk

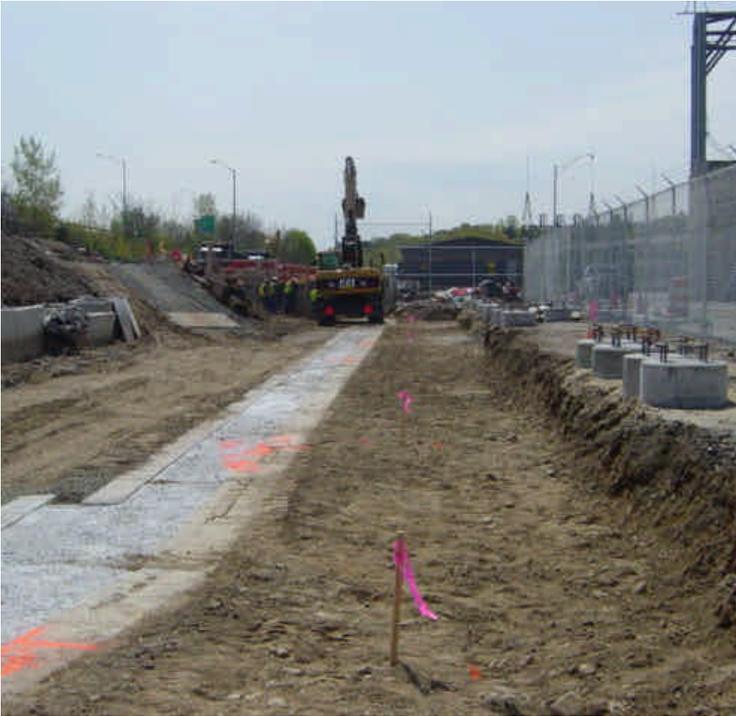
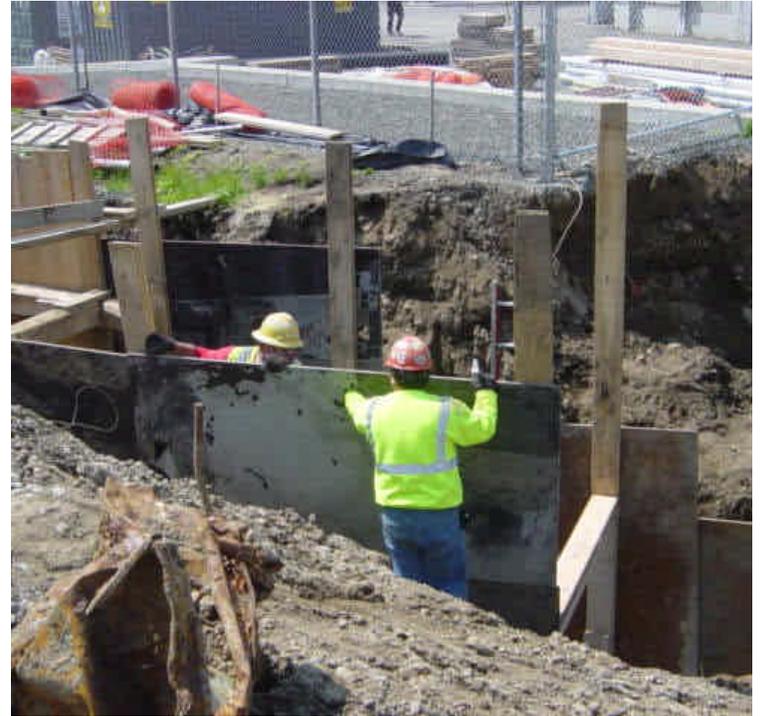
Trenching continues along the Route 7 off ramp and the Norwalk substation near sta. #0-4. The concrete retaining wall at the perimeter of the yard has been temporarily removed to accommodate trenching activities. Foundations are already in place to receive the conduits/circuits.

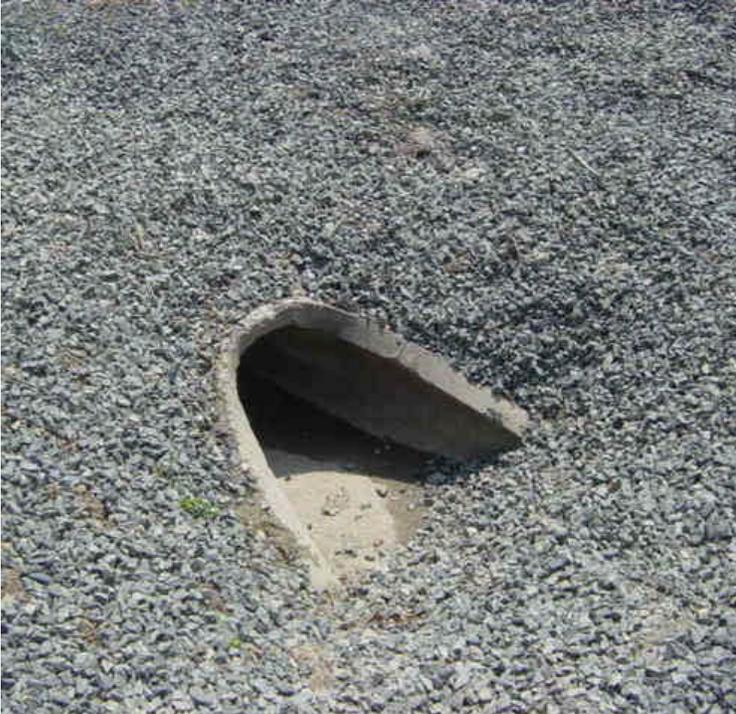
Stone remains in place around the drainage inlet near sta. #9+50. Deteriorated hay bales and silt fence have been removed and accumulated sediment has been removed from the inlet.

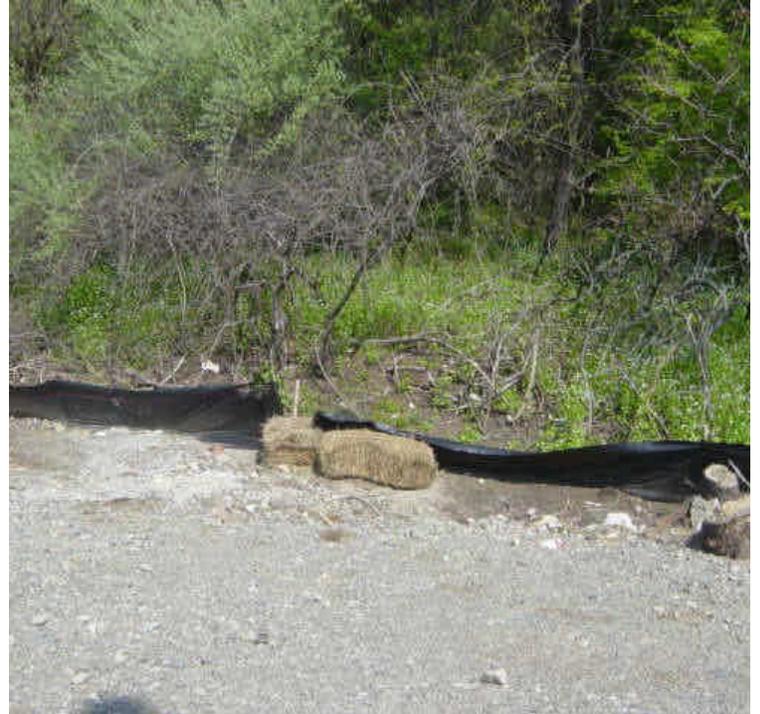
Work is complete in the area between sta. #15-18. Silt fence and haybale barrier remains along the graded slope. Sediment	Monitor and maintain silt fence, install additional erosion control measures as necessary. Continue to remove the	Needs attention when feasible.

Silt fence remains along the toe of the slope near sta. #15-18. A small section is in need of repair and accumulated debris has started to return along the silt fence.
