Docket No. 272 – Development and Management Plan Inspection

Segment 4c Underground Line

Date: May 8, 2008

Location: Westport Avenue to the Norwalk Substation in the City of Norwalk

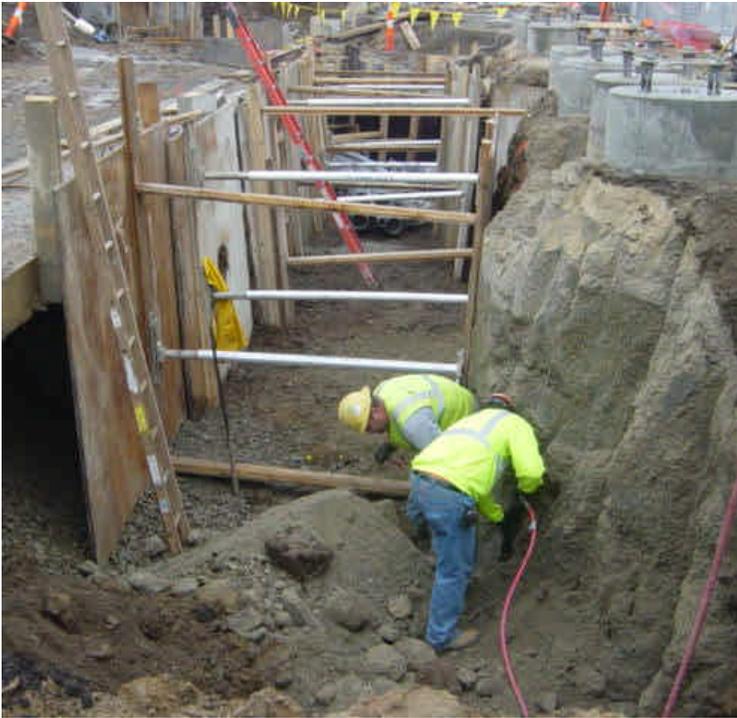
Trenching continues along the Route 7 off-ramp and the Norwalk substation near sta. #0-4. Crews were chipping away material from around the previously placed foundations to accommodate the conduits.

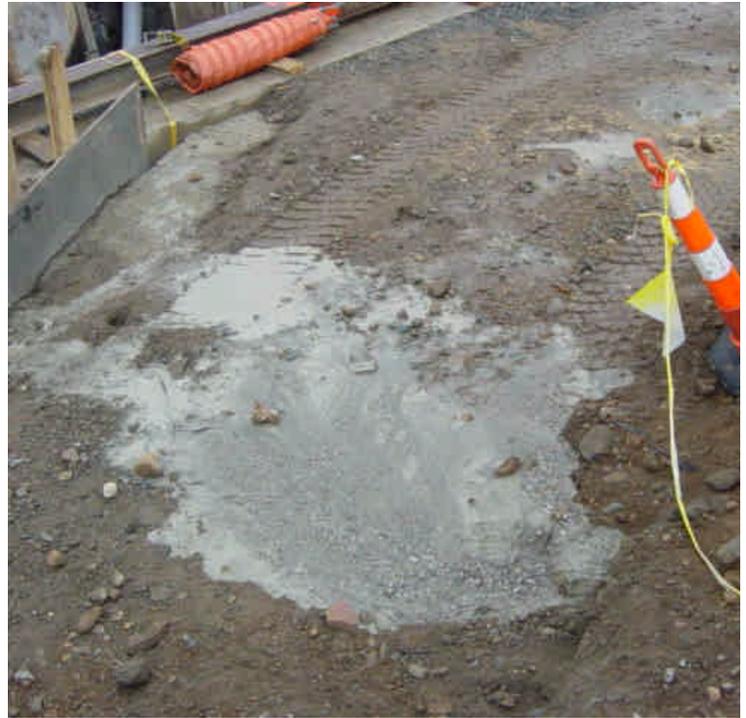
A concrete washout was observed near sta. #3. The area lacked proper containment. Remove the material and establish a designated washout area.

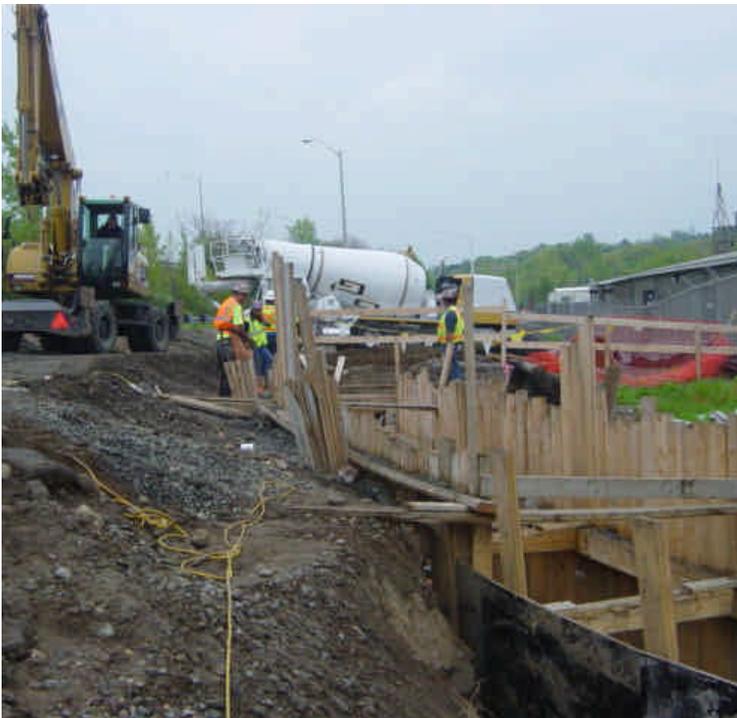
Backfilling work was underway near sta. #3-4.

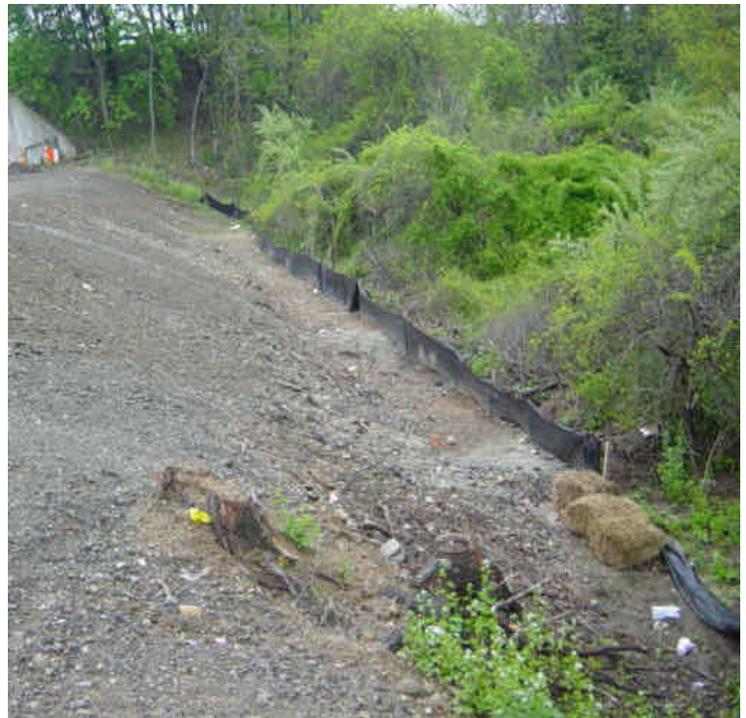
Silt fence remains in place along the toe of the slope near sta. #14-15. Some sections are in need of repair and some sediment continues to accumulate.

Work is complete in the area between sta. #15-18. Silt fence and haybale barrier remains along the graded slope but portions	Monitor and maintain silt fence, install additional erosion control measures as necessary. Portions of the silt fence	Needs attention.
