Docket No. 272 – Development and Management Plan Inspection

Segment 4c Underground Line

Date: May 29, 2008

Location: Westport Avenue to the Norwalk Substation in the City of Norwalk

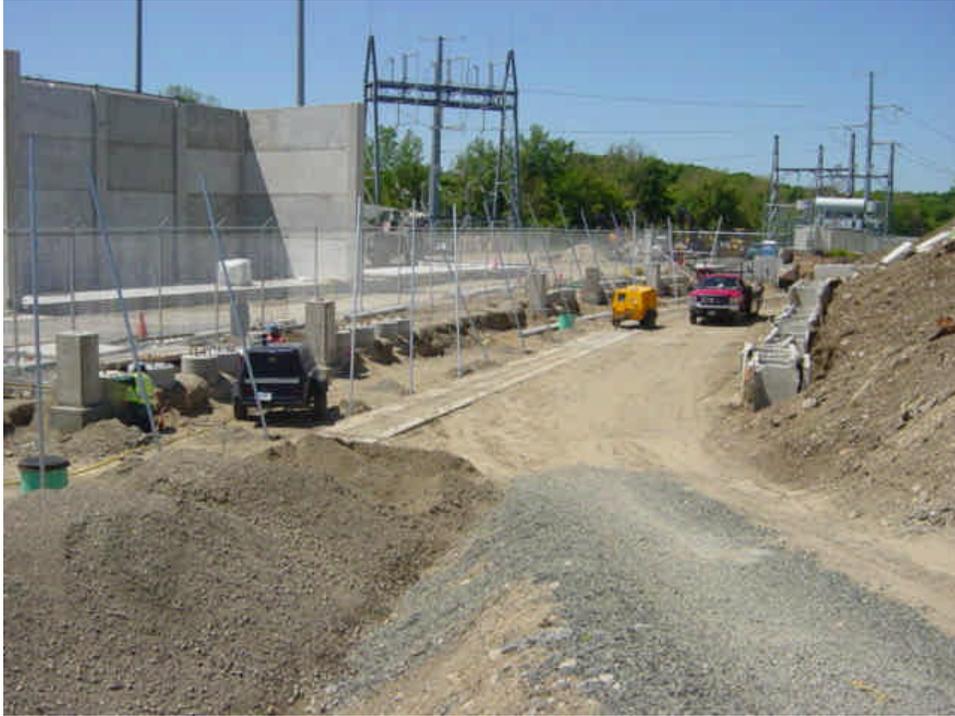
The conduits have been tied in to the termination structures and the trench has been backfilled. Crews were relocating the perimeter fence surrounding the substation to encompass the newly placed foundations.
