**Docket No. 272 – Development and Management Plan Inspection**

**Segment 4c Underground Line**

**Date:** June 6, 2008

**Location:** Westport Avenue to the Norwalk Substation in the City of Norwalk

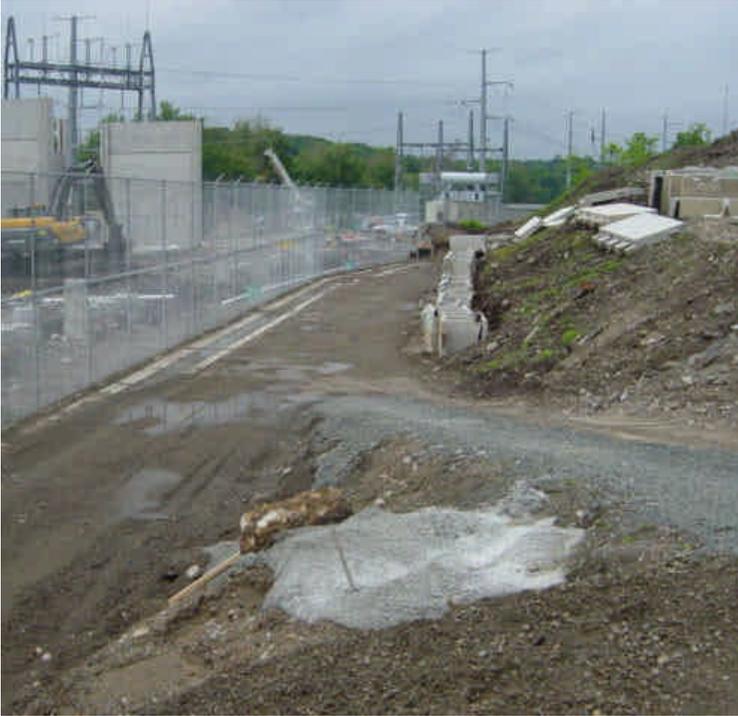
**The conduits have been tied in to the termination structures and the trench has been backfilled. The perimeter fence surrounding the substation has been relocated to encompass the foundations.**

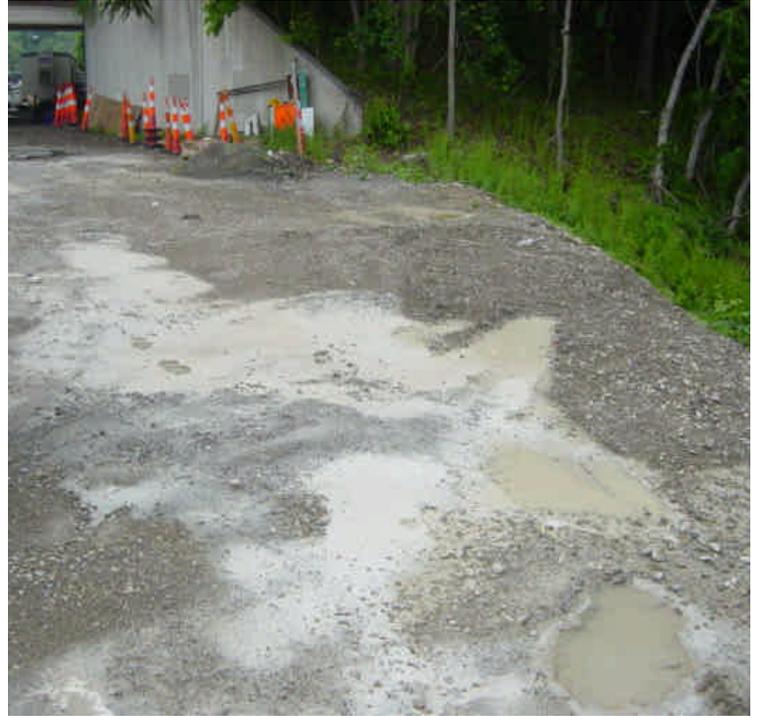
**Some residual slurry material was observed near sta. #14. The material was most likely discharged from the nearby vault structures to facilitate electrical connection work.**

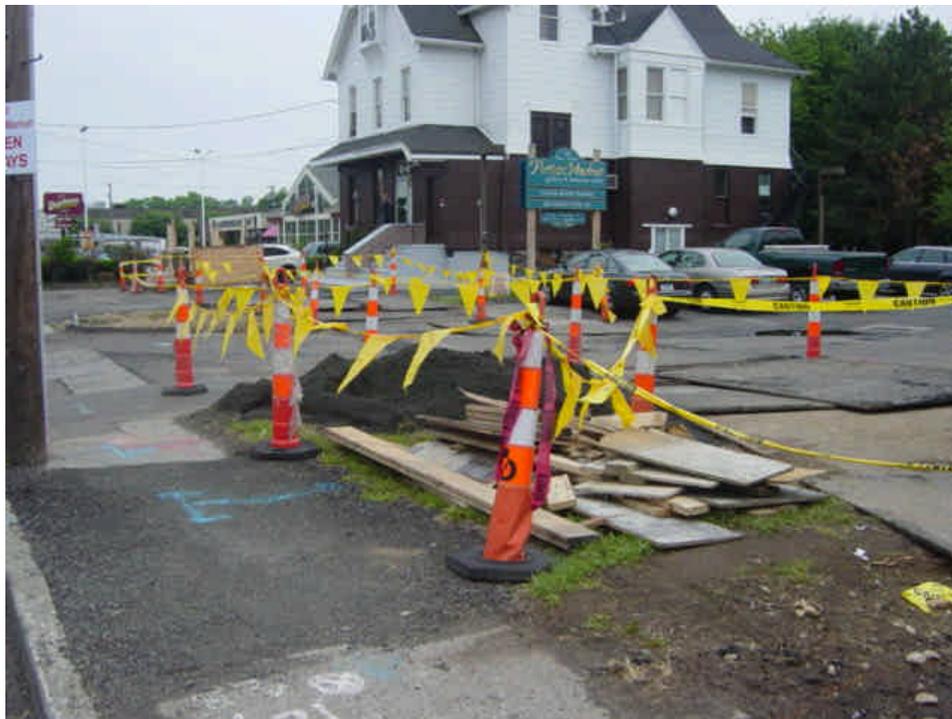
**Steel plates remain in the parking lot area over the trench near sta. #36-38.**
