**Docket No. 272 – Development and Management Plan Inspection**

**Segment 4c Underground Line**

**Date:** July 17, 2008

**Location:** Westport Avenue to the Norwalk Substation in the City of Norwalk

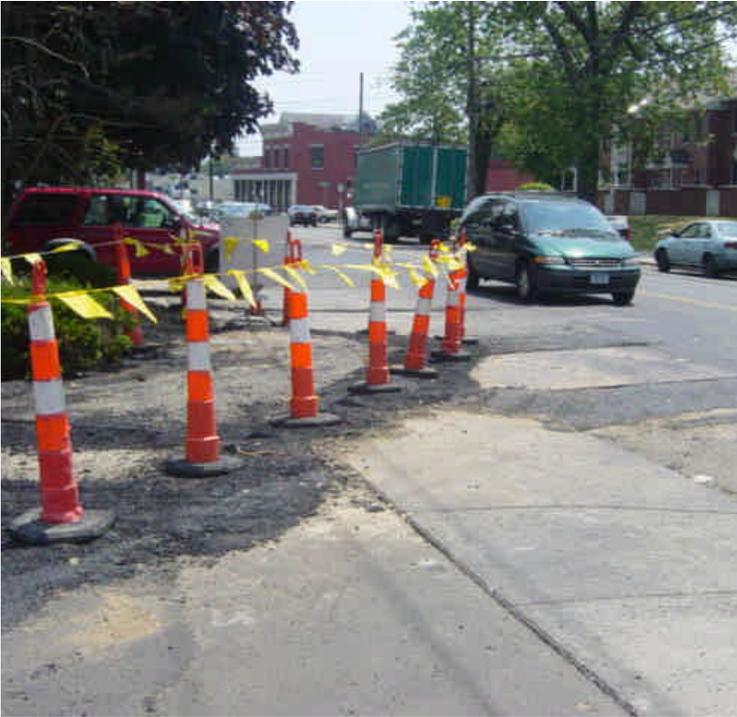
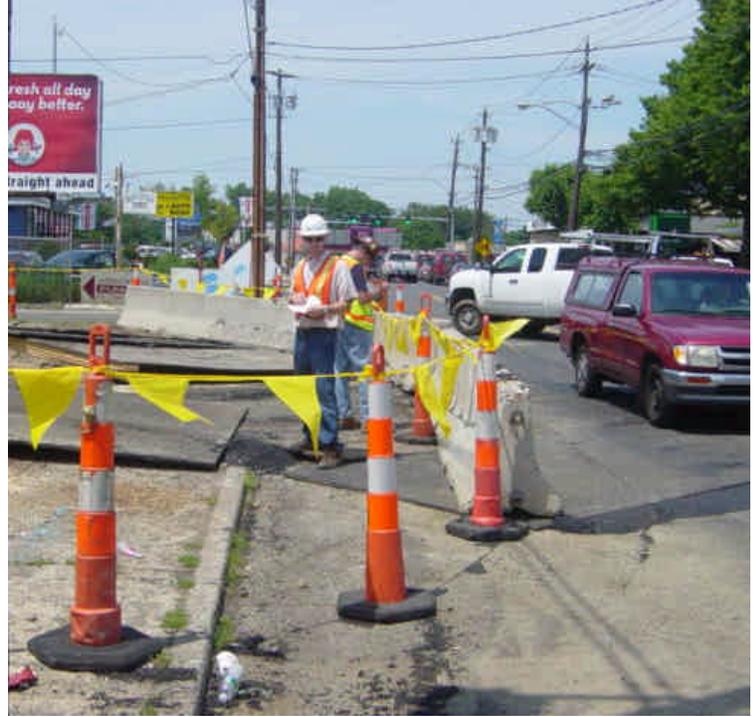
**Steel plates were in place over the trench near sta. #32-33 and #53. Cold mix was patched along the edges of the plates but was not compacted in place. Vehicle traffic over the plates was causing the cold mix to crumble and was then tracked along the roadway. Sweep the area as needed.**

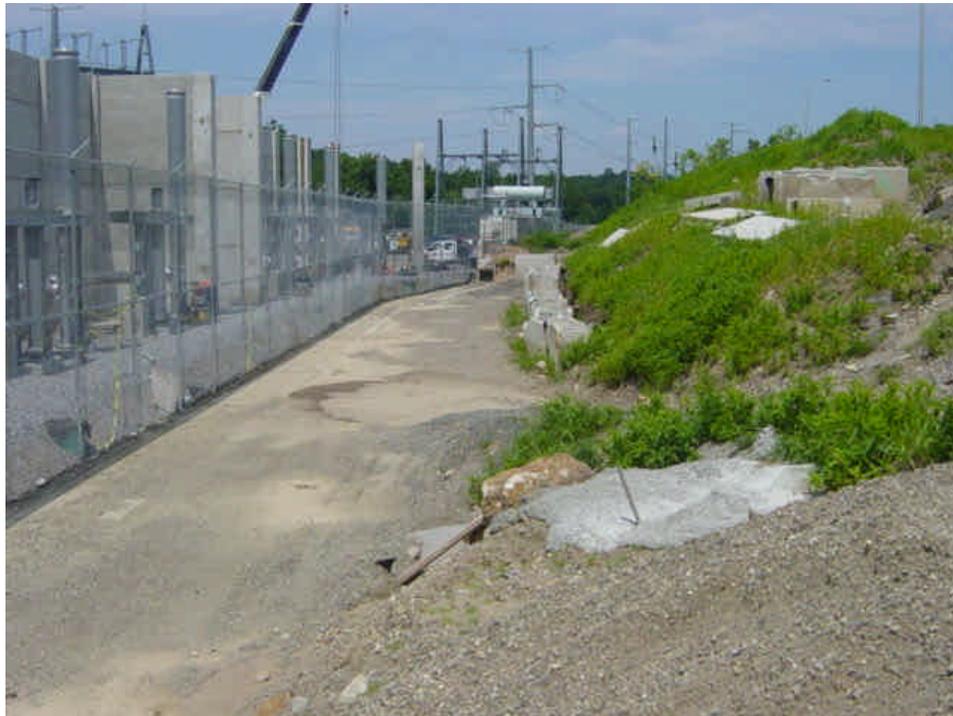
**Tie-in work has been completed at the Norwalk substation. The pre-cast concrete wall needs to be restored.**
