Docket No. 272 – Development and Management Plan Inspection

Segment 4c Underground Line

Date: August 29, 2008

Location: Westport Avenue to the Norwalk Substation in the City of Norwalk

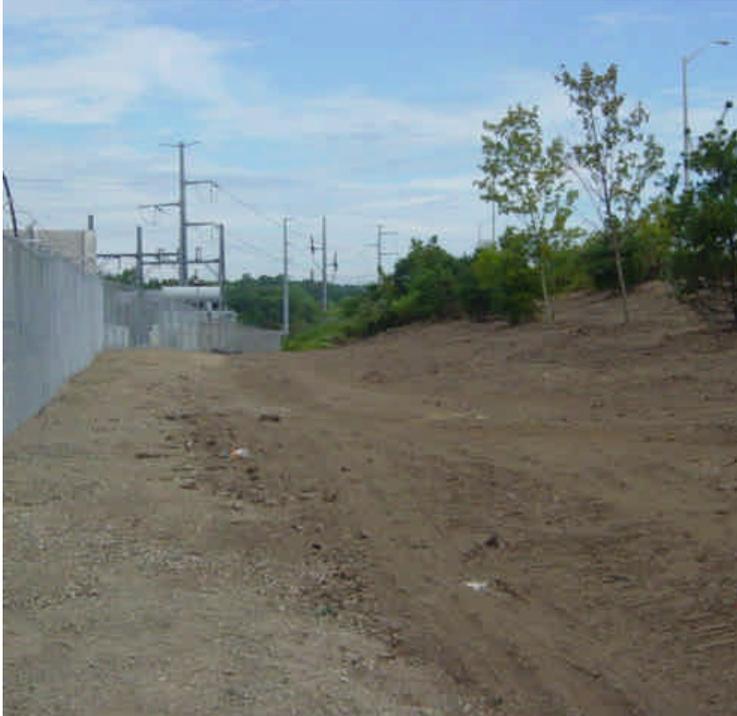
Pre-cast concrete retaining wall has been restored outside of the Norwalk substation near sta. #0 and the area has been backfilled. Some trees and landscaping has also been restored. Exposed soil needs mulch and seed.

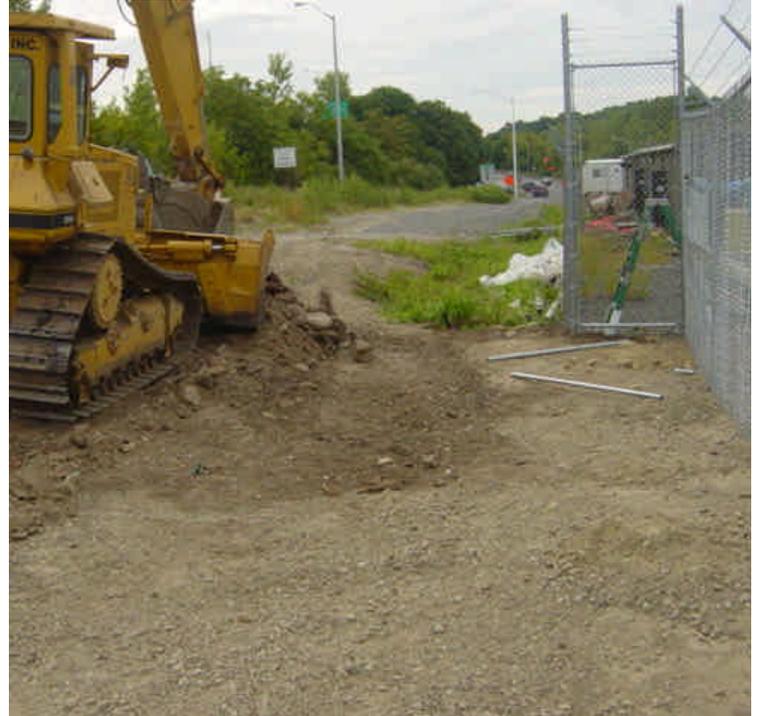
Area between sta. #2-6 was being re-graded to restore the drainage swale along the side of the substation. Ensure the swale is continued to the inlet at the base of slope and that exposed soils are stabilized.

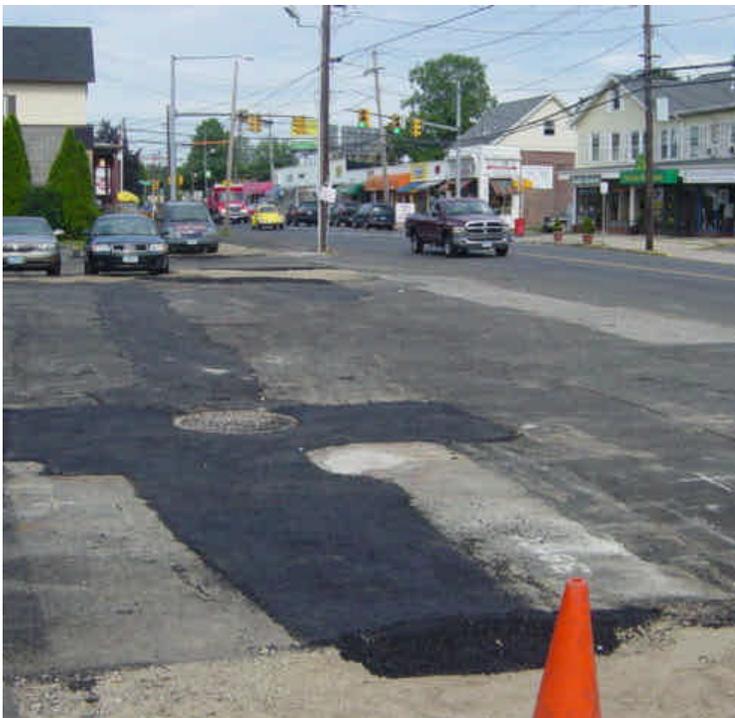
Trenching work has been completed in some locations between sta. #31-40 and the areas have been backfilled and temporarily paved. A minor amount of cold mix/ granular material remains along the edge of the roadway. Sweep where needed.
