Docket No. 272 – Development and Management Plan Inspection

Segment 4c Underground Line

Date: September 12, 2008

Location: Westport Avenue to the Norwalk Substation in the City of Norwalk

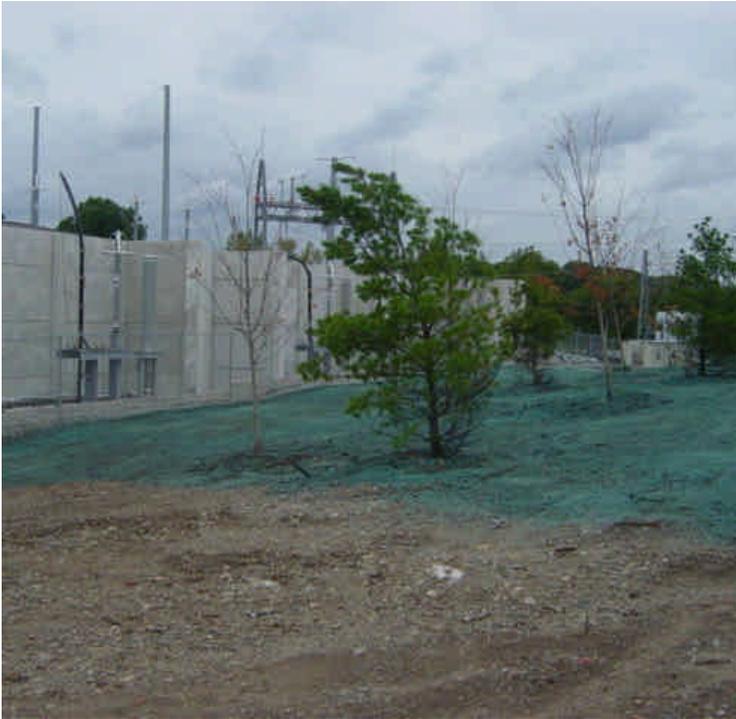
Pre-cast concrete retaining wall has been restored outside of the Norwalk substation near sta. #0 and the area has been backfilled. Trees and landscaping has also been restored and a portion of the area was hydroseeded.

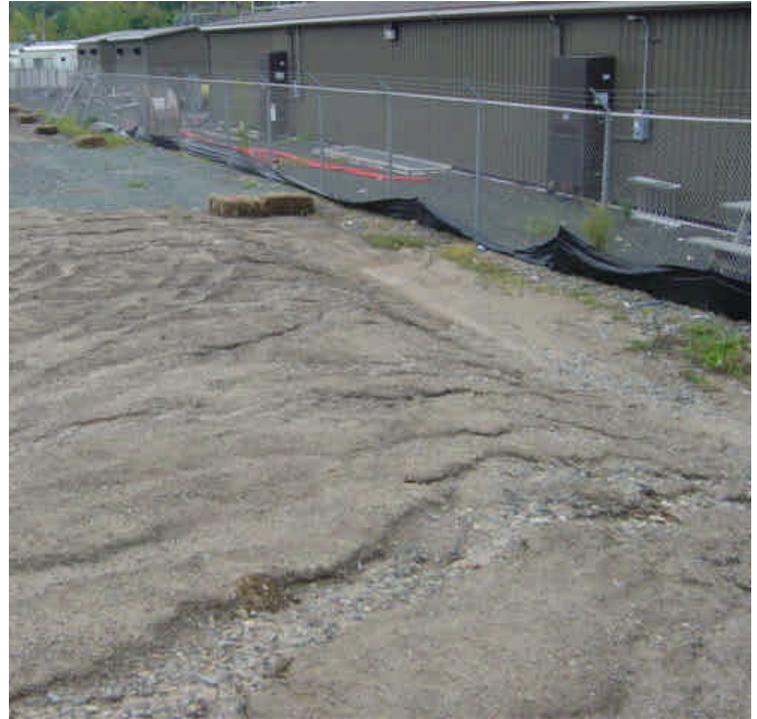
The area near sta. #2-8 has been re-graded and topsoil has been spread. However, heavy rain has washed out some of the topsoil creating gullies, and portions of the previously restored swale have filled with sediment.

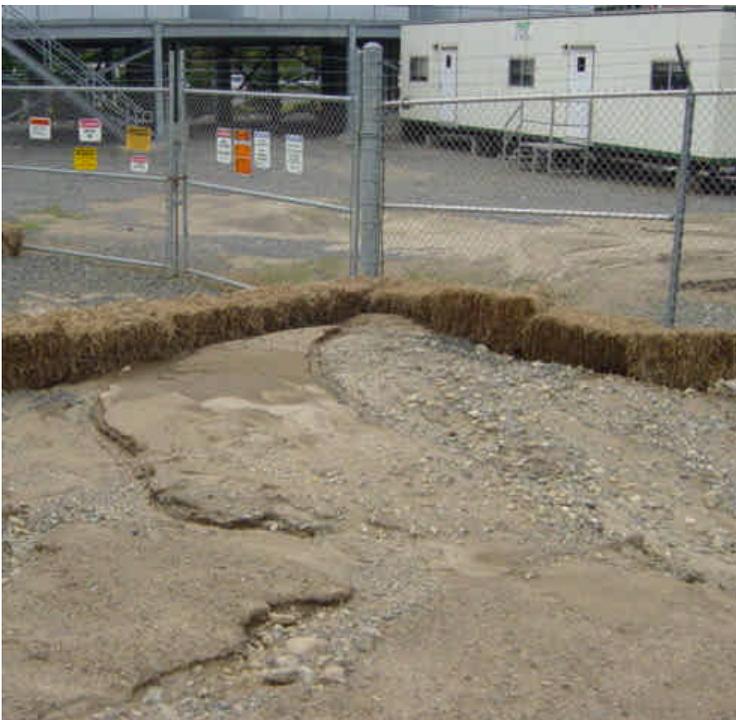
Area between near sta. #9 was re-graded but has since washed out and eroded. A hay bale barrier was installed to contain the exposed soil but a fair amount of sediment migrated into the adjacent substation.

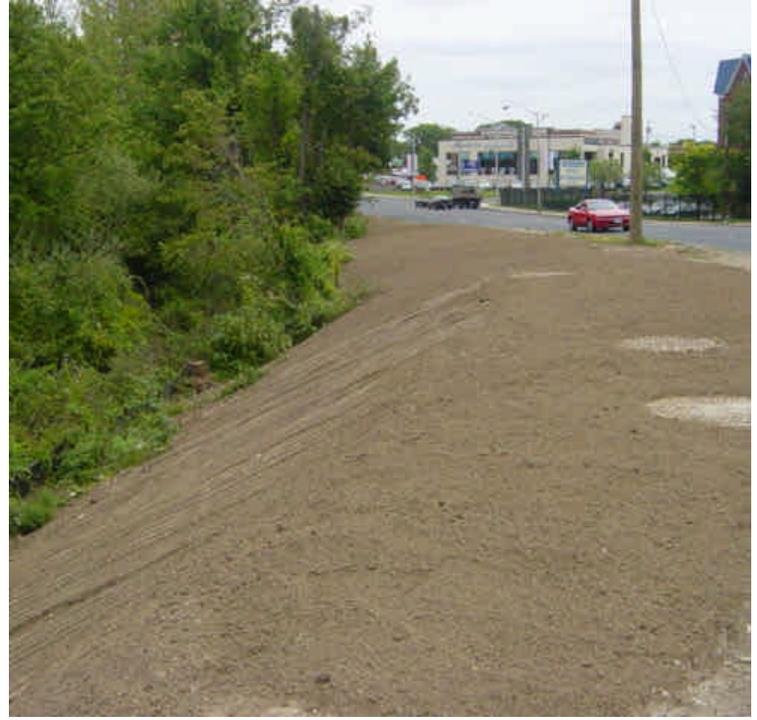
The slope near sta. #14-16 has been re-graded, but did not appear to be seeded or mulched, leaving it vulnerable to erosion.
