Docket No. 272 – Development and Management Plan Inspection

Segment 4c Underground Line

Date: September 19, 2008

Location: Westport Avenue to the Norwalk Substation in the City of Norwalk

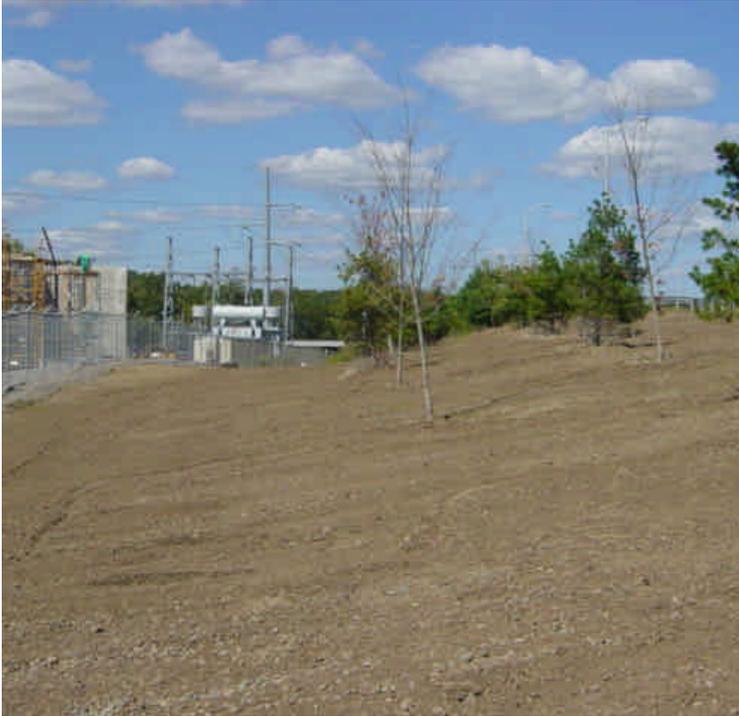
Pre-cast concrete retaining wall was recently restored outside of the Norwalk substation near sta. #0 and the area has been backfilled. Trees, landscaping and hydroseed are also in place.

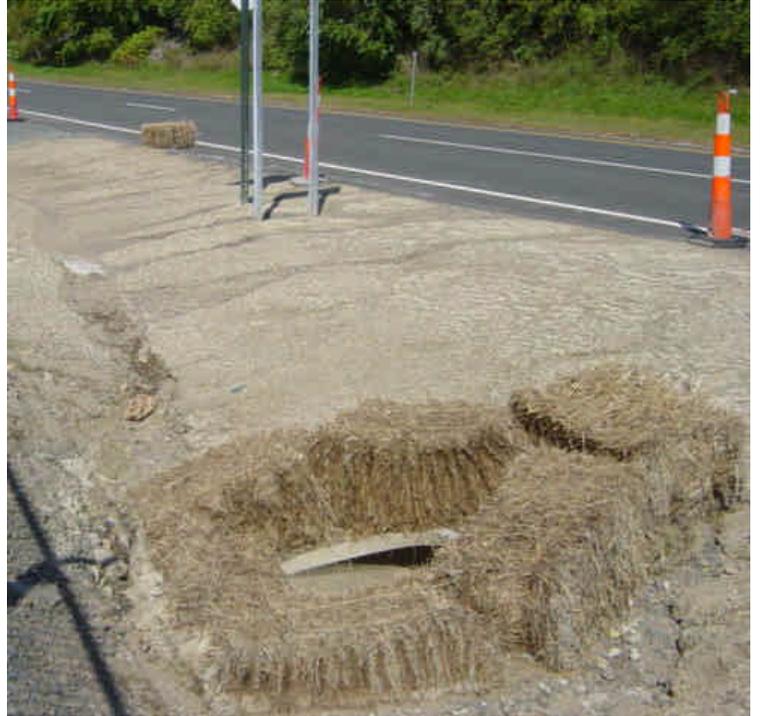
The area around the drainage inlet at sta. #9+50 had been graded and covered in topsoil but heavy rains caused washouts and filled the inlet with sediment and debris despite being surrounded with haybales.

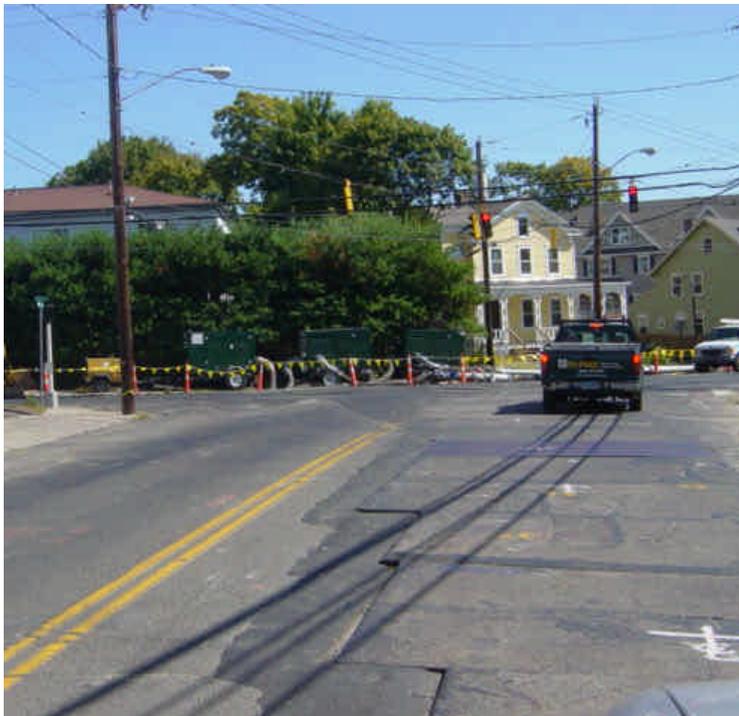
Steel plates are in place near sta. #48-50. Sewer relocation work was also being performed, which may not be project related.

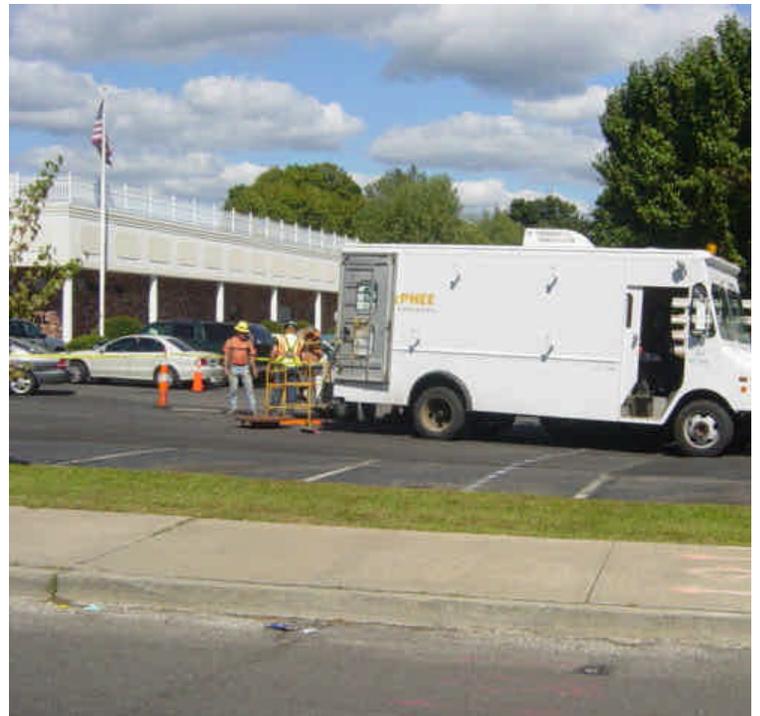
Electrical contractor was on-site at vault #4.
