**Docket No. 272 – Development and Management Plan Inspection**

**Segment 4c Underground Line**

**Date:** October 10, 2008

**Location:** Westport Avenue to the Norwalk Substation in the City of Norwalk

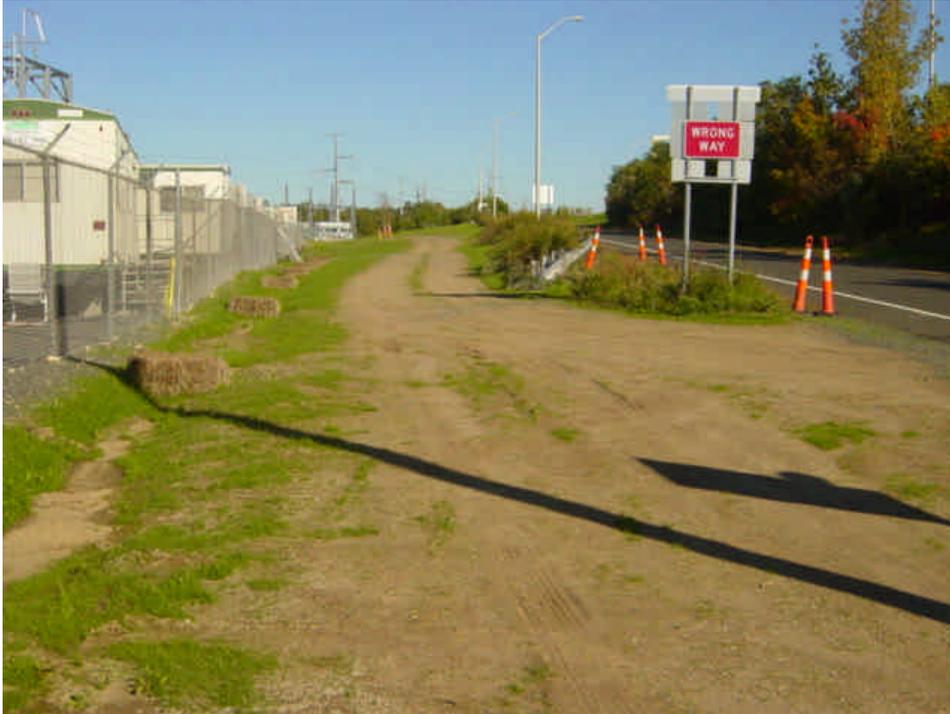
**The area along the Norwalk substation fence near sta. #4-8 has been seeded and the area is beginning to vegetate, except in some areas where construction traffic is impeding growth. The drainage swale has been restored however, heavy rain had caused portions of the swale to fill with sediment. Remove sediment from swale and inlet.**

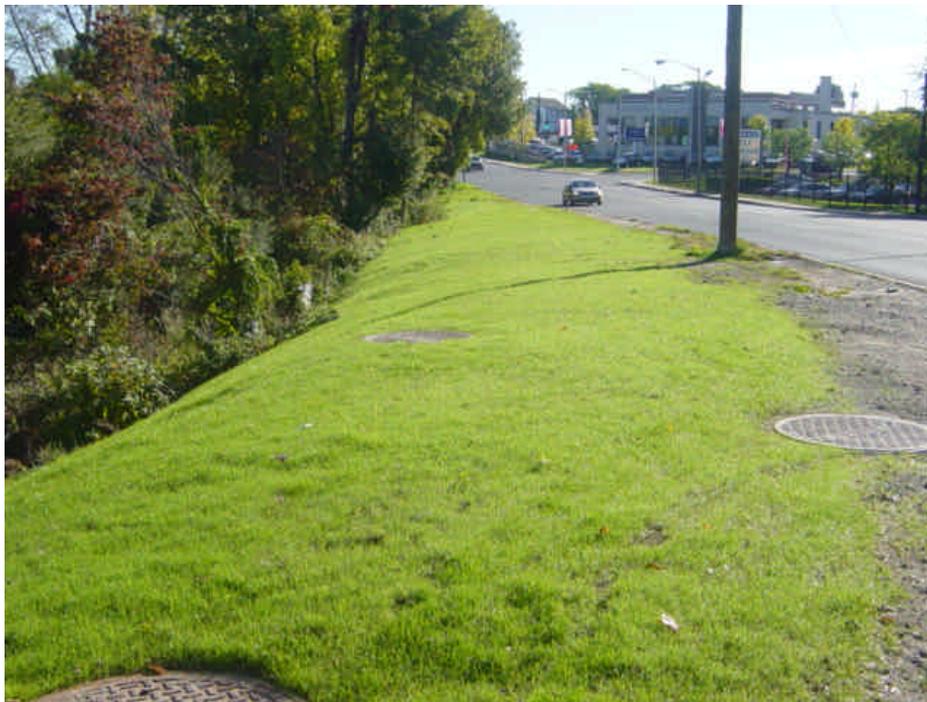
**The slope at sta. #14-18 has been re-graded and is stable, except for a portion near the road where exposed soil remains. Material for the adjacent bridge project (unrelated to M/N) is also being staged in this area.**
