**Docket No. 272 – Development and Management Plan Inspection**

**Segment 4c Underground Line**

**Date:** November 7, 2008

**Location:** Westport Avenue to the Norwalk Substation in the City of Norwalk

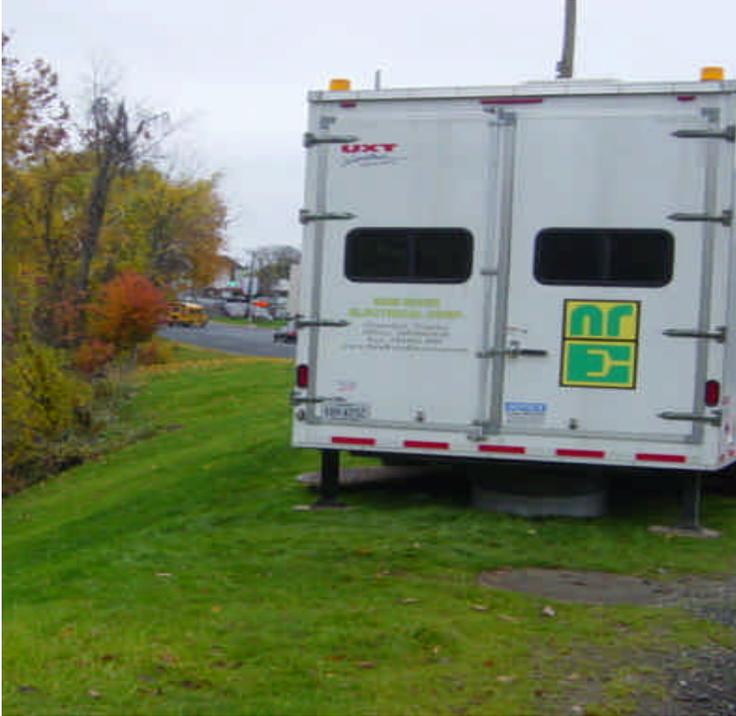
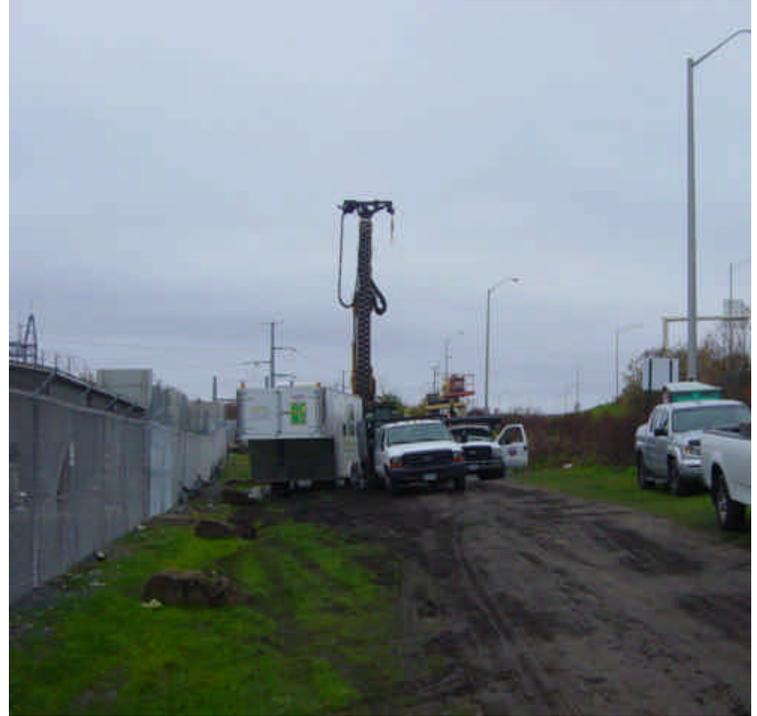
**New River Electric was on site at vaults #0 and #1. The area outside of the Norwalk substation near sta. #6-9 was previously seeded and the area had started to vegetate. Portions of the area remain exposed due to continued construction traffic. Sediment had previously washed out and accumulated in the drainage swale. The receiving catch basin will need to be cleaned out.**

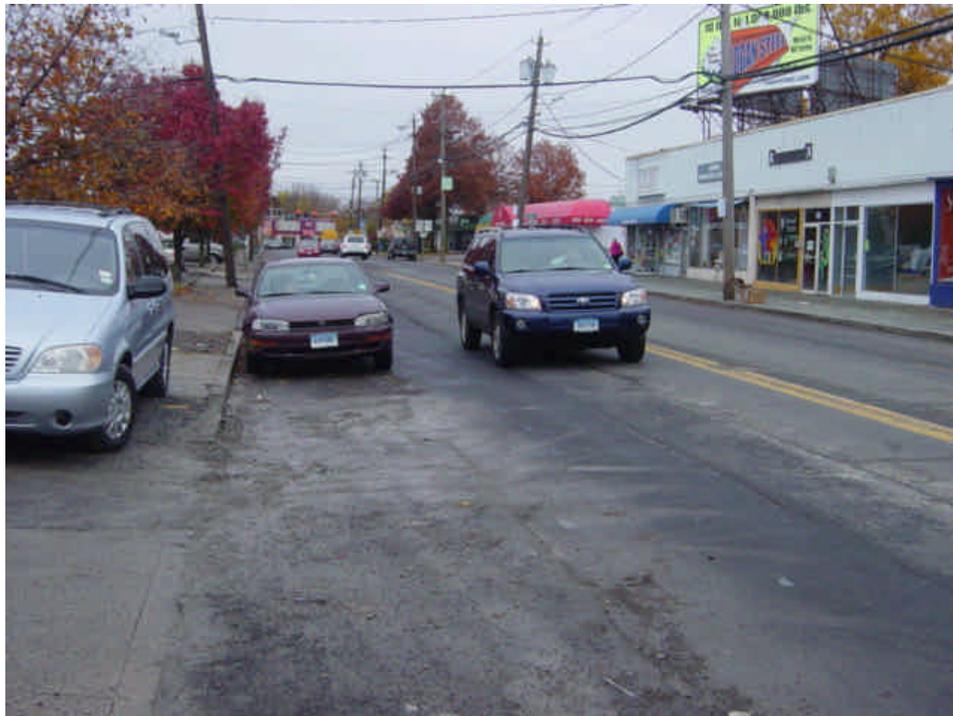
**Sediment and granular material has accumulated along the edge of the roadway near sta. #43-45. The roadway should be swept and the receiving catch basin may need to be cleaned out.**
