**Docket No. 272 – Development and Management Plan Inspection**

**The Connecticut Light and Power Company Certificate of Environmental Compatibility and Public Need for the construction of a new 345-kV electric transmission line and associated facilities between Scovill Rock Switching Station in Middletown and Norwalk Substation in Norwalk, Connecticut, including reconstruction of portions of existing 115-kV and 345-kV electric transmission line, the construction of Beseck Switching Station in Wallingford, East Devon Substation in Milford, (and Singer Substation in Bridgeport), modifications at Scovill Rock Switching Station and Norwalk Substation, and the reconfiguration of certain interconnections.**

**Underground Line Watercourse and Railroad Crossings**

**Date:** February 21, 2008

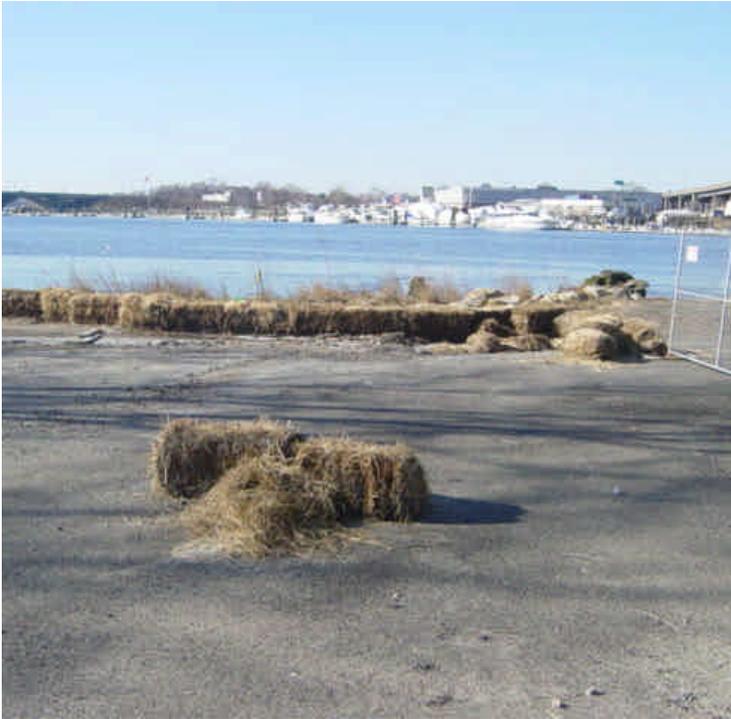
**On the east side of the Housatonic River a haybale barrier remains in place near the end of the paved surface. Haybales are also in place around a small area of pavement that has collapsed near the drilling pit.**

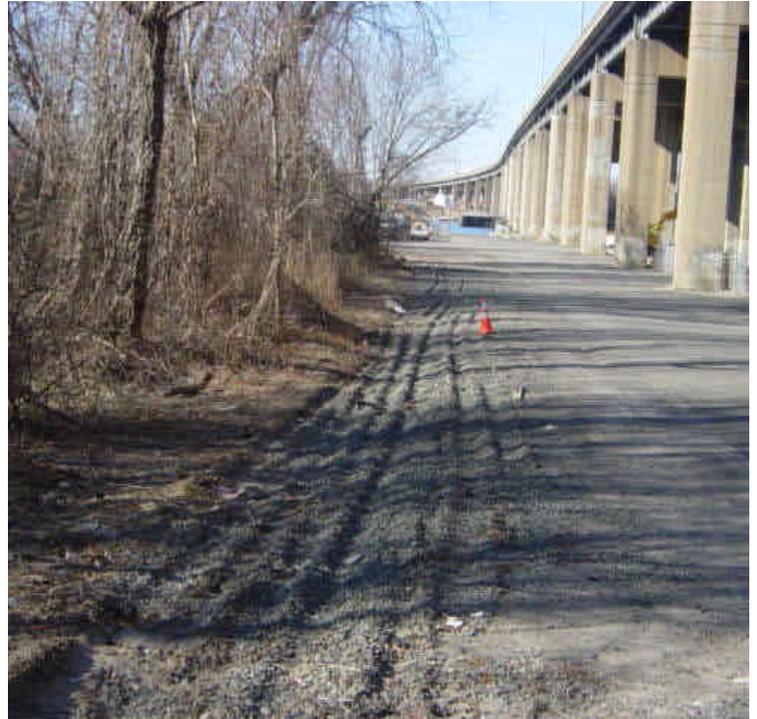
**On the east side of the Housatonic River, conduit had been staged in the area between sta. #1015-1020, creating ruts in the stone backfill installed by Segment 3 contractors. Ruts should be re-graded.**

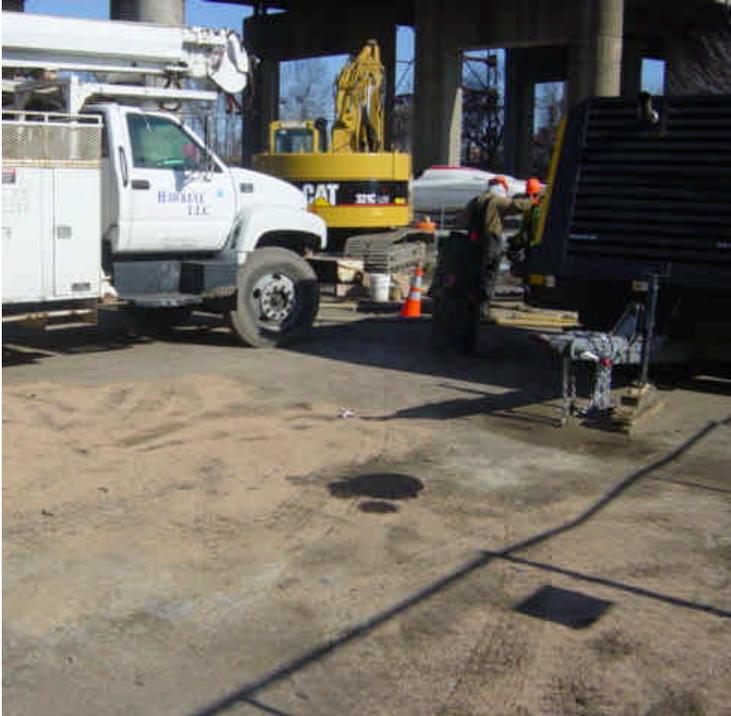
**Spills and absorbent material were still noted near the generator trailer on the west side of the Housatonic River. An additional, fresh spill of oil or some other substance was noted on top of the absorbent material.**

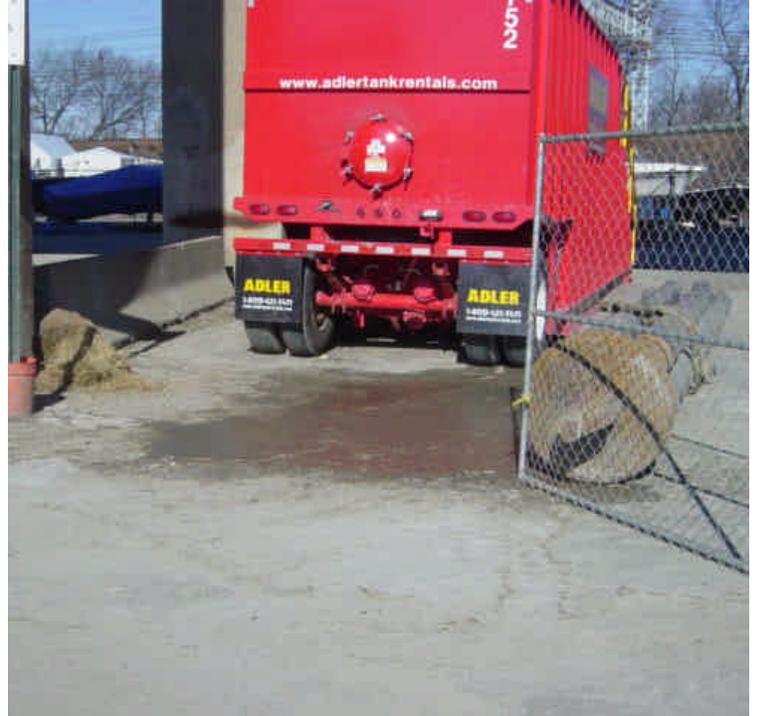
**A frozen puddle of mud/water remains near the frac tank on the west side of the Housatonic River.**

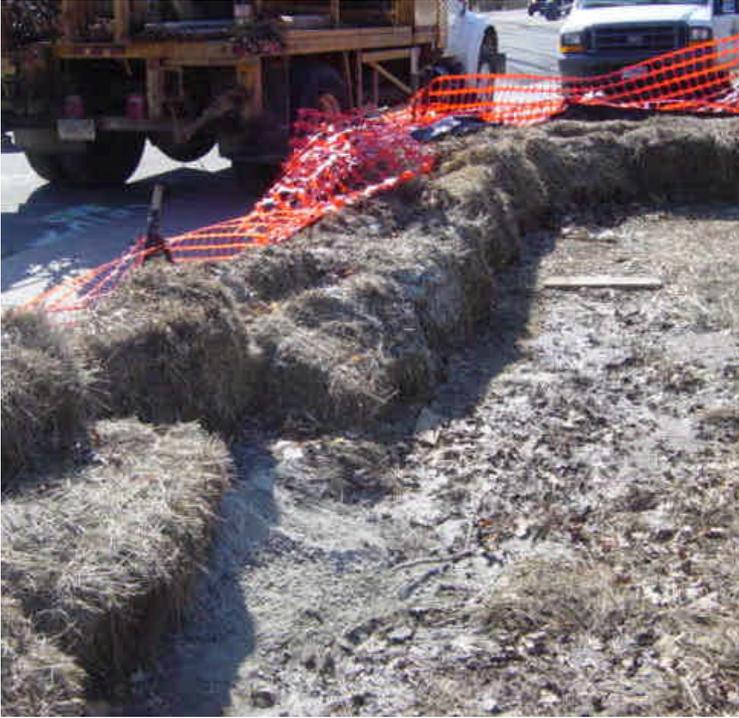
**Haybales in place along Riverside Ave. are successfully retaining a mixture of sediment and what appears to be drilling slurry. This material should be removed as part of the final restoration.**

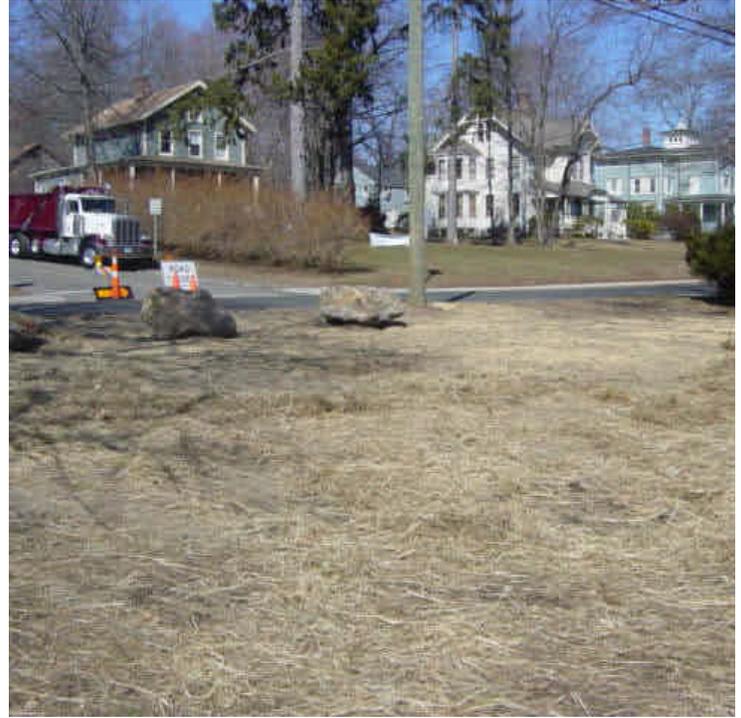
**The park area along Riverside Ave. has been re-graded. Seed and hay mulch have been applied to temporarily stabilize the exposed soil.**

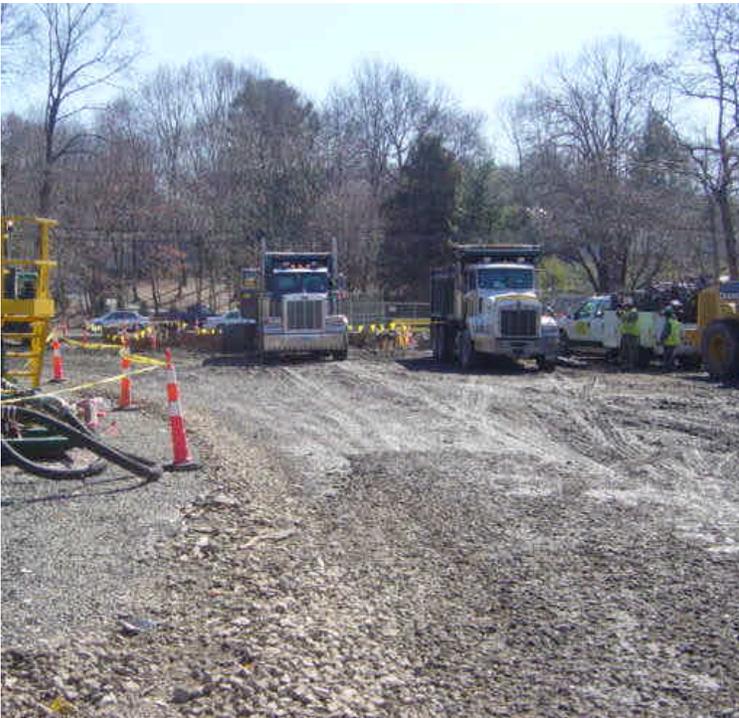
**Staging area on the east side of the Saugatuck River was partially restored but is now being utilized by another contractor to facilitate the vault installation. Final restoration efforts will need to be coordinated between the two contractors.**

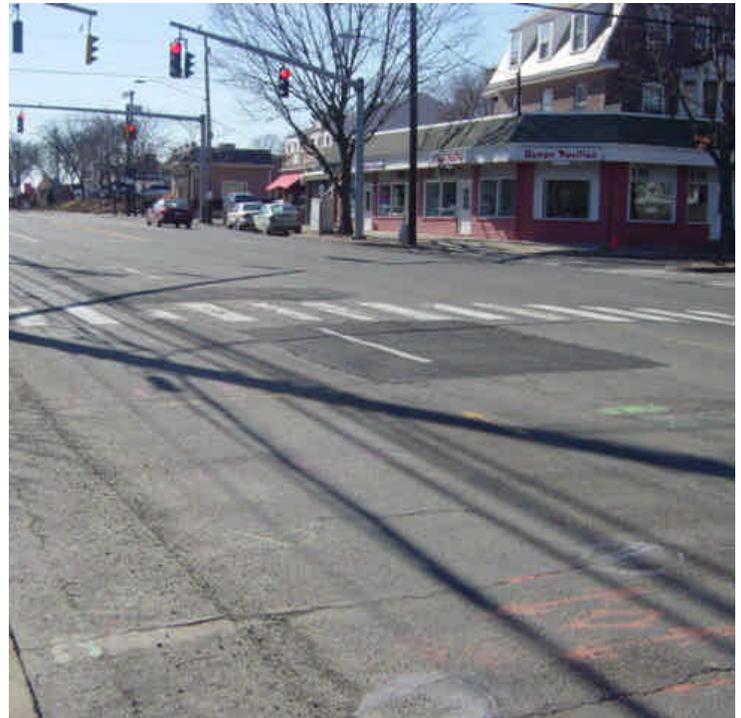
**The HDD work at Ash Creek has been completed. The drilling pits have been backfilled and paved and the temporary lane closure has been removed.**
