Docket No. 272 – Development and Management Plan Inspection

Underground Line Watercourse and Railroad Crossings

Date: March 13, 2008

Location: Crossings of Watercourses and Railroads in Segments 3, 4a and 4b

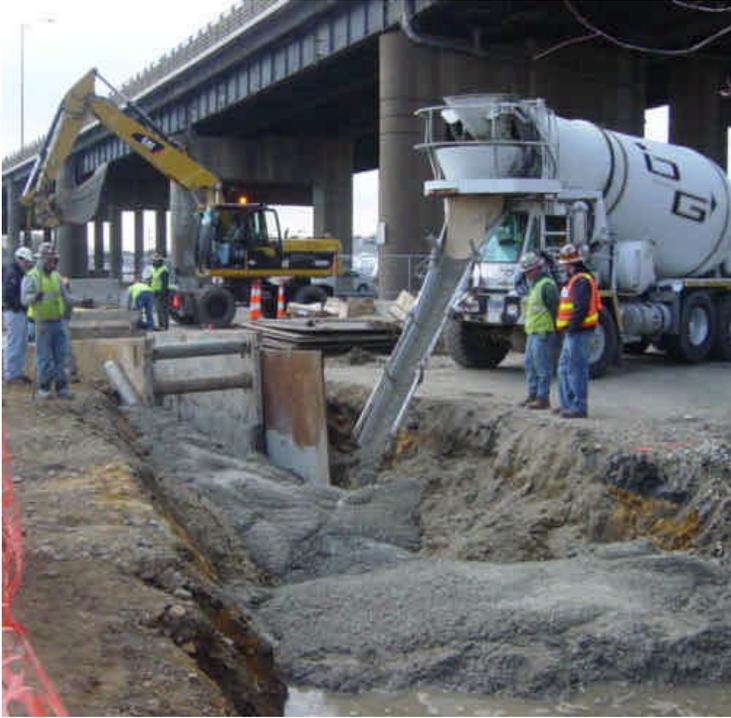
On the west side of the Housatonic River near sta. #999, vault tie-in work is complete and crews were backfilling the drill pit.

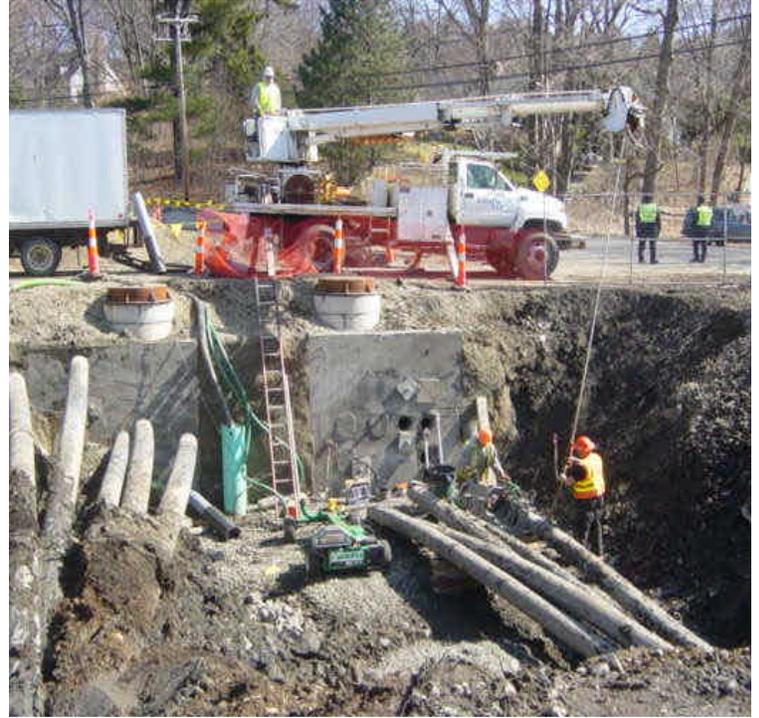
Crews are fusing sections of conduit to complete the tie-in work at the vault near sta. #252.

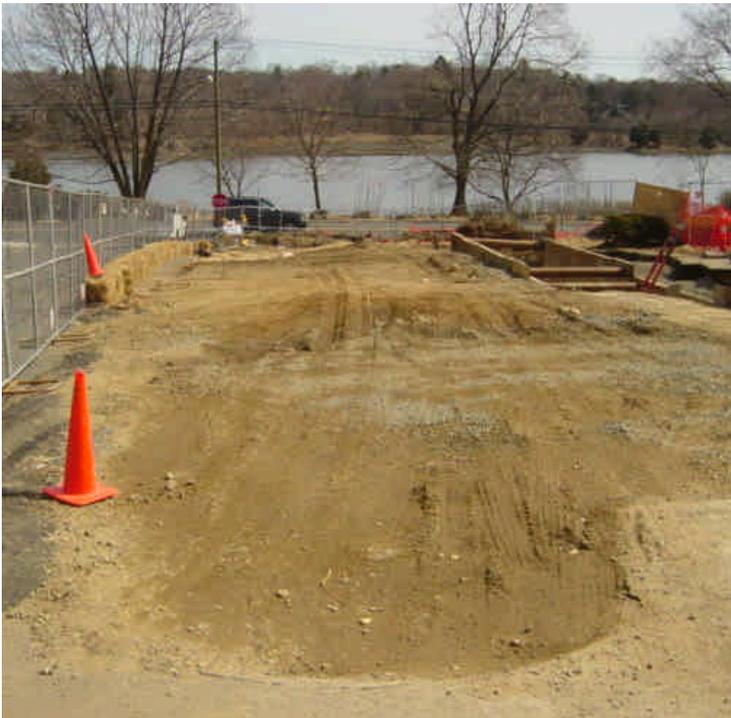
On the west side of the Saugatuck River, the tie-in work for one of the circuits has been completed and the drilling pit has been backfilled. The area is expected to be paved within the next couple of weeks.

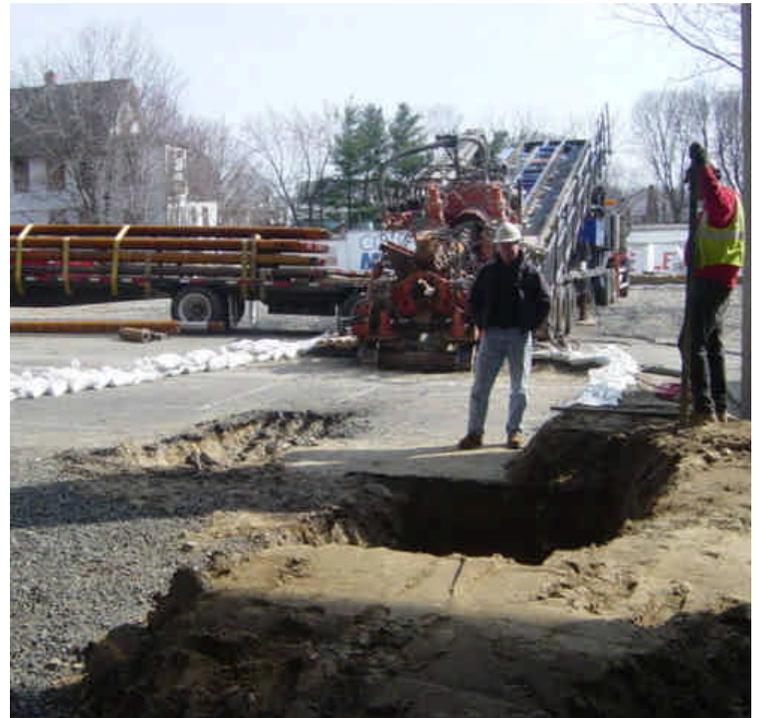
A staging area has been established on the south side of the Metro North R.R. in Milford. The staging area has been surrounded by haybales and a filter boom. Drilling equipment is being set-up and the drill pit has been partially excavated.
