Docket No. 272 – Development and Management Plan Inspection

Underground Line Watercourse and Railroad Crossings

Date: March 20, 2008

Location: Crossings of Watercourses and Railroads in Segments 3, 4a and 4b

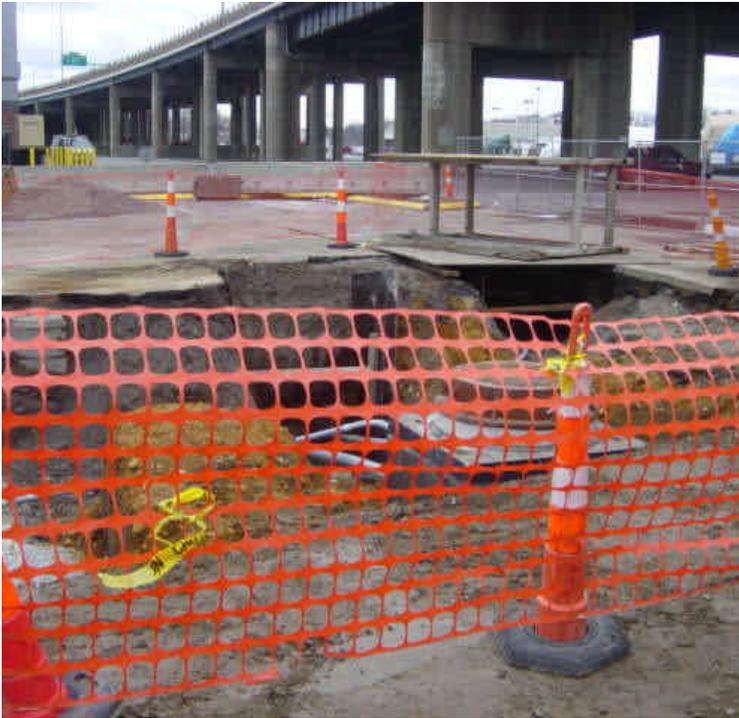
On the west side of the Housatonic River near sta. #999, vault tie-in work is complete and hand holes were installed.

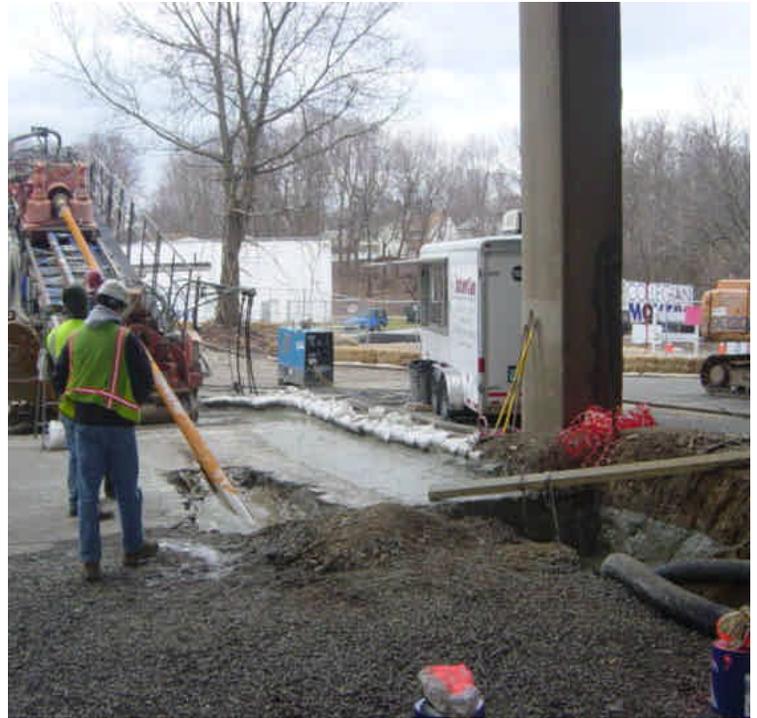
Drilling work is underway at the Metro North R.R. Crossing in Milford. The drilling pit was well contained.

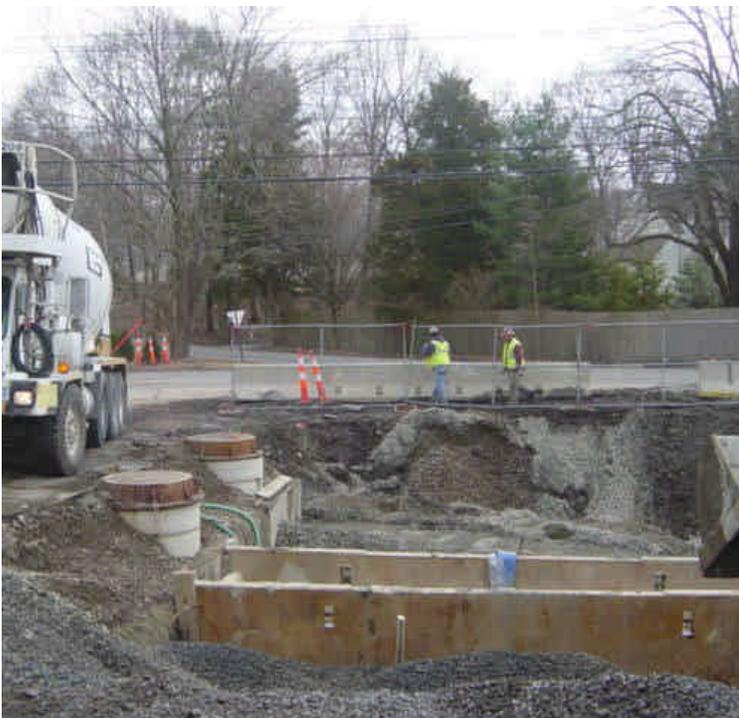
On the east side of the Saugatuck River, the tie-in work is nearing completion. The trench was being backfilled at the time of the inspection.

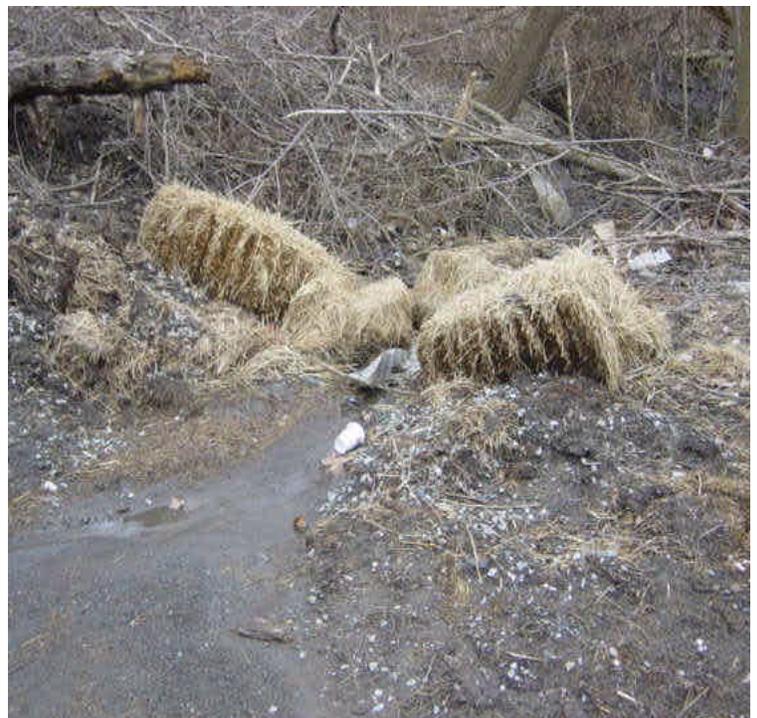
A small channel has formed on the east side of the Housatonic River near the south side of the staging area. Hay bales are in place and are containing most of the sediment but a minor amount has migrated beyond the haybale barrier. A resource area is adjacent to this location.
