Docket No. 272 – Development and Management Plan Inspection

Underground Line Watercourse and Railroad Crossings

Date: March 28, 2008

Location: Crossings of Watercourses and Railroads in Segments 3, 4a and 4b

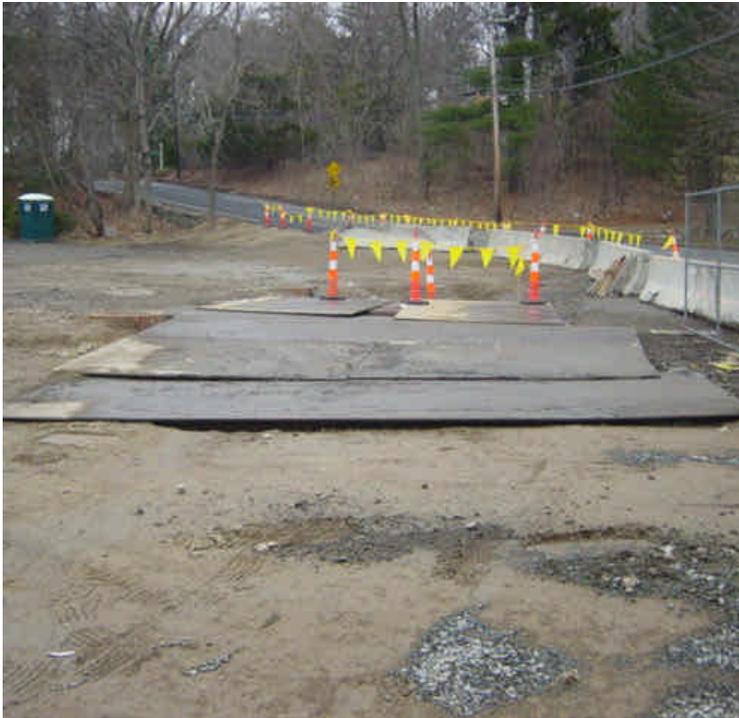
On the east side of the Saugatuck River the drill pit is partially backfilled and steel plates are in place. The staging area has been partially restored.

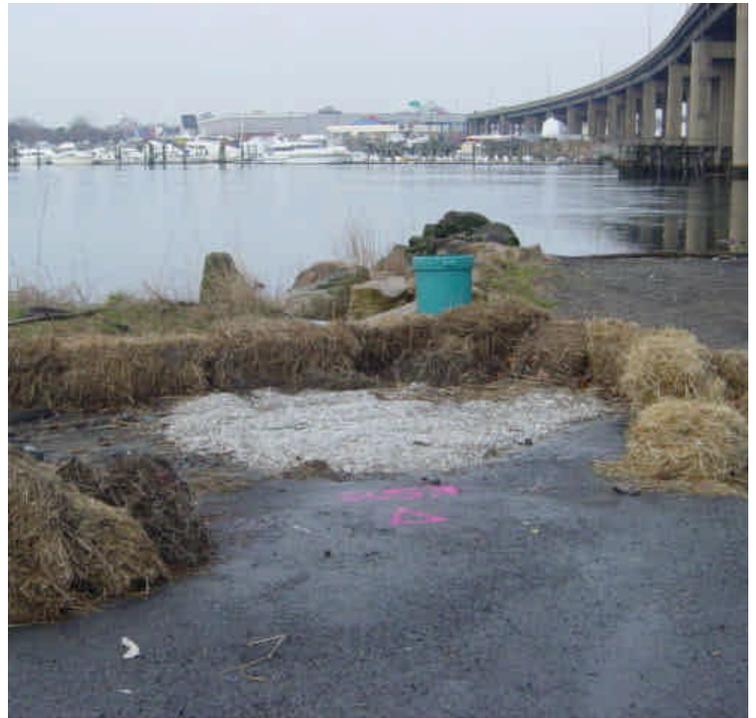
On the east side of the Housatonic River, a previous frac out has been backfilled with crushed stone. Hay bales remain around the area

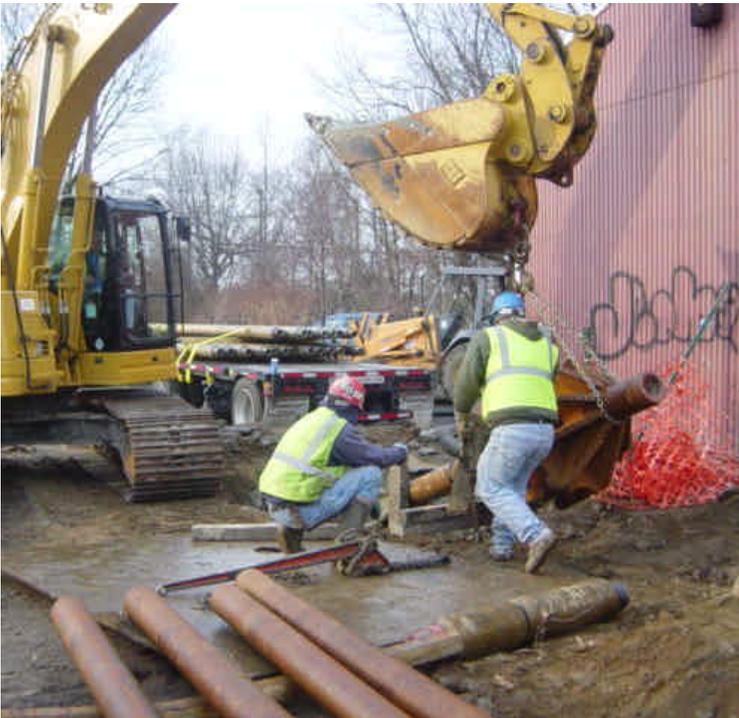
HDD work is underway at the Metro North R.R. crossing in Milford. A larger reaming bit was being installed in the north staging area located just off of Naugatuck Ave.

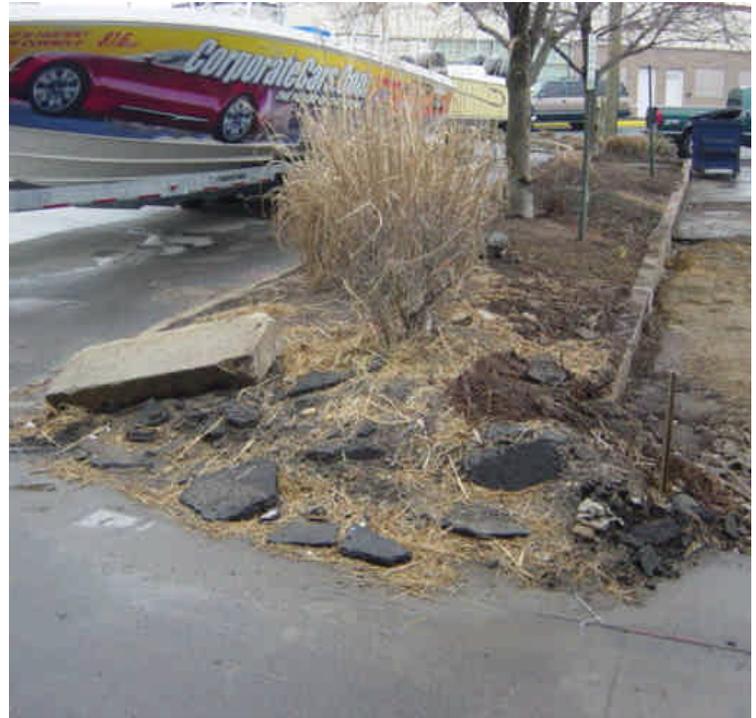
Additional Observations	<p>A small section of curbing has been damaged on the west side of the Housatonic near the corner where the drill pit was located. 3/28/08</p>	<p>Restore damaged section of curbing to pre-construction conditions. Ensure soil is currently contained. 3/28/08</p>	<p>Needs attention during restoration.</p>

A small section of curbing has been damaged near the staging area on the west side of the Housatonic River. Repair the curbing during restoration and make sure exposed soil is currently contained.
