Docket No. 272 – Development and Management Plan Inspection

Underground Line Watercourse and Railroad Crossings

Date: May 8, 2008

Location: Crossings of Watercourses and Railroads in Segments 3, 4a and 4b

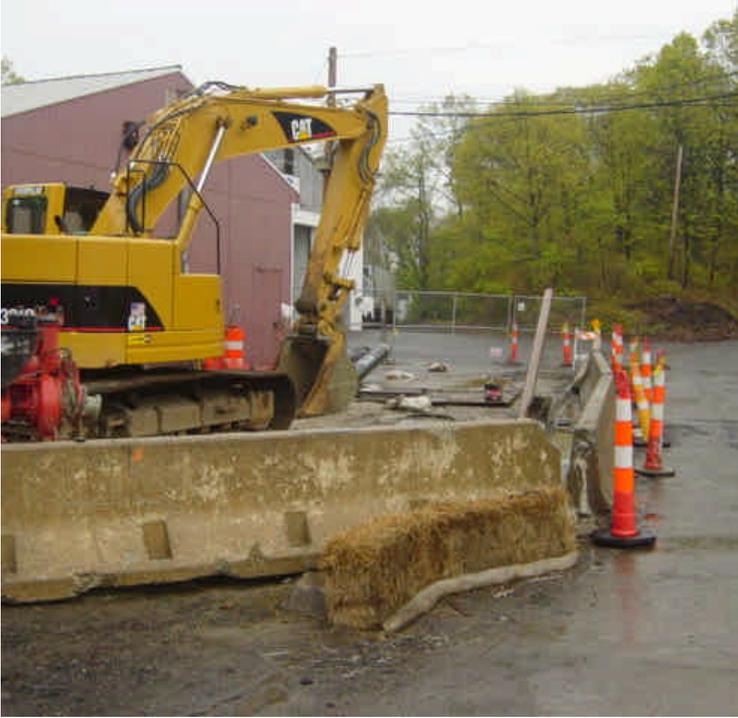
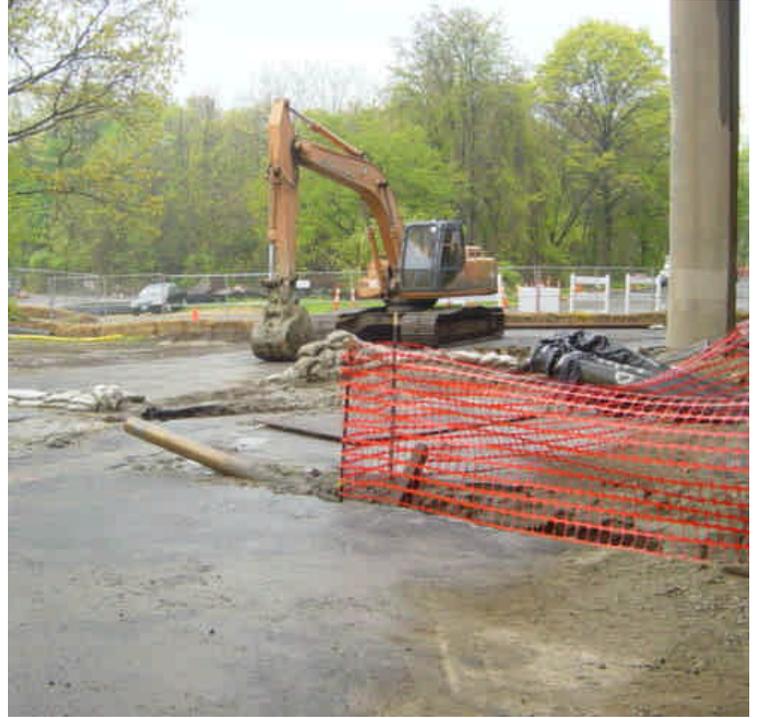
Metro North RR: Work was temporarily on hold as crews were awaiting a larger drilling rig. The catch basin adjacent to the drilling pit along Naugatuck Avenue remains protected. A minor amount of drilling slurry was observed on the roadway. The staging area on the south side remains well contained.

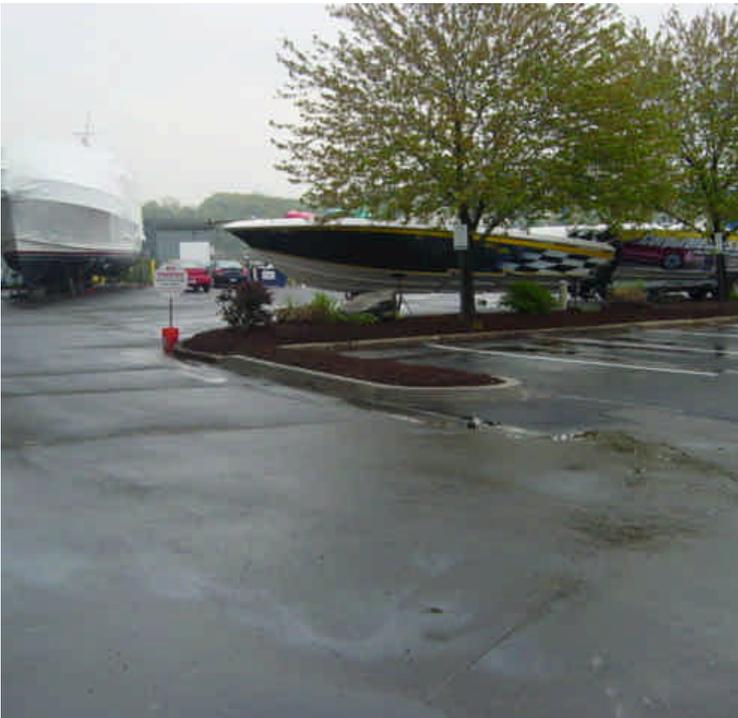
HDD work at the Housatonic River is complete. Damaged curbing has been replaced on the west side of the River, completing the restoration work on this side.

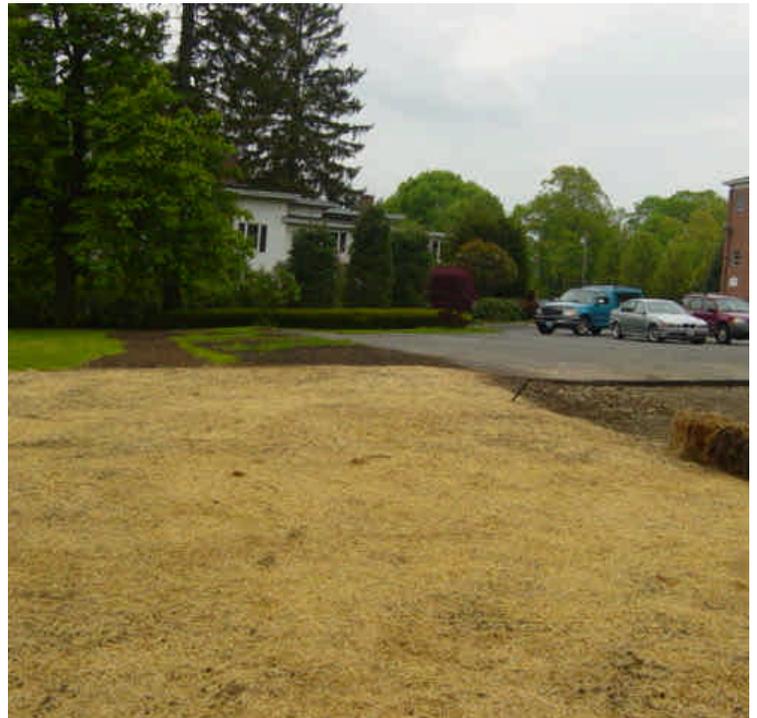
The work area on the west side of the Saugatuck River remains mulched. The area was seeded a few weeks ago.

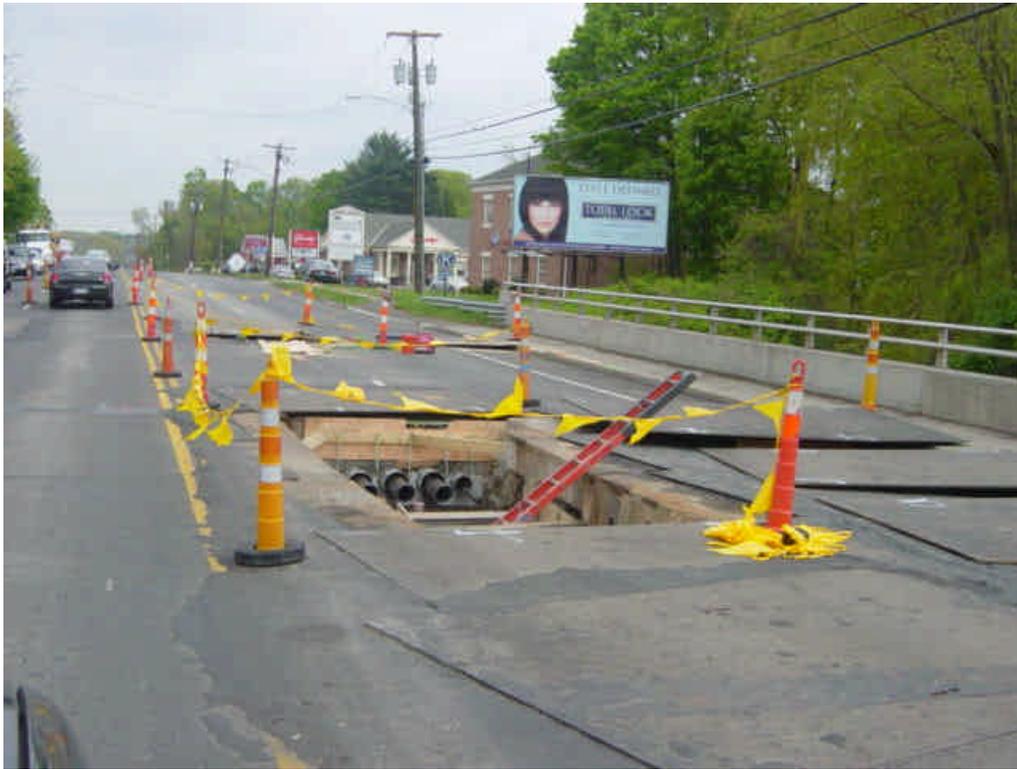
Work continues on both sides of the bridge over Sasco Creek near sta. #435 in preparation for hanging the conduit bank from the bridge deck. (This area represents the intersection between Segments 4A and 4B).
