**Docket No. 272 – Development and Management Plan Inspection**

**The Connecticut Light and Power Company Certificate of Environmental Compatibility and Public Need for the construction of a new 345-kV electric transmission line and associated facilities between Scovill Rock Switching Station in Middletown and Norwalk Substation in Norwalk, Connecticut, including reconstruction of portions of existing 115-kV and 345-kV electric transmission line, the construction of Beseck Switching Station in Wallingford, East Devon Substation in Milford, (and Singer Substation in Bridgeport), modifications at Scovill Rock Switching Station and Norwalk Substation, and the reconfiguration of certain interconnections.**

**Underground Line Watercourse and Railroad Crossings**

**Date:** May 15, 2008

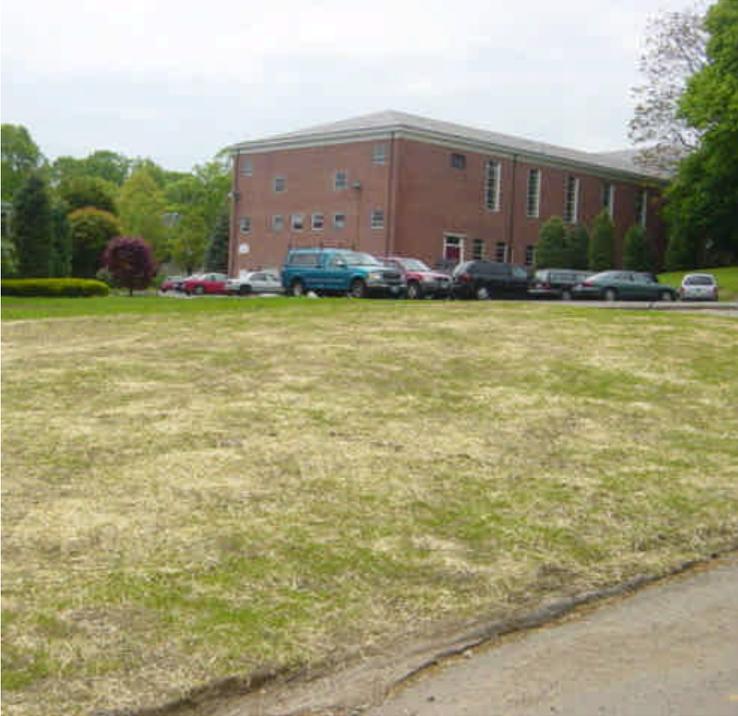
**Vegetation is beginning to grow on the restored portions on the west side of the Saugatuck River near sta. #234. Adjacent areas are still waiting to be paved.**

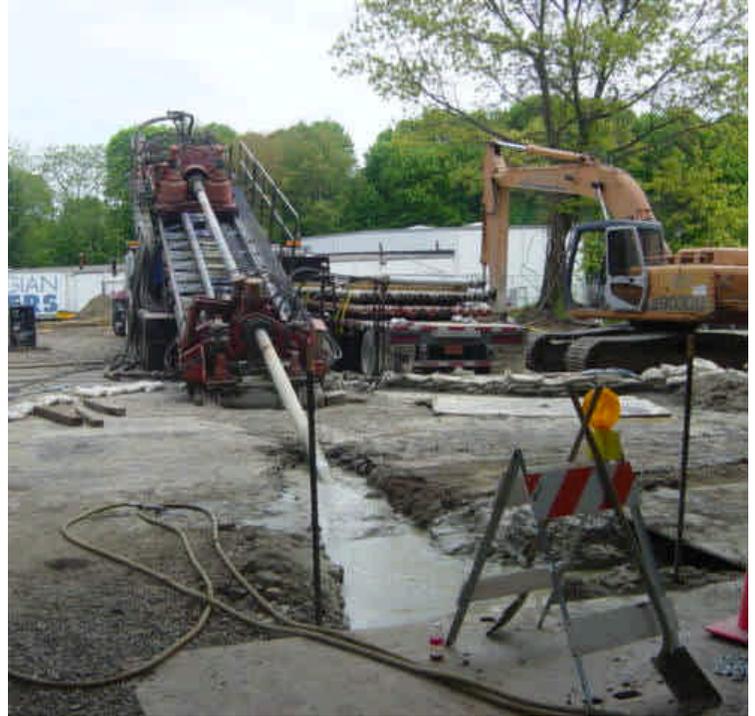
**HDD work continues at the Metro North Railroad crossing in Milford. A sand bag berm remains around the drill pit and the area is well contained.**

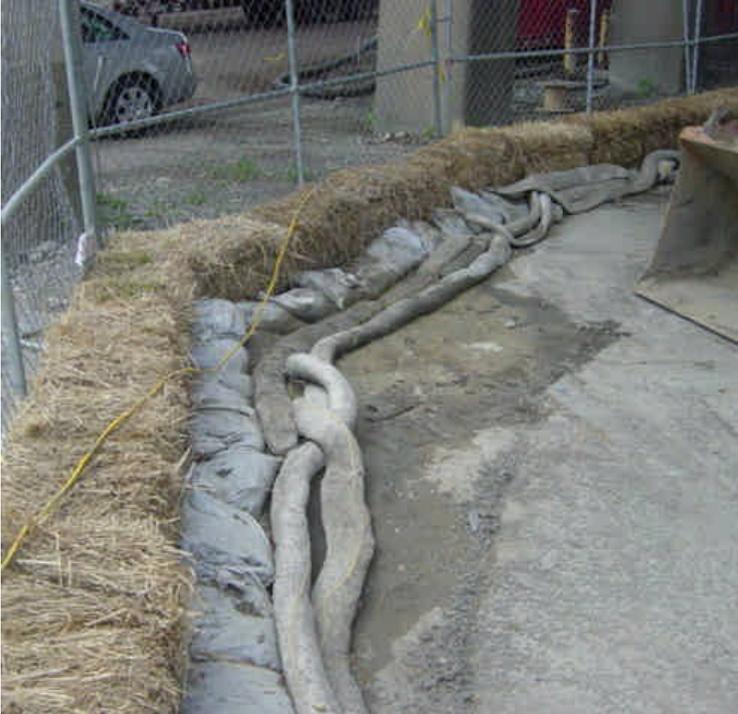
**A minor amount of slurry material has accumulated along the perimeter of the staging area. Controls have been reinforced with sandbags and additional filter booms. Sweep sediment as needed.**

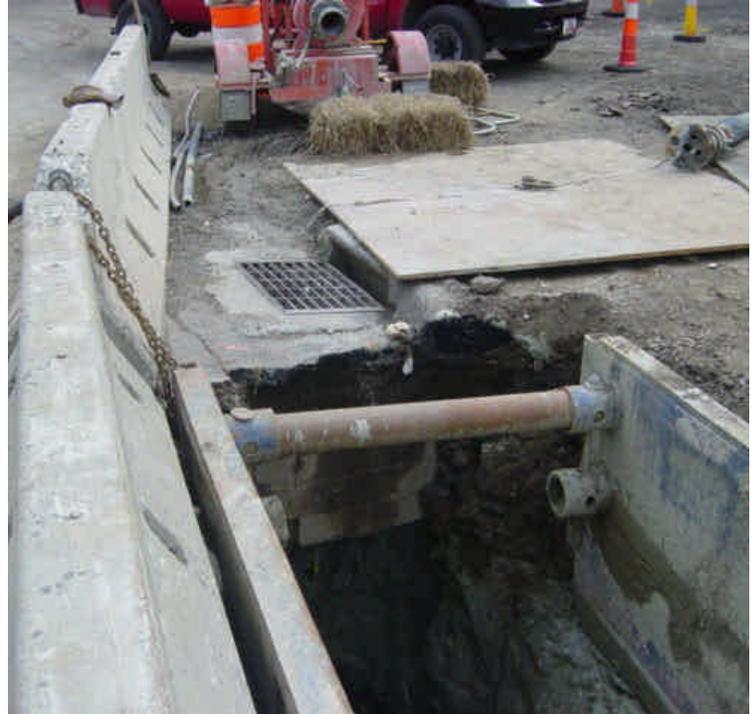
**Catch basin adjacent to the drilling pit along Naugatuck Ave. was previously protected, but the hay bales were removed from the basin. Either install controls directly within the grate or vacuum the basin following the active work.**

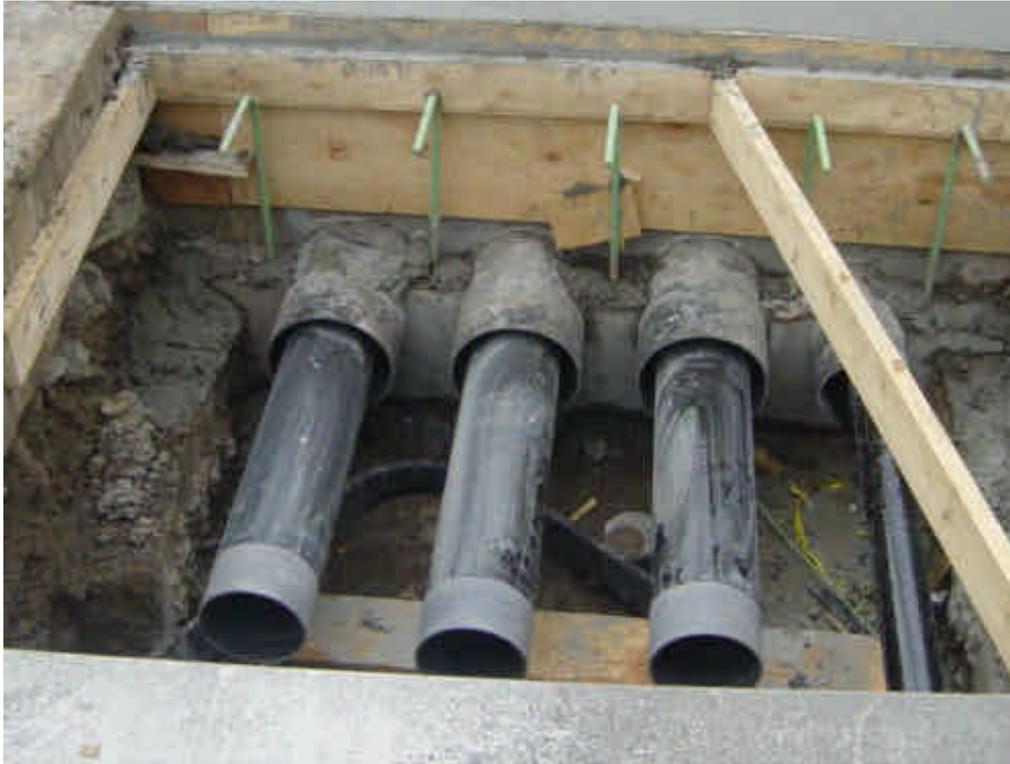
**Work continues on the bridge crossing over Sasco Creek near sta. #434 as conduit sleeves were being installed under the bridge deck.**
